SAND93-3917c

Assessing Braze Quality in the
Actively Cooled Tore Supra Phase III Outboard Pump Limiter

R. E. Nygren, T. L. Lutz, J. D. Miller, R. McGrath
Sandia National Laboratories, Albuquerque, New Mexico, USA*
and G. Dale
University of New Mexico

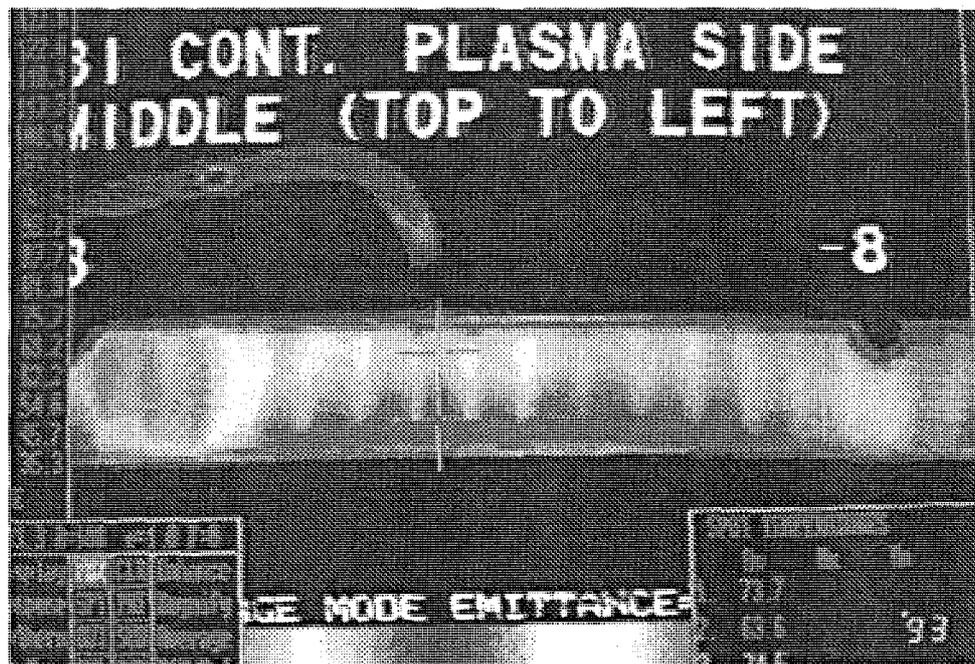
Figure 3 shows the video data (processed IR images) of a view of the central portion of Tube 3i. Here, to the left of "-8", for several tiles (Tiles 3-8), the lower portion is darker than the upper portion indicating a asymmetric temperature distributions. As noted above this, and the grouping of several adjacent tiles, suggests that cracking along the braze may have occured, perhaps during handling of the tubes.

Figure 3. Still frame from (color) IR output for Tube 3i hot water test.

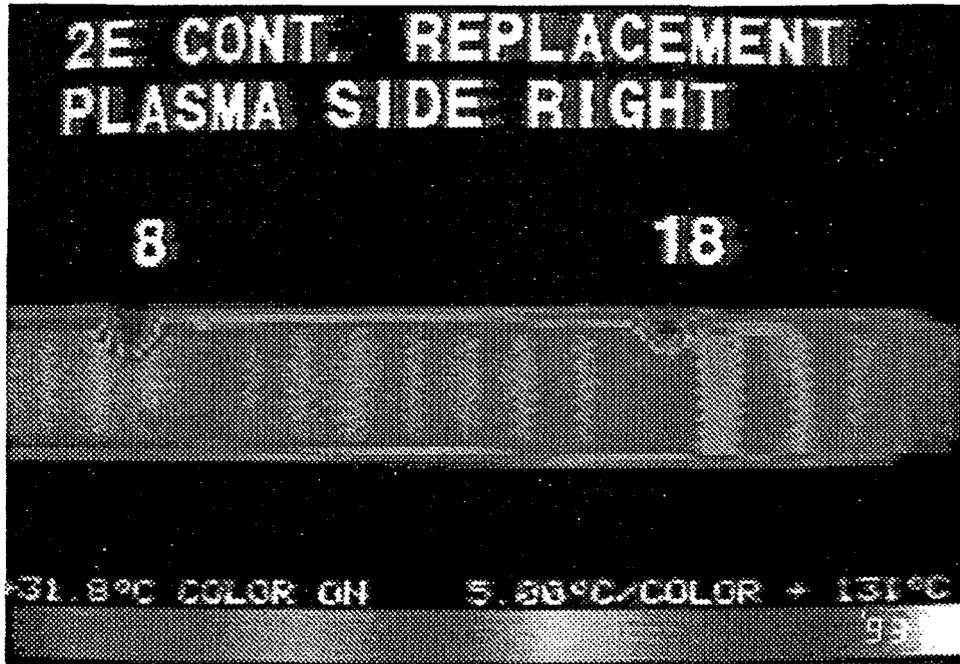
Figure 4 shows the processed IR images for the plasma facing surface of Tube 2e. The vertical bands are the edges of individual tiles. Below and to the right of the marker "18" is a light area (Tile 19). The difference in shading (color[4]) from Tiles 18 and 20 indicates a lag in temperature; the

uniformity of surface temperature across Tile 19 suggests the lag is due to a symmetric braze flaw rather than an asymetric flaw or crack.

Figure 4. IR output for Tube 2e, plasma side, right end. Black
depressions below 8 and 18 are markers.

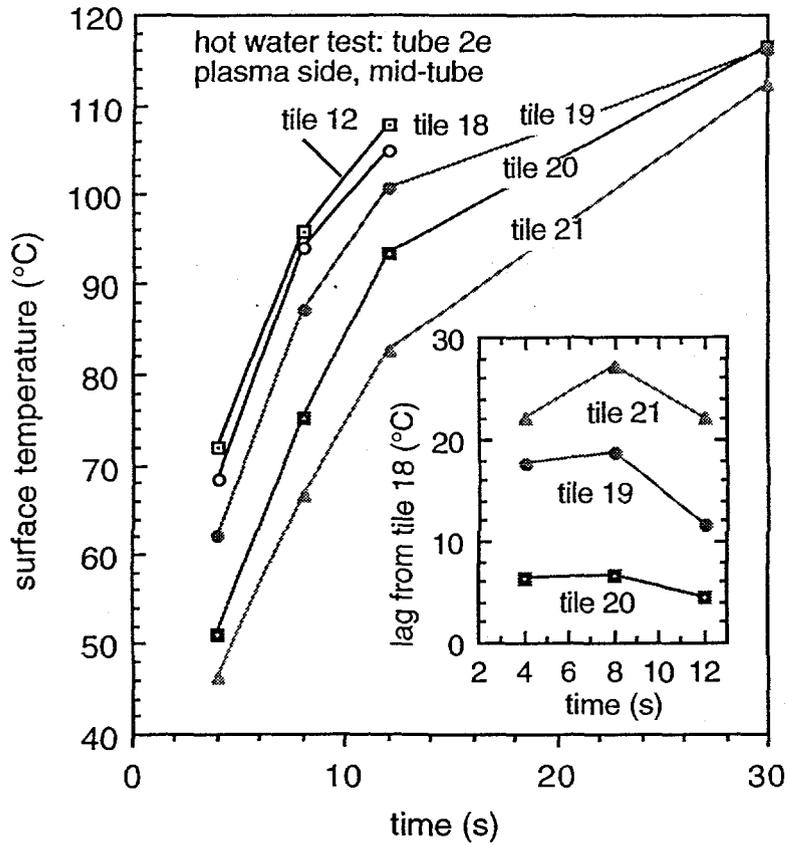
Figure 5 shows the temperature rise for selected spots on Tube 2e. The temperature lag for Tile 19 is apparent.[5] In Figure 5, the temperature lags are also plotted directly. The course sampling of the IR data (every four seconds in Figure 5) was representative of the data used and was considered adequate to show the magnitude and the rise and fall of the temperature lags for the large tubes. A final point near the equilibration temperature was also used to confirm that the emissivity of the tiles being compared was nearly the same. More rapid sampling was used for the smaller tubes. Typically the individual data points were an average at the designated location of the IR readings over 20 frames. The apparent scatter of individual readings was about $\pm 2°$ C over times short compared to the rising temperature.

Figure 5. Surface temperature versus time for selected points on Tube 2e during hot water test. Temperature lag is shown in the insert.
