IN SITU MEASUREMENT OF CERAMIC VACUUM CHAMBER CONDUCTIVE COATING QUALITY

C. Doose, K. Harkay, S. Kim and S. Milton

Advanced Photon Source, Argonne National Laboratory

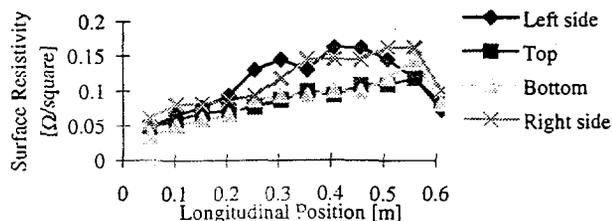
Figure 5: Uneven coating surface resistivity.

In situ measurements on the suspect ceramic vacuum chambers using the sensor coil revealed the cause of the heating to be a lack of sufficient conductive coating. In fact, the coating surface resistivity was so large on two chambers that it was beyond the measurement resolution of the sensor coil system. After removal from the storage ring it was found that the end-to-end DC resistance of one chamber was greater than 1 MΩ. The second chamber's DC resistance was 320 Ω, these are to be compared to the desired value of 0.3 Ω.. Measurements on new spare chambers, before their installation into the machine, revealed another defect, and that was uneven coating along the length of the chamber as shown in Figure 5. This was caused due to sagging of the liquid coating during the initial curing process of the coating on the chamber (the chamber had been mounted vertically). After correcting the sagging problem, subsequent chamber coating quality has met design requirements as shown in Figure 6.

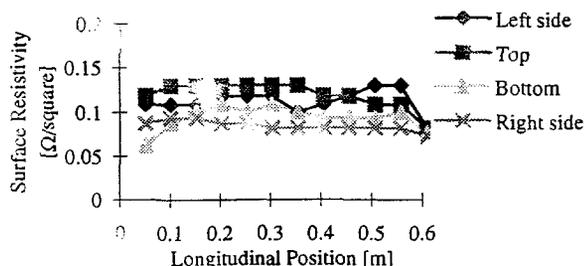
Figure 6: Relatively even coating surface resistivity.

f the cavity. The calculated surface resistivity for the chamber depicted in Figu

re 6 is between 0.06 and 0.3 Ω/square. The surface resistivity for the two defective storage ring chambers was more than a factor of 200 higher.
