THE CRACKING OF PRESSURE TUBES IN THE PICKERING REACTOR

Small cracks in 17 of the 390 pressure tubes in Unit 3 of the 2056 MW (electrical) Pickering Generating Station and of 52 tubes in Unit 4, resulted in each of these units being out of service for many months. The cracks originated at areas of extremely high residual tensile stress produced by improper positioning of the rolling tool used during construction to join the pressure tube to its end-fitting. The mechanism of failure was delayed hydrogen cracking.

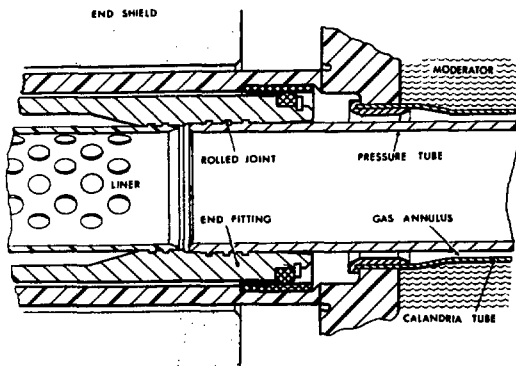
Figure 2 – Rolled joint arrangement in Pickering reactor.

Figure 2 shows the cross section of a rolled joint. Three grooves are machined in the end fitting bore. The pressure tube is inserted into the end fitting covering the grooves. A tube expander is introduced into the pressure tube through the end fitting (Figure 3). The tube is roll expanded into the end fitting. The tube wall thickness is reduced by 12 to 13% and the grooves in the end fitting are partially filled with tube material which locks the tube to the end fitting producing leak tightness and axial strength. Although the rolled joints themselves have behaved perfectly, improper rolling procedures during construction caused cracks close to the rolled joint in 17 pressure tubes of Unit 3 and in 60 tubes in Unit 4. However, before discussing the cracks in the tubes, the events leading to the discovery of the cracks will be reviewed.

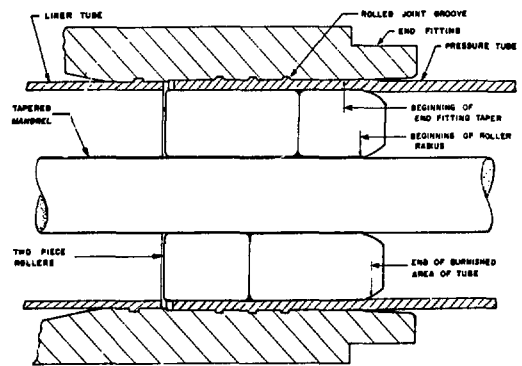
Figure 3 – Cross section of a rolled joint during roll expanding.

a) Dimensional measurements in the tube and rolled joint showed that the rolling tool had been inserted about 13 mm (0.5 in.) too far into the tube at the 'West' end during the rolling operation. This condition is termed 'over-extended' rolling. The rolling tool had thus been expanding the tube for about 10 to 15 mm (0.4 to 0.6 in.) beyond the hub (the parallel bore of the end fitting), and in a region where the tube has little support. (See position of taper and roll in a poor joint, Figure 5.) The joints at the 'East' end of the reactor were not as over-extended as those at the 'West' end.
