As part of LLNL's program on radionuclide migration through fractured rock, major geologic discontinuities have been mapped and characterized at the 420 m level in the Climax Stock, adjacent to LLNL's Spent Fuel Test. Persistence or continuity of features was the principal sampling criterion, and ninety major fractures and faults were mapped in the main access and tail drifts. Although the purpose and nature of this study was different from previous fracture surveys in the Climax Stock, the results are generally consistent in that three predominant fracture sets are identified: NW strike/vertical, NE strike/vertical, NW strike/subhorizontal. The frequency of major features in the main access drift is somewhat higher than in the tail drift. Those mapped in the main access drift are generally braided, stepped, or en echelon, while those in the tail drift appear to be more distinct and planar. Several of the fractures in the tail drift lie in the NE/vertical set, while most form an entirely different set oriented N5E/55NW. Sub-horizontal fractures were common to both drifts. An area of seepage associated with some of these low-angle features was mapped in the main access drift.

The f

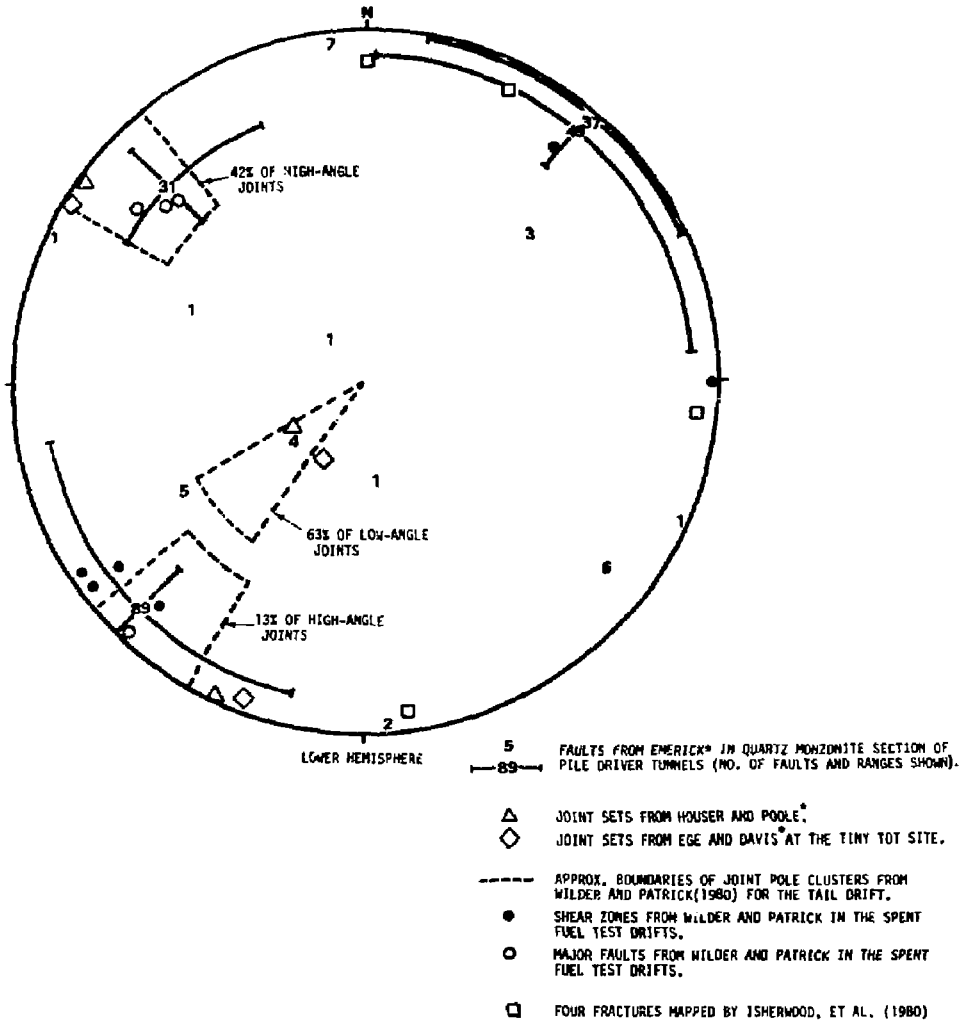
For the quartz-monzonite portion of the Pile Driver tunnel complex, Maldonado gives the average orientations of 239 faults, based on unpublished data by W. L. Emerick (1966). These data are also plotted in Fig. 3, and the ranges in strike and dip (from Maldonado's Table 10) around the dominant pole directions are indicated. The diagram shows that most of the mean fault orientations in the quartz-monzonite, which includes the area of the present study, are within 25° of the three joint sets cited above. Considering the usual scatter of poles about a mean, the correlation is fairly strong.

Fig. 3. Equal-area pole plot summarizing fracture orientations found in previous surveys of the Climax Stock.

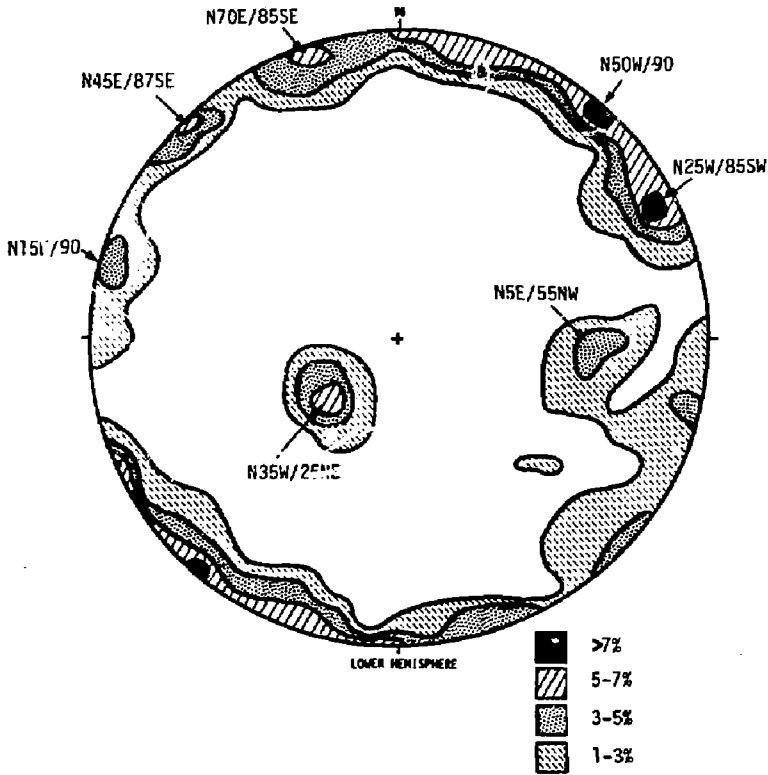
Another prominent grouping in Fig. 6 is oriented N45E/87SE and corresponds to the NE-striking set of high-angle fractures reported by Maldonado (1977) and Wilder and Patrick (1980). Two lesser modes occur near this set at N70E/85SE and N15E/90, however these do not correlate with previous mappings. Throughout most of the area mapped in the main access

Fig. 6. Equal-area contour diagram of poles to 90 fractures measured in the main access and tail drifts, based on data from Figs. 7 and 9. (Concentrations in percentage of points within on percent area counting circle).

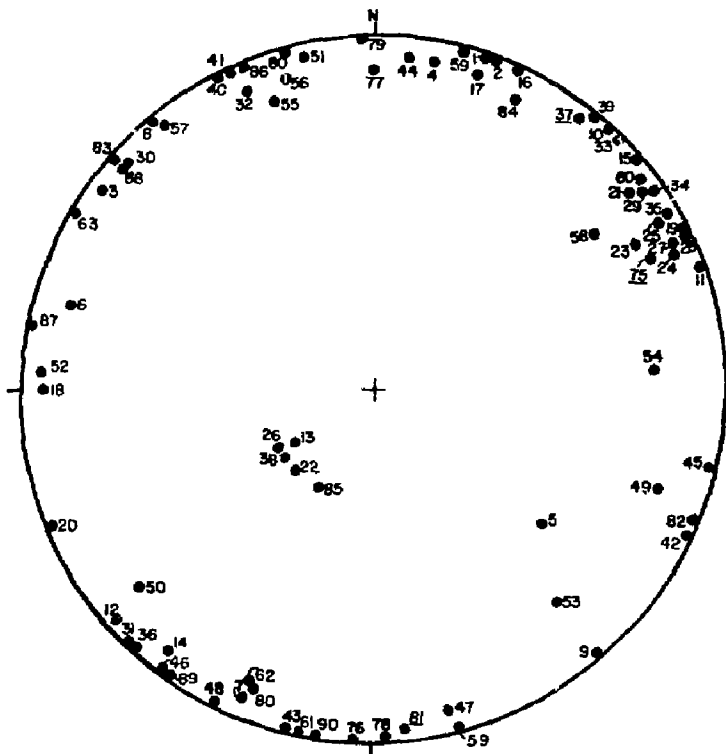
Seventy-nine of the fractures mapped are located in the main access drift, and an equal-area pole plot of these is given in Fig. 7. In cases where a fracture is curved, the average of several different measured orientations was plotted. The predominant orientation of the fractures in the access drift is N50W/90 as indicated by Fig. 6. A somewhat lesser peak within this clustering is oriented N25W/85SW. These correspond roughly to the NW-striking fault and joint sets reported by Maldonado, as well as to some of the shear zones and joints given by Wilder and Patrick (1980). Typical mineralization of fractures in the main access drift is mostly calcite, with some iron oxide and chlorite. The wall rock is sometimes altered to clay. Thickness of filling varies widely both on a given fracture and among fractures, but for single, unsheared features it is typically one to three millimeters.

Seven fault zones within the N50W/90 set were mapped in the main access drift, all of which were identified in Maldonado's report. They are typically composed of many braided or en echelon fractures, and gouge material includes calcite, clay, and chlorite materials. Widths of the zones range from about 0.3 to 1.0 meter. A reliable direction of shearing could not be determined from the observed slickensides, though dip-slip motion is indicated. The wall rock is generally homogeneous, and because few other features were observed to cross these faults it was difficult to determine the amount of offset along the faults.

Fig. 7. Lower hemisphere Schmidt plot of poles to fractures mapped in the main access drift. Numbers correspond to features on base map; those underlined indicate average measurements on curved surfaces.

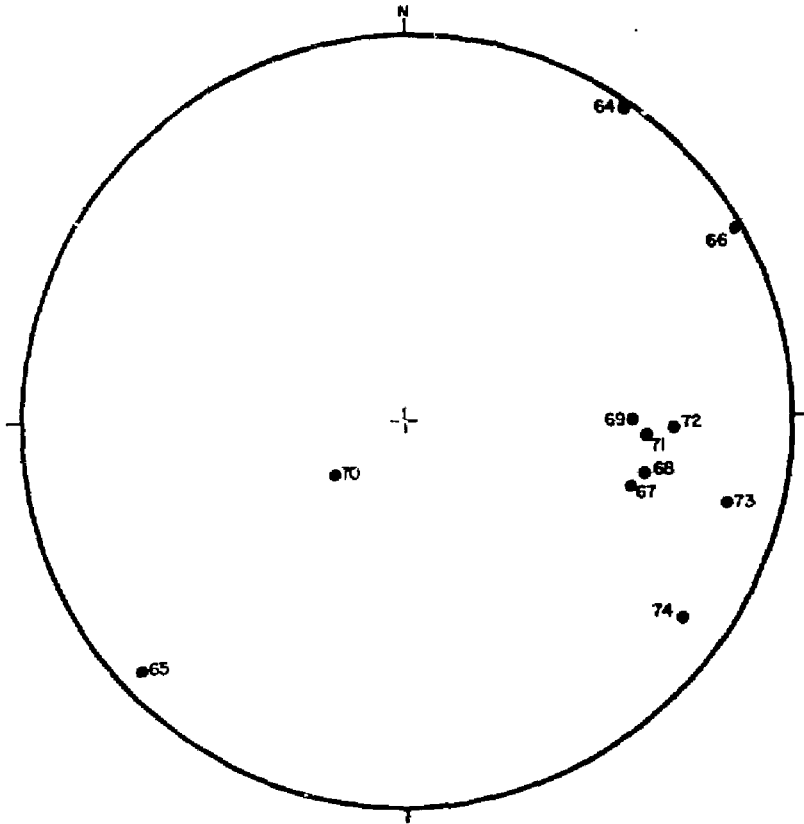
Far fewer major fractures were found in the tail drift than in the main access drift. Only eleven were identified over a distance of about 30 meters (frequency = 0.37 fracture/m), whereas the main access drift yielded a frequency of 79/85 m = 0.93 fracture/m. Three of the major fractures fall into the NW-striking, high-angle set, and one belongs to the low-angle NE-dipping set of the Stock (Fig. 9). The remaining seven fractures have a mean orientation of about N5E/50NW, which lies outside the major NE-striking set described earlier. However, Wilder and Patrick (1980) report the latter as the dominant joint orientation in the tail drift, which would indicate that none of those joints apparently met the continuity or persistence criteria for our mapping. Orientation of the drift with respect to the NE-striking set would be of lesser importance in causing this bias.

Fig. 9. Lower hemisphere Schmidt plot of poles to fractures mapped in the tail drift.

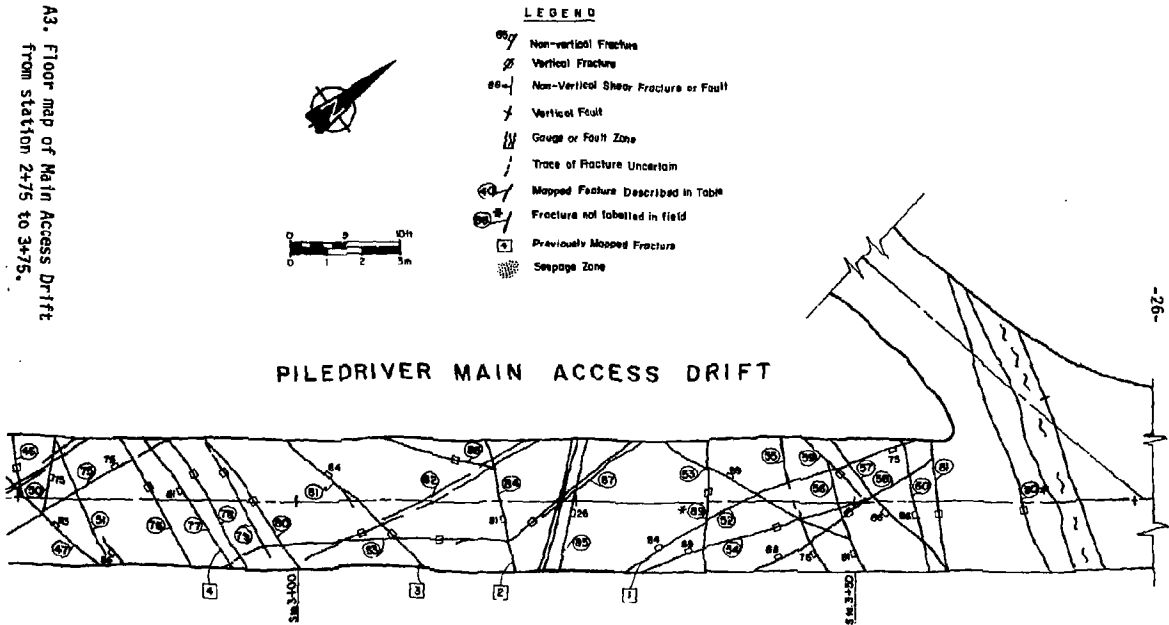
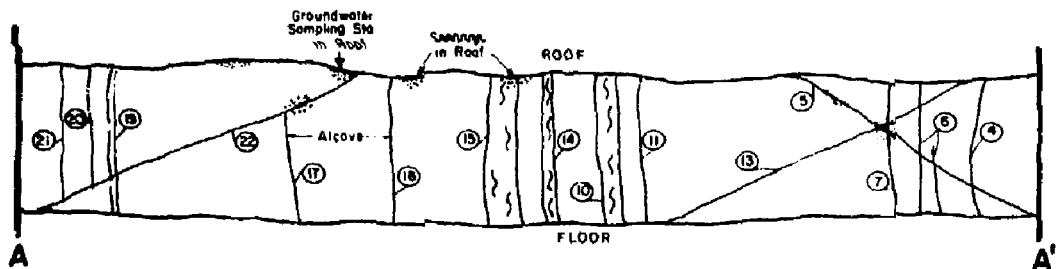
RIB SECTION A-A'

Along the access drift from station 1+10 to station 1+85 water can be seen seeping from low-angle discontinuities. In order to show the relation of the wet and dry features in this area, an additional map of part of the southwest rib was prepared. This appears as section A-A' on the fracture map which is discussed in the following section.

In many places, the northeast-dipping, low-angle features are observed to truncate high angle fractures. Examples of this can be found in the rib map (Section AA') of Fig. 5. Evidence of faulting along the low-angle fractures is absent, and therefore would be an unlikely cause for the truncation. Our tentative explanation is that the low-angle discontinuities, either open or healed at the time, effectively blocked the propagation of the later high-angle fractures. Our data on such a relationship is indeed limited, and further detailed mapping would be needed to substantiate this explanation.
