COMMITTEE'S REPORT ON RUTHENIUM FALL-OUT INCIDENT

Subject: COMMITTEE'S REPORT ON RUTHENIUM FALL-OUT INCIDENT

REPORT OF THE COMMITTEE ON THE RUTHENIUM FALL-OUT INCIDENT

November 11-12, 1959

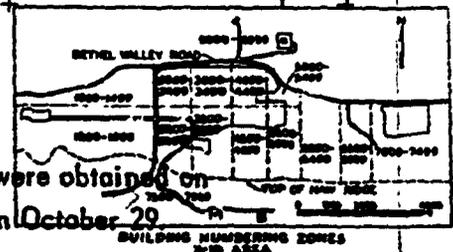
E5423

are in m/hr (Ra equivalent) and were obtained on
indicated. Other values were found on October 29
