**CANDU-PHW  
Fuel Channel  
Replacement Experience**

by J.T. Dunn, B.K. Kakaria  
Atomic Energy of Canada Limited;  
J. Graham, A.H. Jackman  
Ontario Hydro

Presented to the IAEA  
Specialists' Meeting in  
Riso, Denmark

AECL-7538

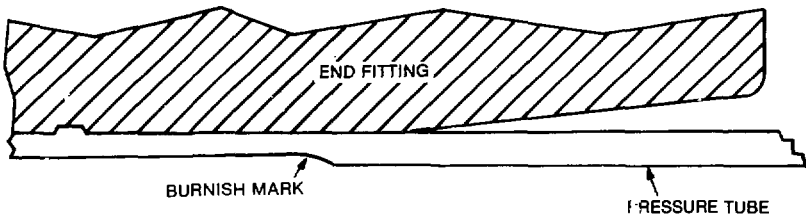
FIGURE 8 DIMENSIONS AND LOCATION OF DEFECT IN PRESSURE TUBE

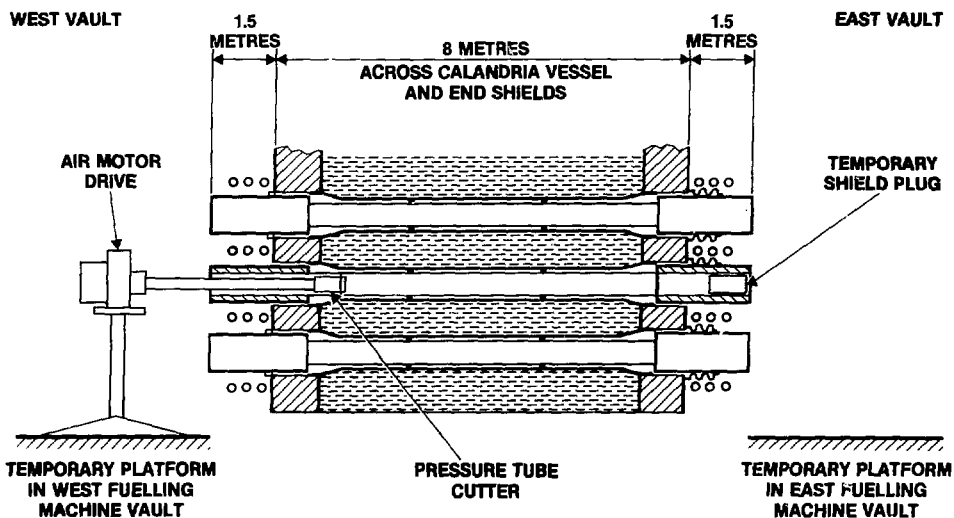
**FIGURE 13 THE FIRST PRESSURE TUBE CUT**

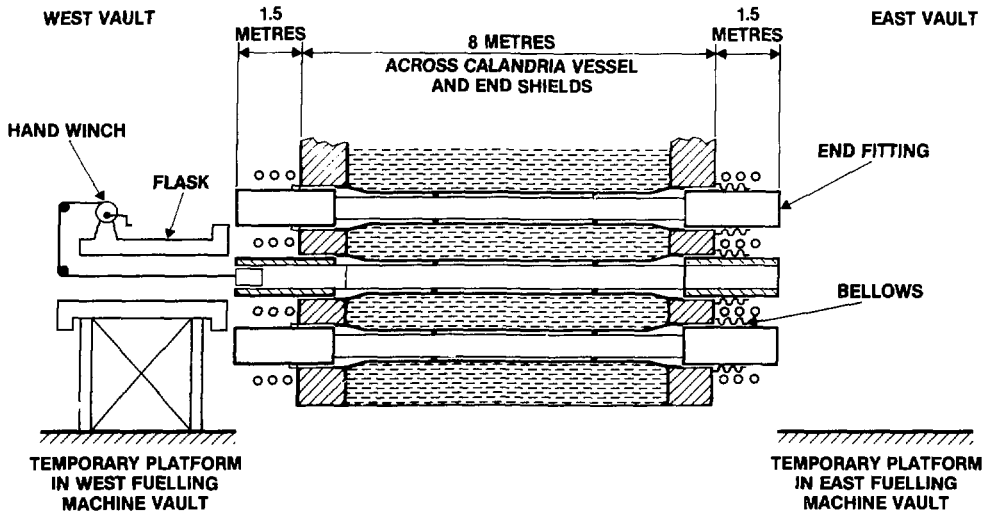
**FIGURE 14 LEAD FILLED FLASK READY TO RECEIVE WEST END FITTING**

A shielding flask was aligned with the end fitting and a support trough about 5 m long was inserted through the flask to extend under the end fitting as far as the stop collar, Figure 14. A cable from a winch mounted on the outboard end of the flask was passed through the flask and secured to the end fitting, which was then pulled along the trough into the flask, by means of the winch and cable. The operator was located behind the flask and was shielded by it.

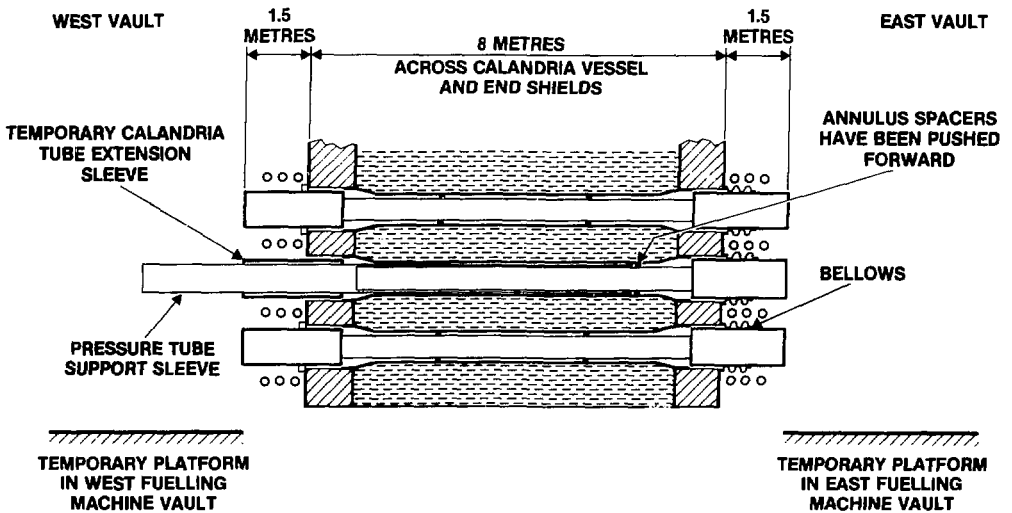
**FIGURE 15 SUPPORT SLEEVE INSERTED IN THE ANNULAR SPACE BETWEEN THE CALANDRIA TUBE AND PRESSURE TUBE**

An extension sleeve extending from the West calandria tube insert to just outboard of the reactor end fitting face, and with a bore slightly larger than that of the calandria tube, was then installed in the West end shield lattice tube, Figure 15. This formed a bridge between the calandria tube and the working platform.

A pressure tube support sleeve, made up from three sections coupled together, was then passed through this extension sleeve and through the annulus between the pressure tube and calandria tube until its leading end reached a distance of about 450 mm from the East end fitting, Figure 15. While passing through the annulus it pushes the two garter springs ahead of it towards the East end fitting. This support sleeve has three main purposes; it moves and positions the garter springs; it protects the calandria tube during movement of the cut pressure tube, and it contains the cut pressure tube from the reactor into the shielding flask.

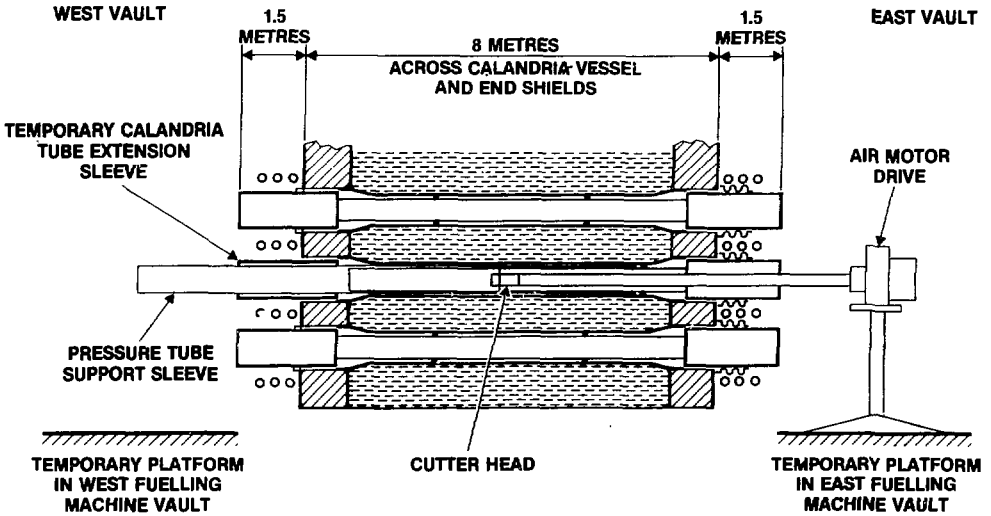
FIGURE 16 PRESSURE TUBE CUTTING AT THE CENTER OF THE REACTOR

The pressure tube cutting tool was then inserted through the East end fitting, and two pressure tube cuts made, one in the middle and one about 200 mm from the East end fitting, Figures 16 and 17.

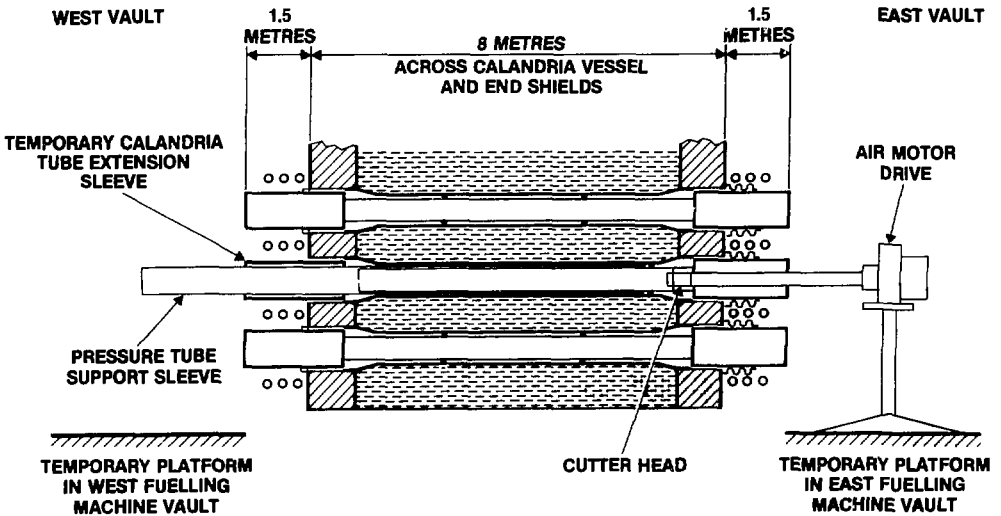
FIGURE 17 THIRD AND FINAL PRESSURE TUBE CUT

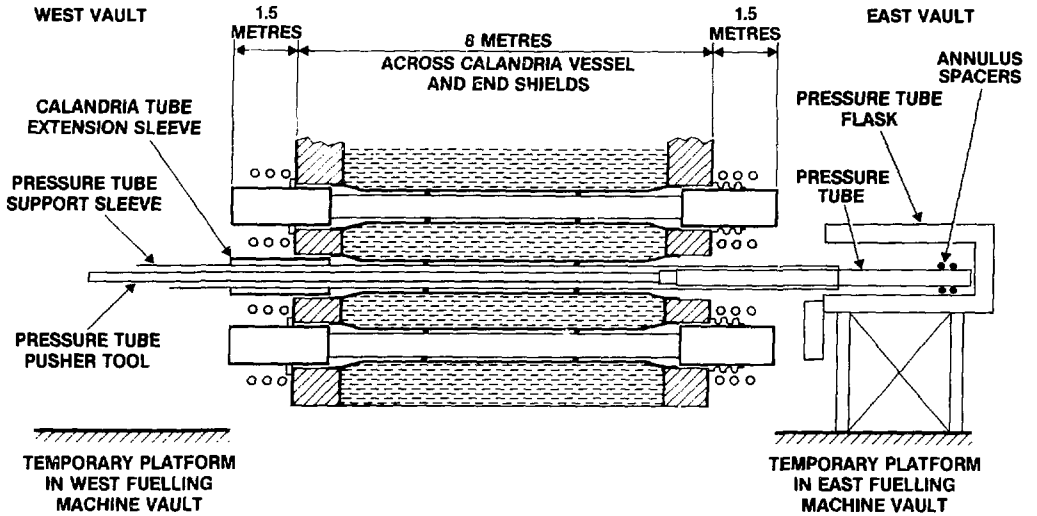
FIGURE 18 FIRST HALF OF THE PRESSURE TUBE BEING PUSHED INTO THE FLASK

Following the cutting of the bellows/end fitting weld, the East end fitting was removed in the same manner as the West end fitting and a similar calandria tube extension sleeve was then inserted and secured in this end of the reactor. A shielding flask was next positioned at the East end of the reactor in line with the extension sleeve ready to receive the first half of the pressure tube, Figure 18.

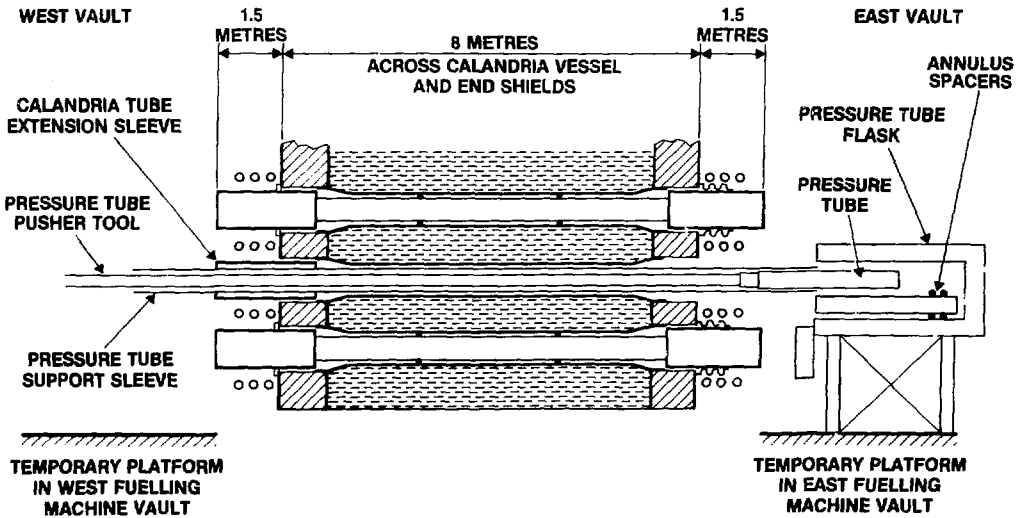
FIGURE 19 SECOND HALF OF THE PRESSURE TUBE BEING PUSHED INTO THE FLASK

At the West end, the pusher tool, hence the pressure tube and garter springs, were advanced towards the East end until the leading end of the support sleeve just entered the flask. At this point the support sleeve was uncoupled from the pusher tool and restrained axially, the pusher tool was then advanced until the first half of the pressure tube and the garter springs had entered the flask, Figure 18. The flask was then lowered about 110 mm by means of the bridge controls until the support sleeve was correctly aligned with the upper half of the flask bore. The pusher tool was further advanced until the second half of the pressure tube was fully in the flask, Figure 19. The pusher tool and support sleeve were then withdrawn and removed from the reactor. The flask doors were then closed and following a satisfactory radiation survey, the flask removed from the vault.

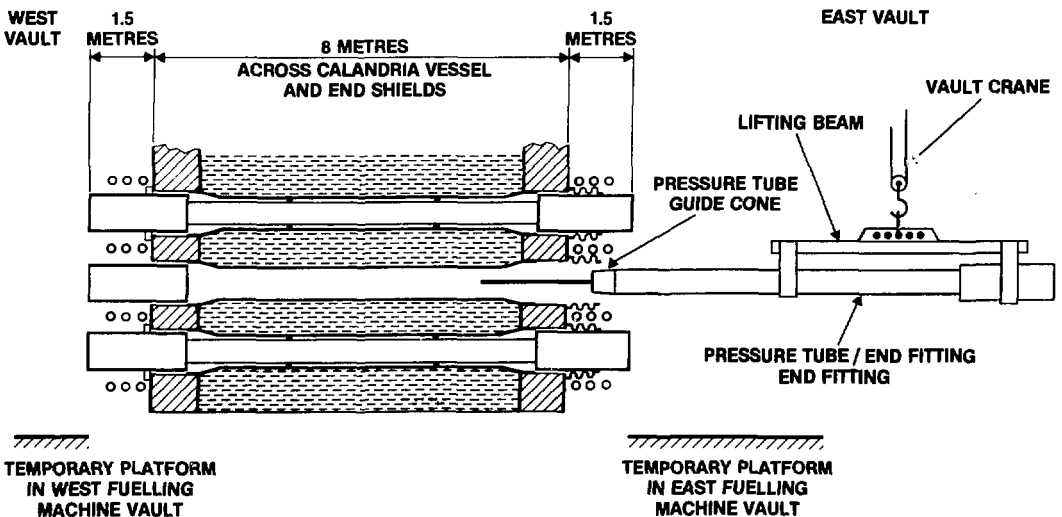
FIGURE 21 REPLACEMENT SUB-ASSEMBLY SUSPENDED FROM THE EAST VAULT CRANE

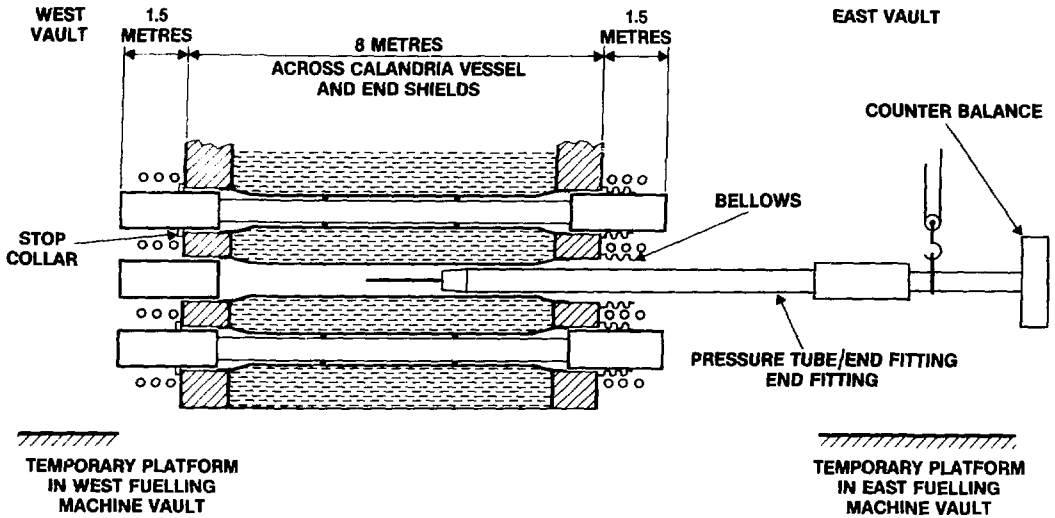
FIGURE 22 SUB-ASSEMBLY INSERTION USING THE COUNTERBALANCE WEIGHT

The sub-assembly was removed from its box using a special lifting beam necessary to limit bending stresses in the rolled joint during handling. A nose cone with rollers was inserted in the leading end of the pressure tube and the sub-assembly was advanced into the East end of the reactor using the vault crane, Figure 21. The leading end of the pressure tube was supported by the nose cone as it passed through the end shield and calandria tube to the West side of the reactor. After advancing it some 4 m, a counterbalance tool was assembled to the outboard end of the end fitting and the lift was transferred to this tooling using an A-frame hoist, while the lifting beam was removed, Figure 22. The sub-assembly was then advanced until the East end fitting was resting on its bearings, at which point the counterbalance tool and nose cone were removed. The end fitting was then correctly aligned and oriented before clamping.

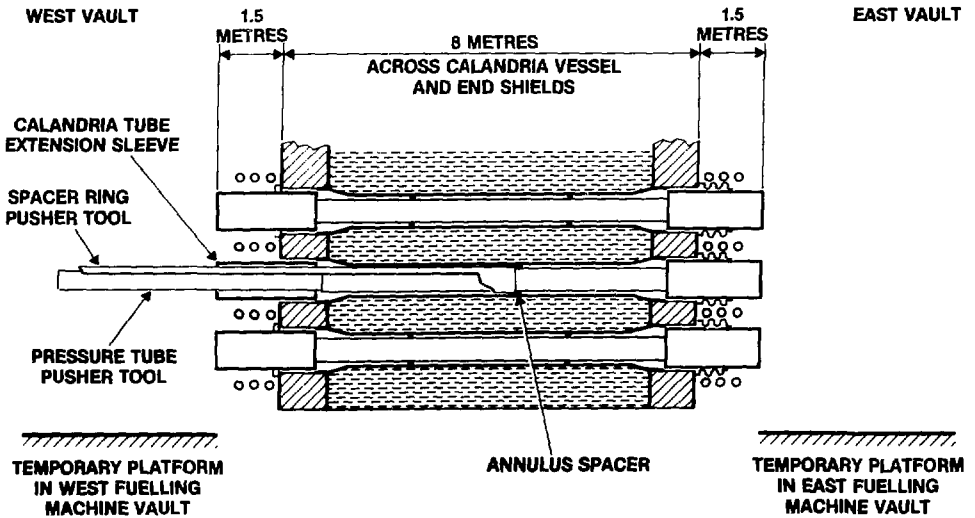
FIGURE 23 INSTALLATION OF THE ANNULUS SPACER RINGS

Installation of the garter springs, was performed from the reactor West end, Figure 23. A pressure tube support tool, of the same outside diameter as the pressure tube was spigoted into the pressure tube bore and was used to center the West end of the pressure tube in the calandria tube. A garter spring was installed on the outboard end of the support tool and advanced by a pusher tool along the support tool and pressure tube, to its correct position in the reactor. This was repeated for a second garter spring and the support and garter spring pusher tool were removed.

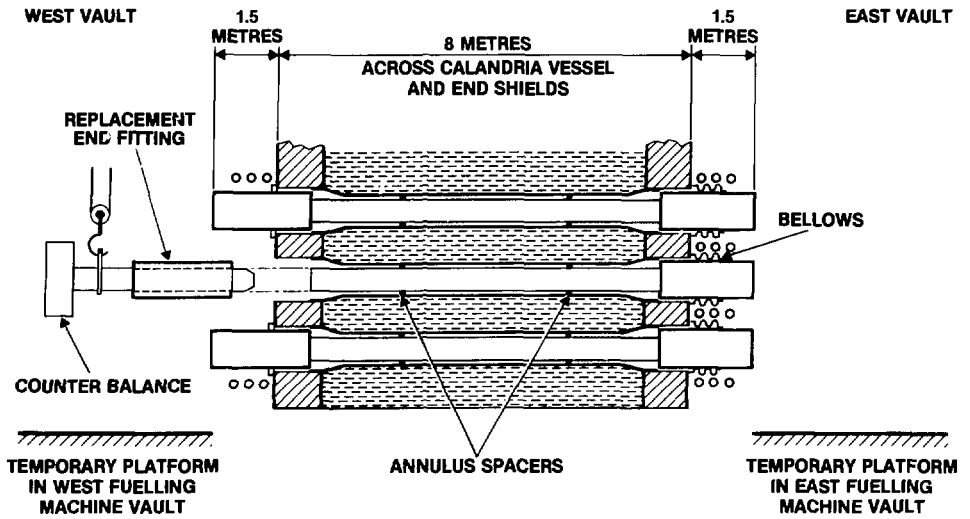
**FIGURE 24 END FITTING INSERTION USING A COUNTERBALANCE TOOL**

After garter spring installation, the West end fitting was lifted using a counterbalance tool, Figure 24. A nose cone projecting from the inboard end of the end fitting, picked up the pressure tube end, and centered it in the end fitting bore during the last part of insertion. The end fitting was then aligned with adjoining end fittings, and

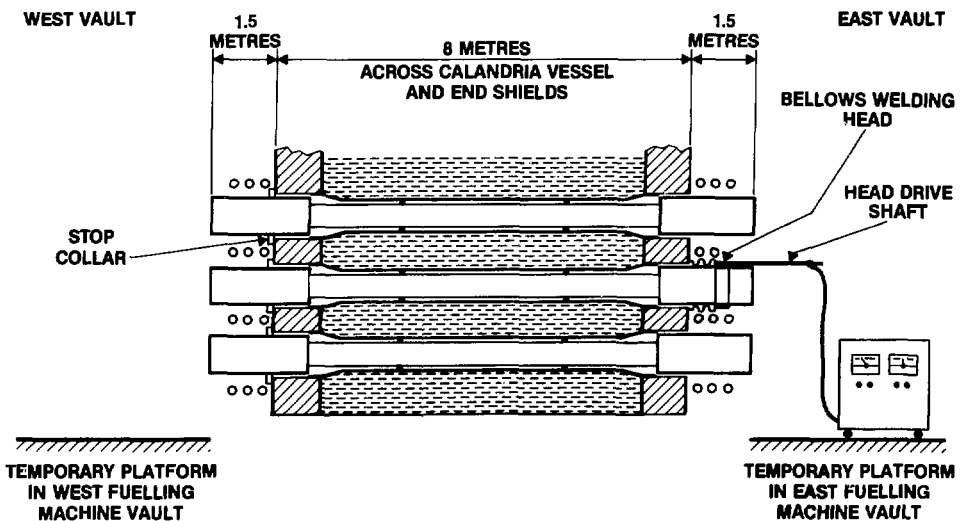
**FIGURE 25 BELLOWS WELDING**

the position of the pressure tube end in the end fitting checked. This verified that the pressure tube length was satisfactory, before performing the bellows/end fitting weld at the East end of the reactor, Figure 25.
