Submitted for the Proceedings of the Fifth National Conference on Synchrotron Radiation Instrumentation, June 21-25, 1987, University of Wisconsin-Madison.

ANALYSIS OF SURFACE CONTAMINANTS ON BERYLLIUM AND ALUMINUM WINDOWS

Nicholas F. Gmur
National Synchrotron Light Source
Brookhaven National Laboratory
Upton, New York 11973, USA

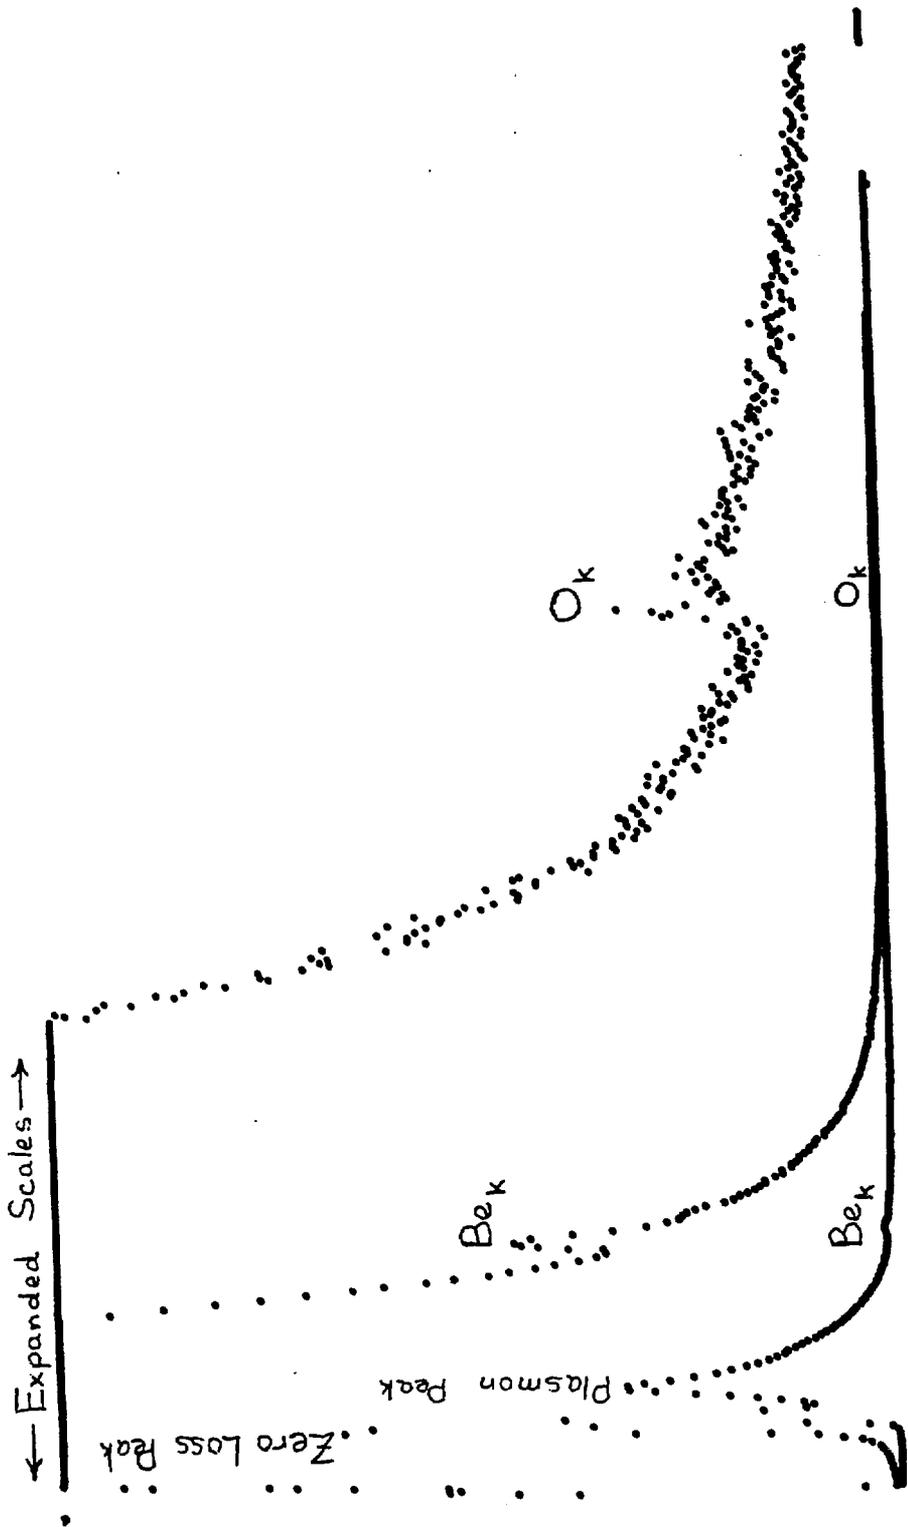
Fig. 9

Fig. 9. EELS plot showing beryllium (~ 111 eV) and oxygen (~ 532 eV) k-absorption edges in white powder.

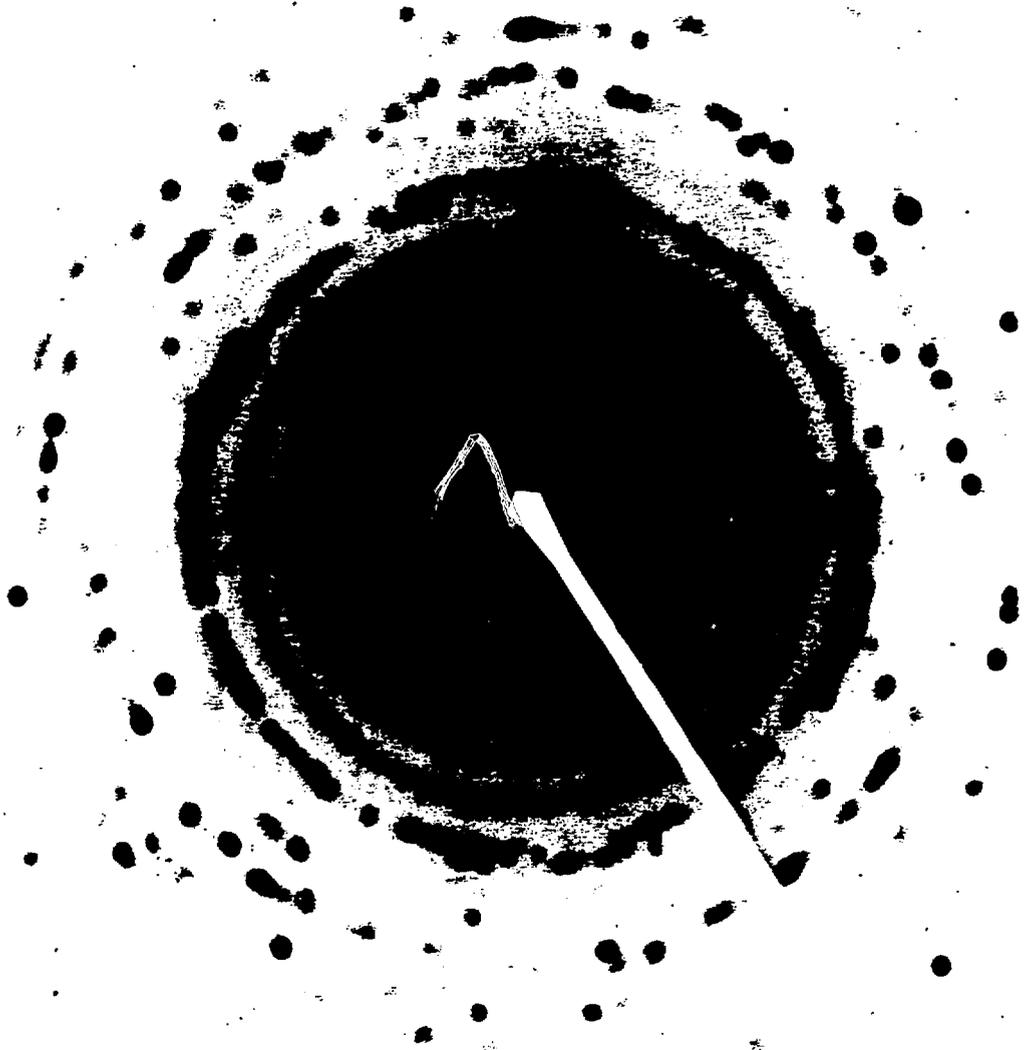
Fig. 11

and EELS analyses was made difficult by the fact that the crystals were in a sense glued to their Be substrate which in turn had lost some of its hardness in this area and had been rendered very heavily viscous (similar to the gels) by action with the SR beam. The electron diffraction pattern (similar to Fig. 11) exhibits spotty rings akin to metallic copper as well as weak discontinuous rings related to Cu_2O . The EELS analysis confirmed the presence of copper and oxygen. The evidence of the M_1 copper edge at 121 eV was further confirmed by the L_2 and L_3 copper edges at 931 and 951 eV, respectively. Also found in this sample by EELS was the additional presence of carbon with the π^* edge feature, probably a residue from the O-ring and/or some lubricant. The source of metallic copper in this highly reactive zone was probably the copper mount.

Fig. 11. Electron diffraction pattern of blue/green gel - Cu and Cu_2O .

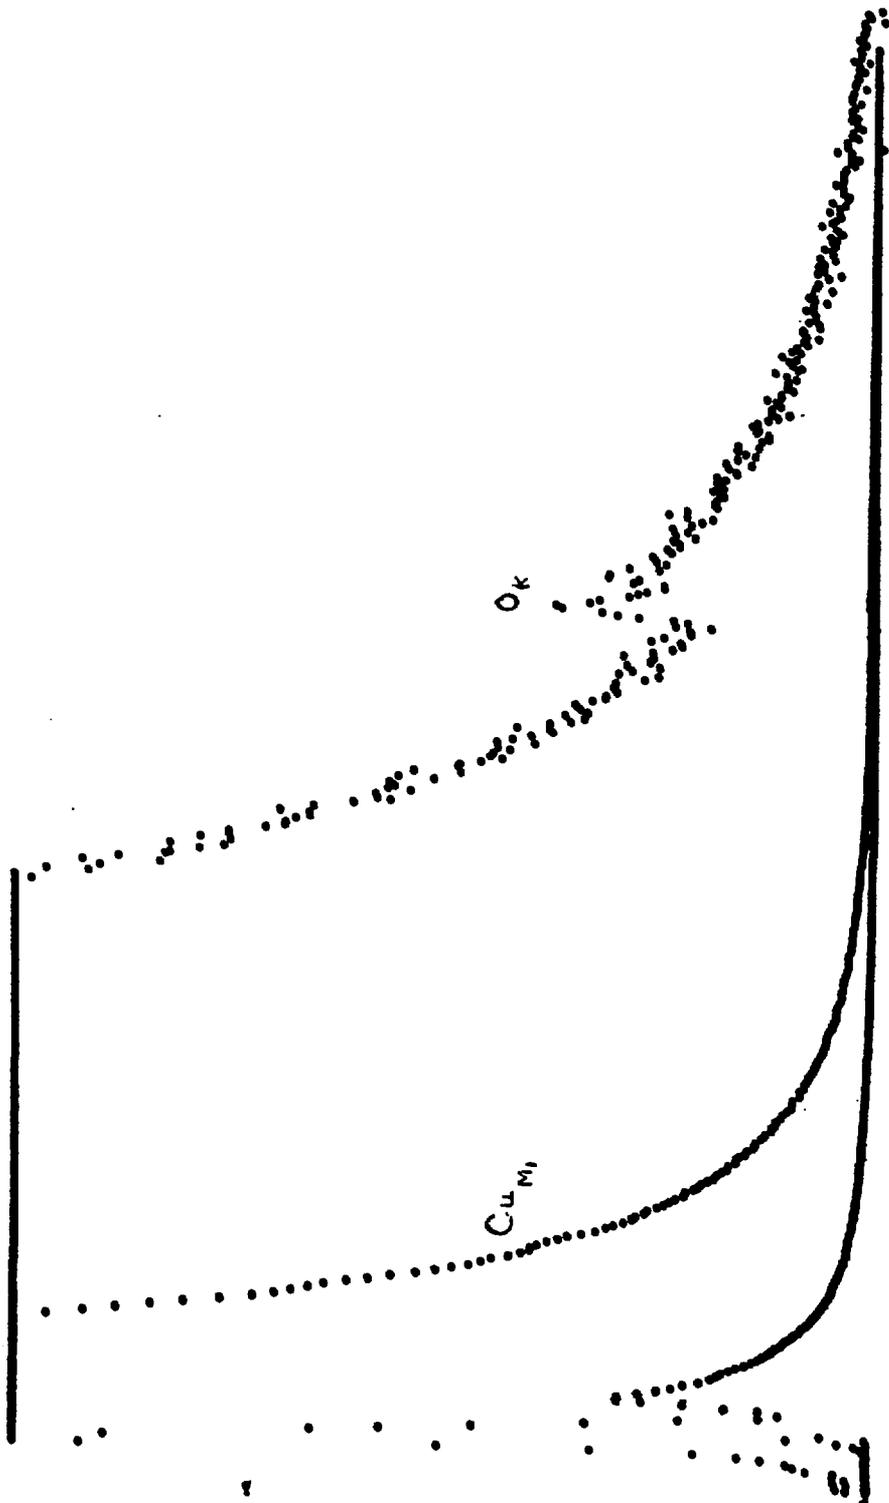
Fig. 12

Fig. 12. EELS plot showing copper (~ 121 eV) and oxygen (~ 540 eV) M_1 and k-absorption edges, respectively, in blue/green gel.

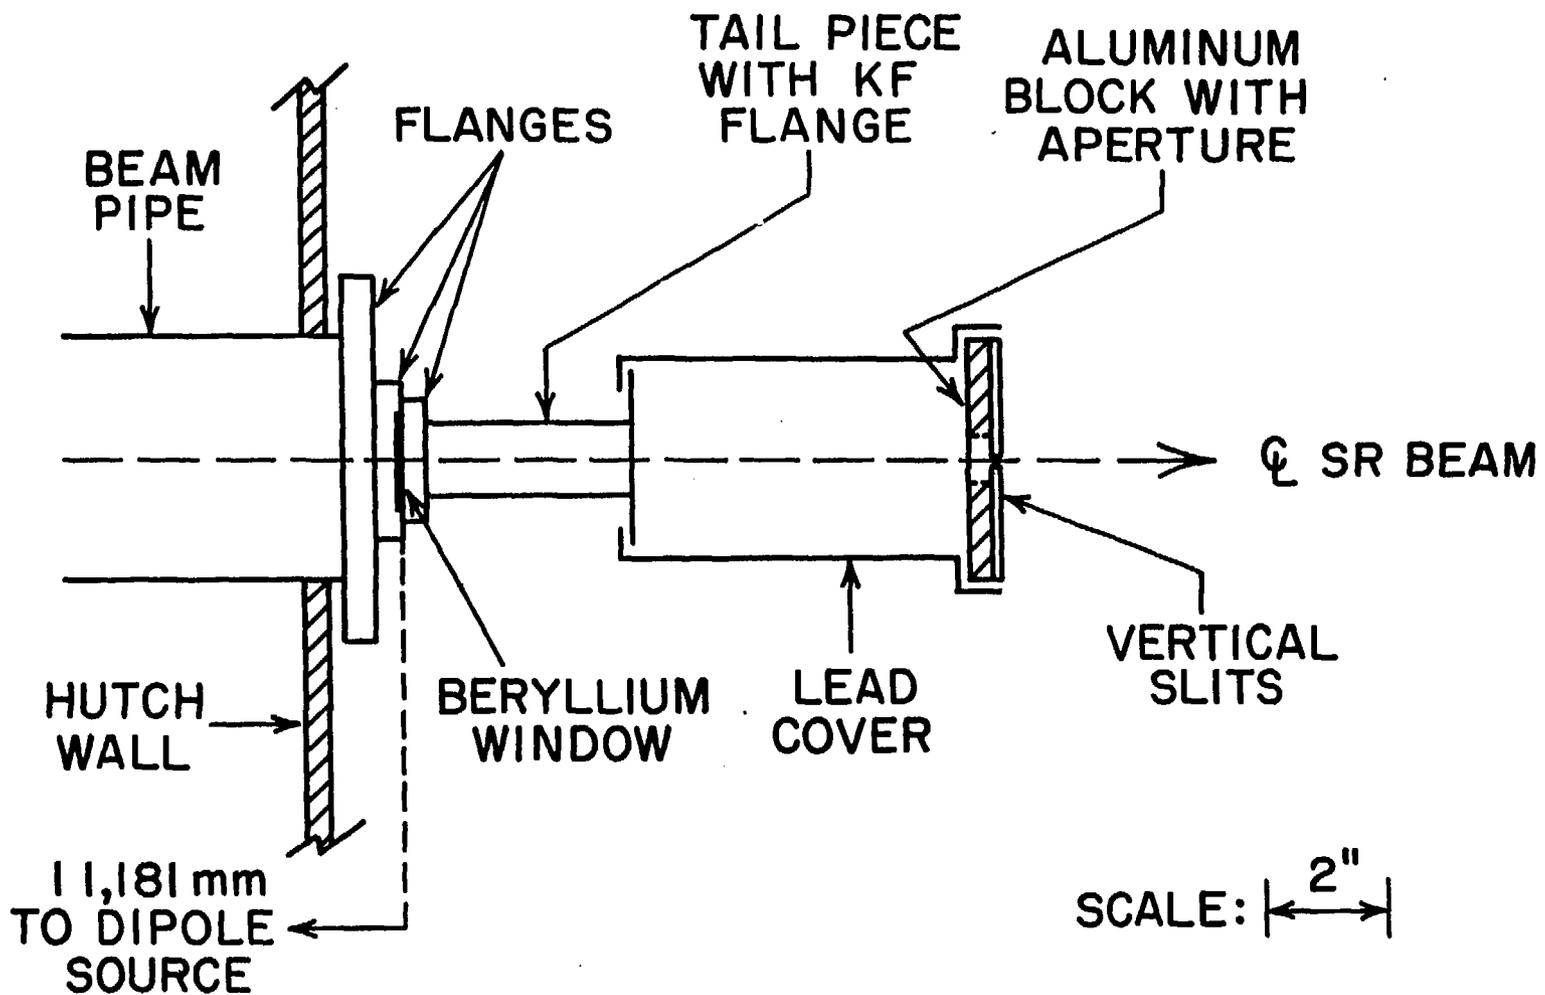
Fig. 13

As mentioned above, no liquids were detected on these windows. However, in a separate experiment to test protective coatings on beryllium window surfaces (to be described in a future report), liquid droplets were formed on surfaces in air in the vicinity of the SR beam. Figure 13 shows the configuration used on the X12A diagnostic beam line. The lead cover in the diagram is a 1/16" thick piece of lead sheet loosely wrapped around the volume separating the tail piece KF flange and the aluminum block. No initial attempt was made to seal any of the gaps formed in this wrapping, thus air exchange was possible in and around the covered volume. Air movement in the hutch was generated by a 590 cfm exhaust fan.

This last statement typifies the conditions prevalent around the configuration in Fig. 13.

Fig. 13. Diagram of beam line configuration during generation of nitric acid droplets.
