Operation of Finnish nuclear power plants

Quarterly report
2nd quarter, 1990

Kirsti Tossavainen (Ed.)
DECEMBER 1990

STUK - B - YTO - - 76.

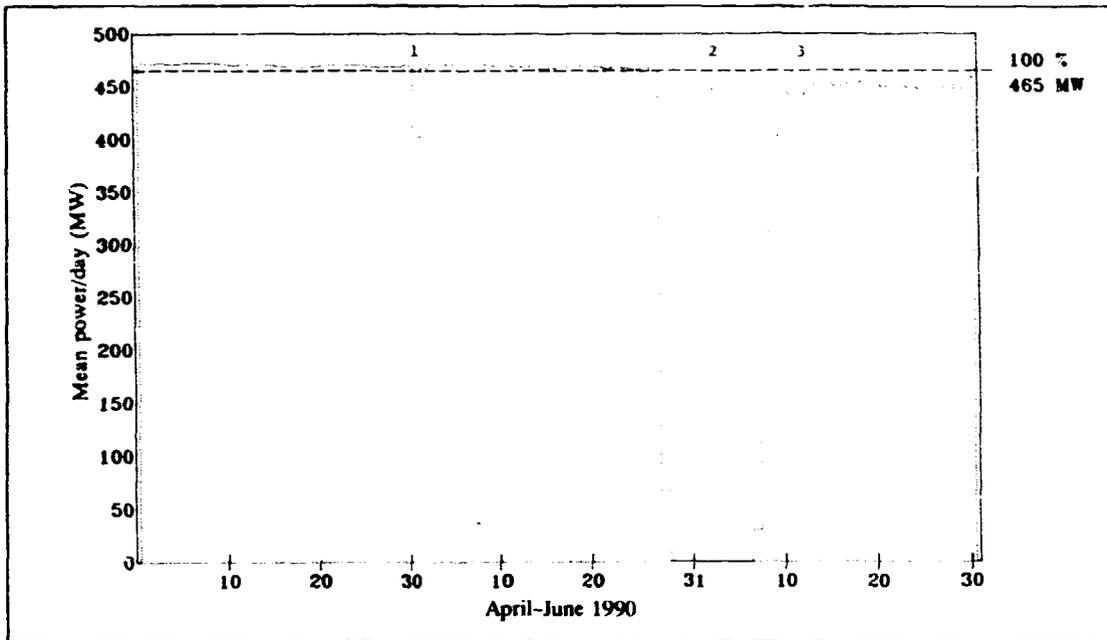
Fig 1. Average daily gross power of Loviisa 1 in April-June 1990

- 1 Less demand for electricity, reactor operating at 79 % power
- 2 Shutdown due to feedwater pipe rupture and cold shutdown for inspection and repair of feedwater piping
- 3 Primary circulating pump trip, reactor to 76 % power

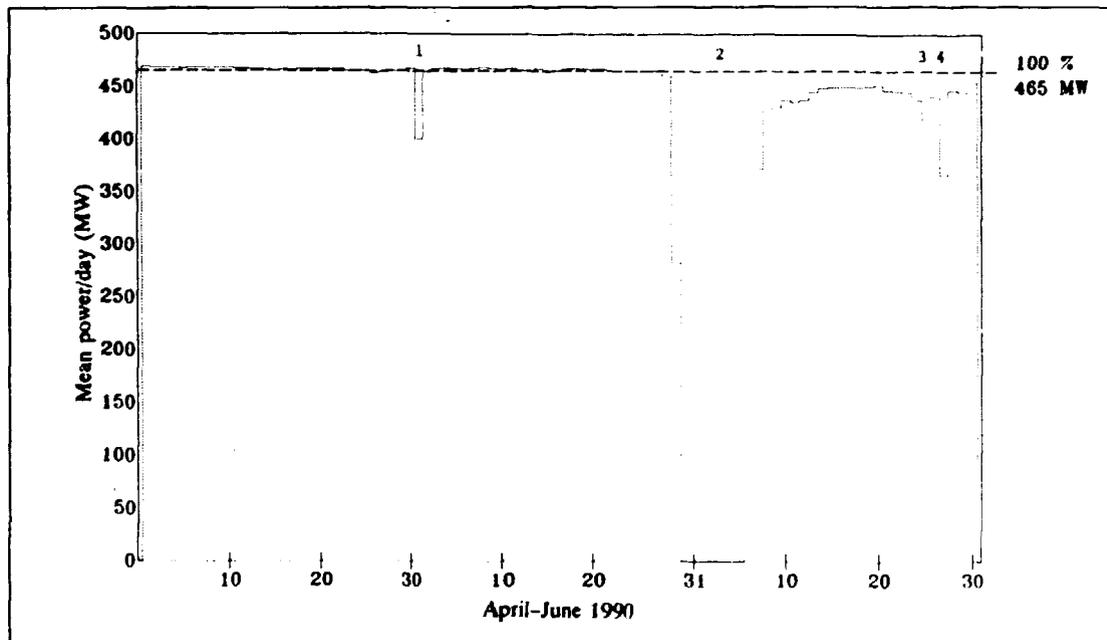
Fig 2. Average daily gross power of Loviisa 2 in April-June 1990.

- 1 Less demand for electricity, reactor operating at 79 % power
- 2 Cold shutdown for inspection and repair of feedwater piping
- 3 Repair of the circulating filter of the condenser purification system, reactor operating at 73 % power
- 4 Turbine trip in consequence of the tripping of the generator differential protection, reactor to 52 % power

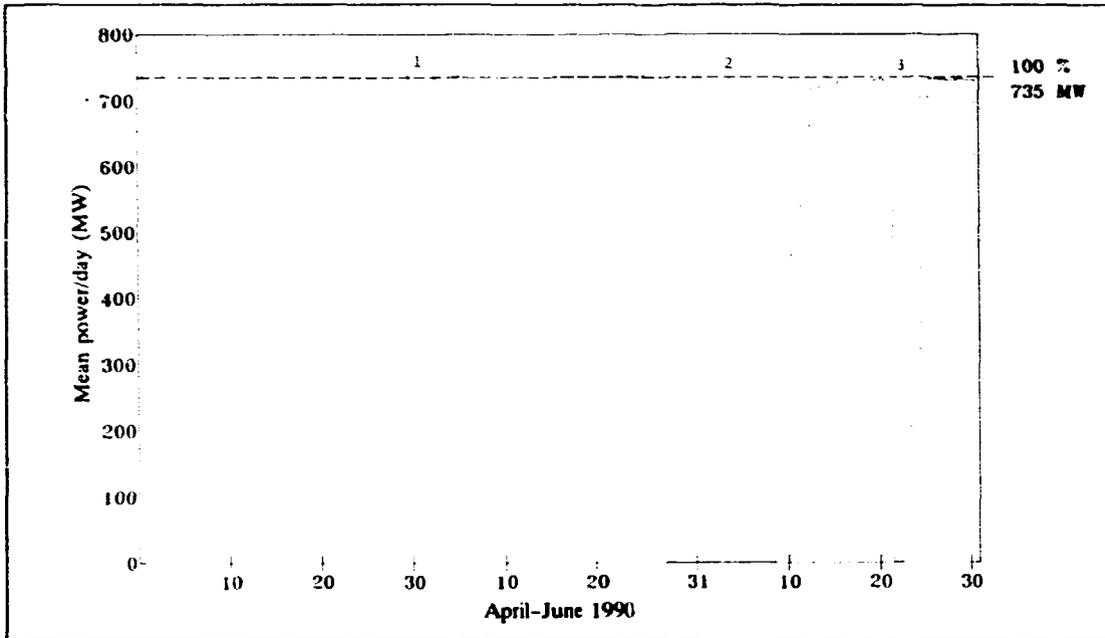
Fig 3. Average daily gross power of TVO I in April-June 1990.

- 1 Less demand for electricity, reactor in hot shutdown with closed isolation valves
- 2 Annual maintenance and refuelling outage

- 3 Less demand for electricity, reactor in hot shutdown with closed isolation valves

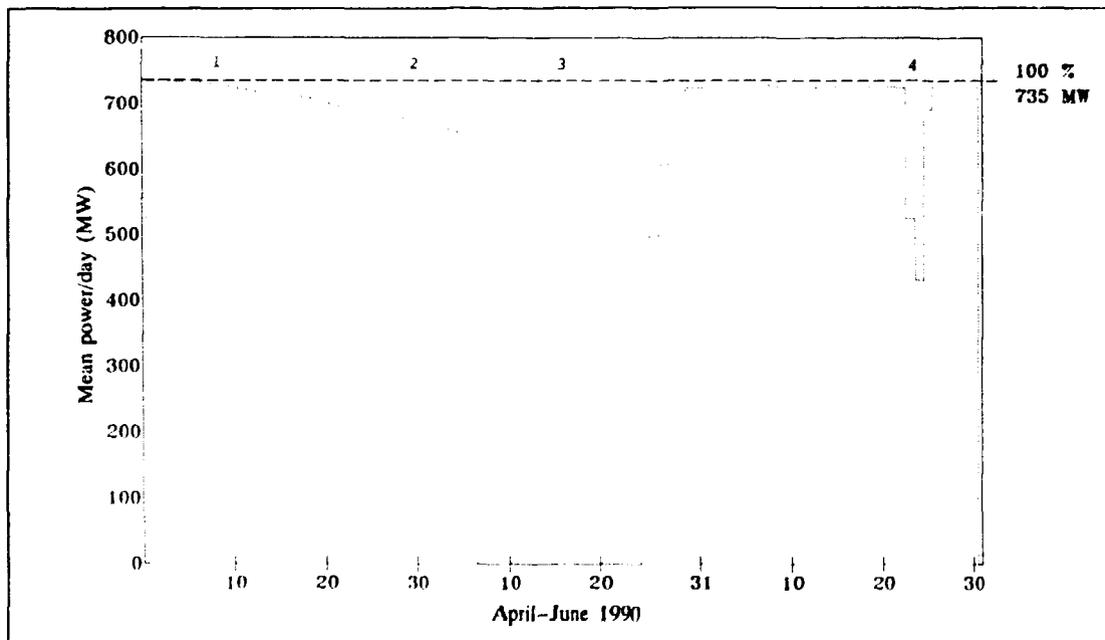
Fig 4. Average daily gross power of TVO II in April-June 1990.

- 1 Nuclear fuel has burned to such an extent that power has started to sink gradually (coast-down)
- 2 Less demand for electricity, reactor operating at 91 % power
