MANAGING THE AGING OF BWR CONTROL ROD DRIVE SYSTEMS*

Rebecca H. Greene
Oak Ridge National Laboratory
Oak Ridge, TN 37831-8038
and
William S. Farmer, USNRC-RES
5650 Nicholson Lane, NLS-217B
Rockville, MD 20852

ABSTRACT

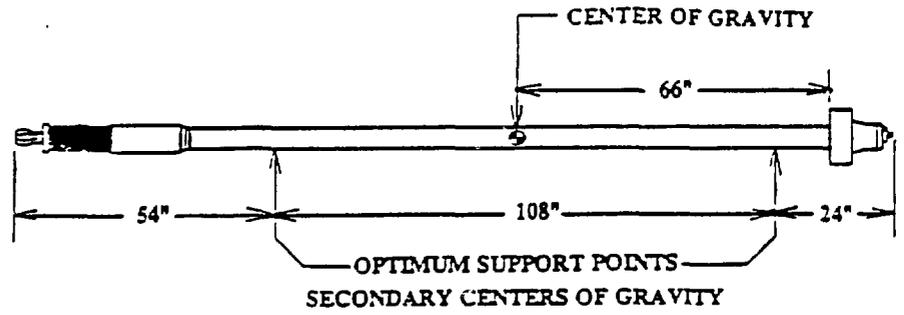
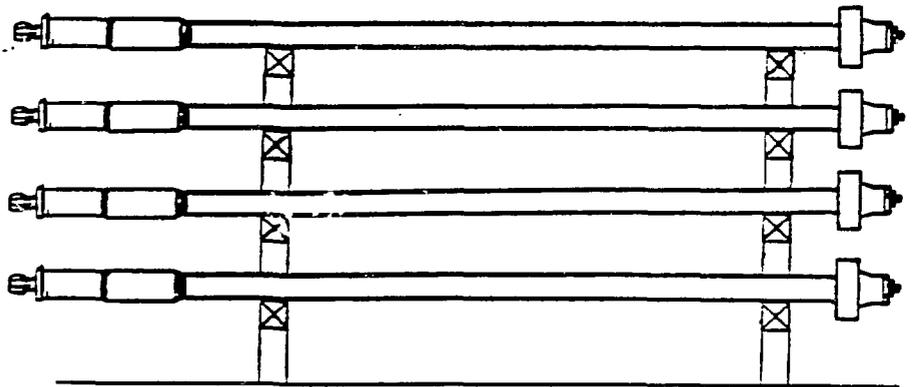
Figure 8. Acceptable CRDM storage arrangement. 2

essence, transmits the weight of the stack to the lowest drive. Heavy, lead shielding "pigs" are sometimes left hanging on the spud end of "hot" drives for long periods of time, which places a moment on the collet housing. As shown in Figure 8, CRDMs should be stored in racks or vaults with a minimum of 2 points of support located 61 cm (24 in) from the flange end and 137 cm (54 in) from the spud end.

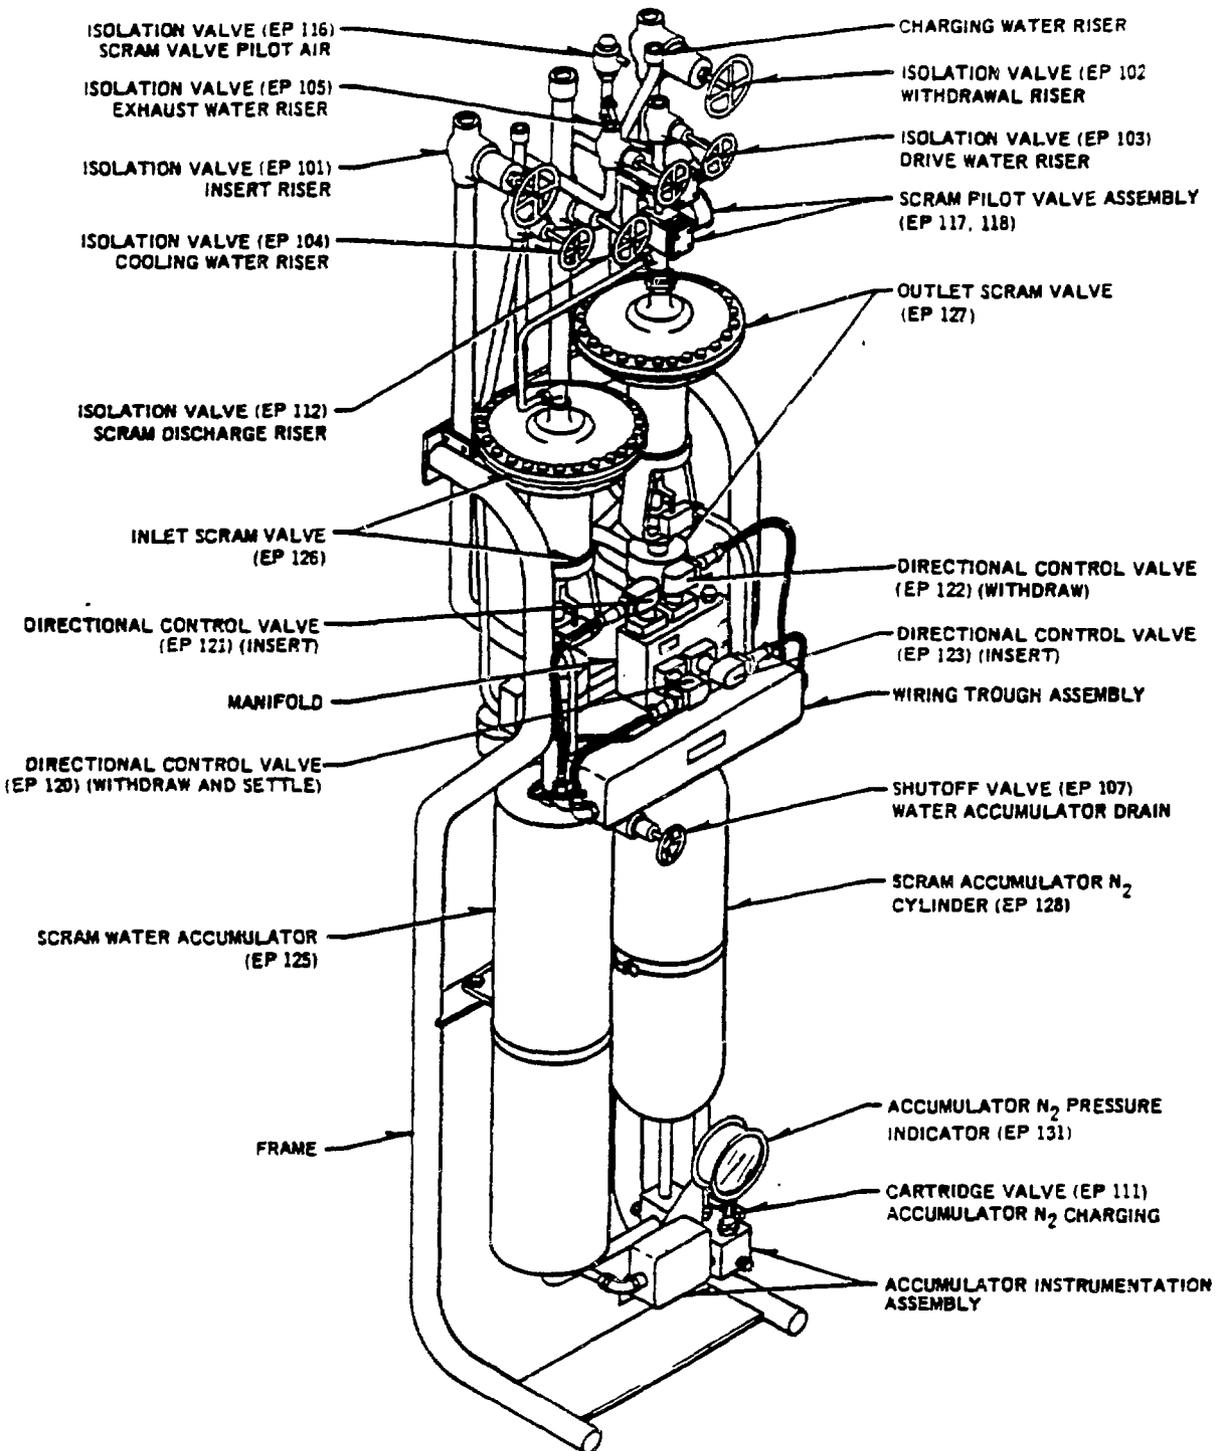
Figure 9. A BWR hydraulic control unit (HCU) and its components. 6

The NPRDS analysis yielded specific information on HCU degradation. Over 59% of the CRD system failures are attributable to the HCU. The HCU components requiring the most maintenance and replacement (as reported in the NPRDS) are identified in Figure 9. The following information discusses the HCU components requiring the most maintenance and the causes of their aging.

The NPRDS has recorded 189 failure reports of this component with 119 of them requiring replacement units. In the pre-BWR-6 models, the chromium plating liner of this carbon steel tank is porous enough to allow water to seep in and cause corrosion of the carbon steel. General Electric issued a service information letter regarding the interior surfaces of these accumulators and determined that high-chloride, low pH water conditions would produce blistering and pitting of the plating throughout the cylinder. It was further reported that loose flakes of this plating may leave the accumulator and collect on the Teflon seat of the inlet scram valve and cause some leakage. If this occurs, it can result in control rod insertion. In addition, the tank's corrosion flakes can etch Teflon from the scram valve seat and subsequently become entrapped in the cooling water orifice of the companion CRDM. General Electric and the Toshiba Corporation have

developed stainless steel replacement units for this component. The predominant symptom of accumulator degradation reported in the NPRDS is a high water level alarm for the accumulator.
