**EXPERIENCE FROM UNUSUAL OCCURRENCES
IN HWP (TUTICORIN)**

**W.S.A KANTHIAH, P.A.O VAIDYAN, S.C. BHOWMICK
HEAVY WATER PLANT, TUTICORIN.**

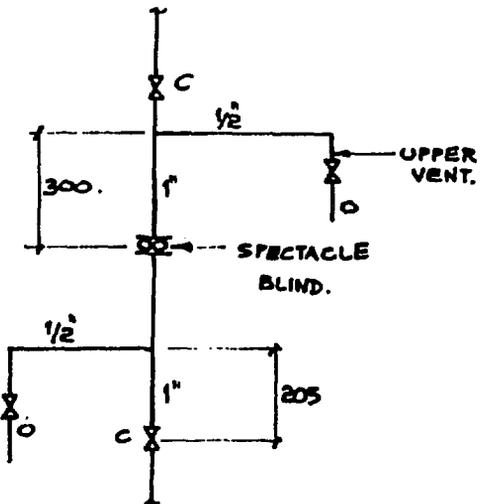
FIG. 3a.

One spectacle blind in a 1" process line handling potassium amide solution was being reversed from close to open position after due clearance from process side. While loosening and lifting the flange of the blind, amide solution splashed on a technician. In spite of his washing under the nearest drench shower immediately, he sustained first degree burn injury on his arm. The above process line was isolated and depressurised through vent points (as shown in the Fig-3a) before opening the flange. On investigation, it was understood that the splashing of the liquid was due to locked up pressure inside, though the vent points were
