# Waste Site Characterization Through Digital Analysis of Historical Aerial Photographs at Los Alamos National Laboratory and Eglin Air Force Base

Ed Van Eeckhout, Paul Pope, Bob Wells, Cheryl Rofer, and Brad Martin  
MS C335, Los Alamos National Lab, Los Alamos NM 87545 (e-mail: emvan@lanl.gov)

**Fifth Annual**  
**Major Range and Test Facility Base Environmental Workshop**  
*"Environmental Compliance--Part of the T&E Manager's Job"*  
May 23-25, 1995

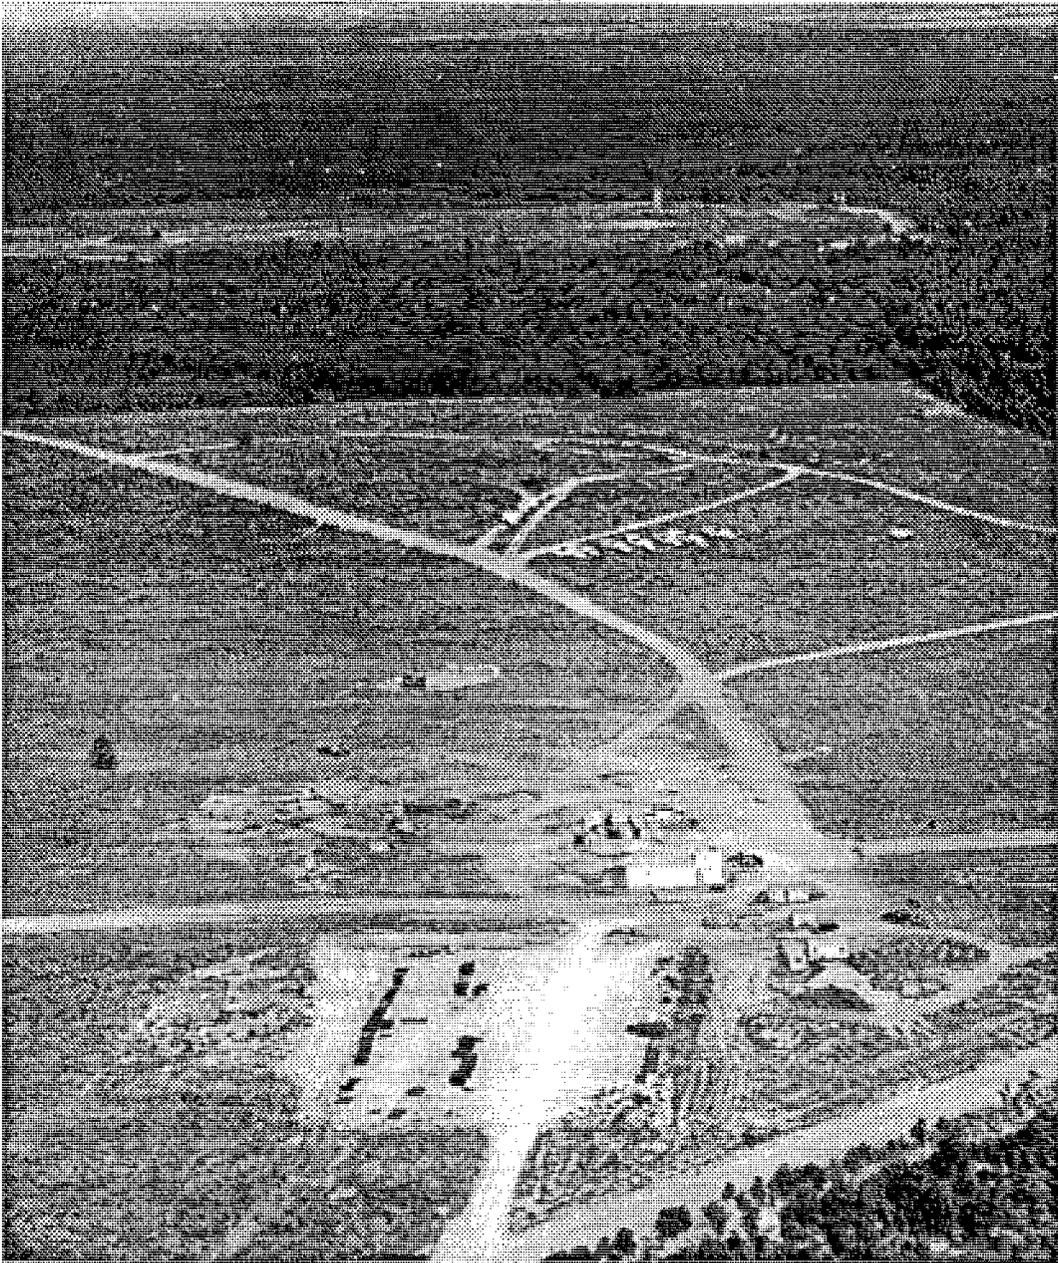
Eglin AFB is a key air-delivered armaments testing complex and was very active during the Vietnam War era. The main base area is located on Choctawhatchee Bay, just northeast of Fort Walton Beach. The focus of this particular example is Area C-64C, as observed in a 1985 low altitude oblique view in Fig. 5. In the early 1990s, subsequent to the construction of an experimentation complex at this site, a radiological survey was conducted which resulted in findings of higher-than-background radiation levels. It is believed that this radiation resulted from residual depleted uranium used in ordnance tests during the 1970s and the early 1980s.

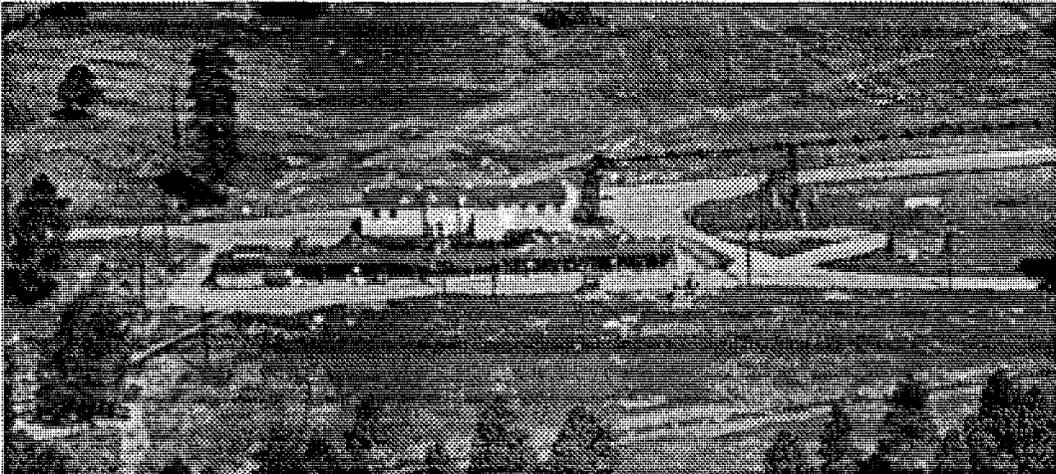
In the early days of the cold war, Los Alamos had a number of processing facilities for weapons grade materials. One such facility is shown as it existed in 1950 in Fig. 10, and is located at what is known as the GMX-2 facility. This facility was later decommissioned by burning the buildings and removing the sumps as shown in a 1965 aerial view (Fig. 11a). This figure shows the area after the buildings were burned but before the sumps were removed. The sumps are clearly visible as a row of six white rectangles in the scanned 1965 photo of the area. Much later (1991), a drastically different scene is observed (Fig. 11b). The building debris, pipes, utility poles, as well as the sumps have all been removed and the area has grown over with grass to the extent that even some of the roads are no longer visible. Work at the area now consists solely of environmental assessment and remediation.

Fig. 10. 1950 oblique view of weapons grade material processing facility.
