# Main Examination Results of VVER-1000 Fuel After Its Irradiation in Power Reactors

## 1 Introduction

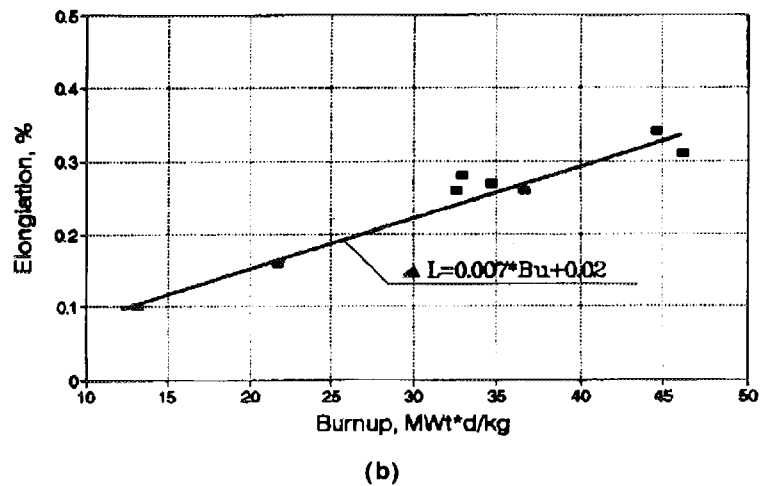
Figure 2 Elongation of fuel elements of VVER-1000:  
(a) elongation of fuel elements into fuel assembly;  
(b) dependence of fuel rod elongation on average fuel burnup

A substantial scattering of fuel rods elongation was observed even in one fuel assmeby (Fig. 2a). But an averaged elongation (Fig. 2b) had a linear correlation with fuel burnup.

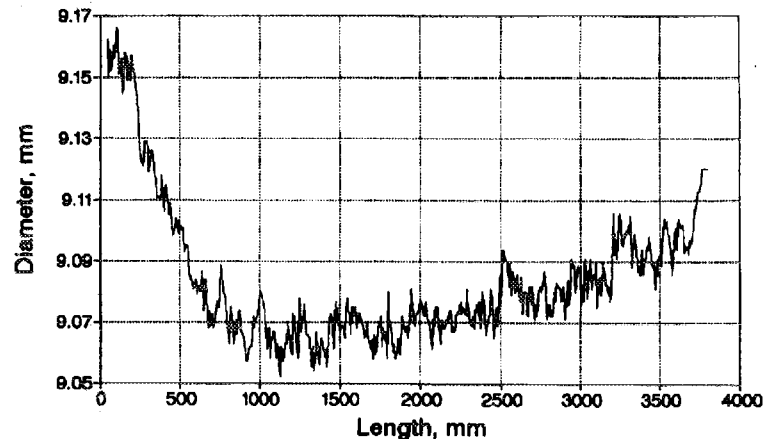
Figure 3 Distribution of fuel rod diameter size along length of the VVER-1000 fuel element

The typical axial distribution of fuel rod diameter is given in Fig. 3. Taking into account the initial was observed of fuel pellet and inner cladding diameter it should be expected that in some cases the fuel-cladding gap will disappear even at burnups of  $35 \text{ MWd/kgU}$ . But the examination shows that on the average the decrease of fuel cladding diameter was observed at burnups up to  $50 \text{ MWd/kgU}$  (Fig. 4).

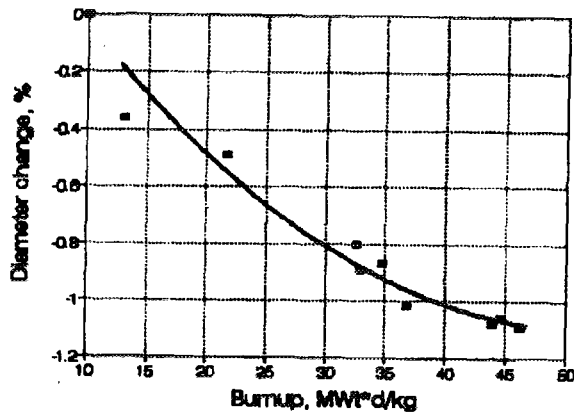
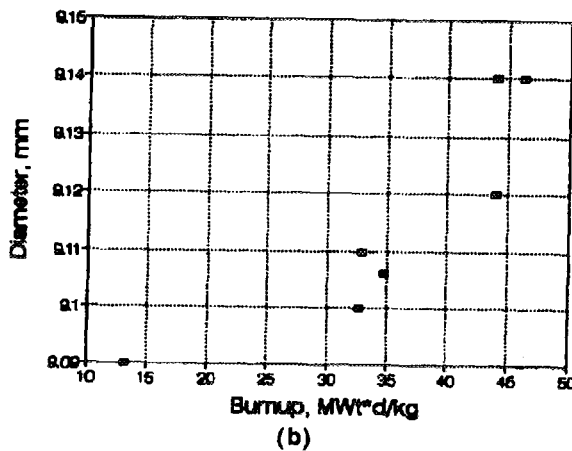
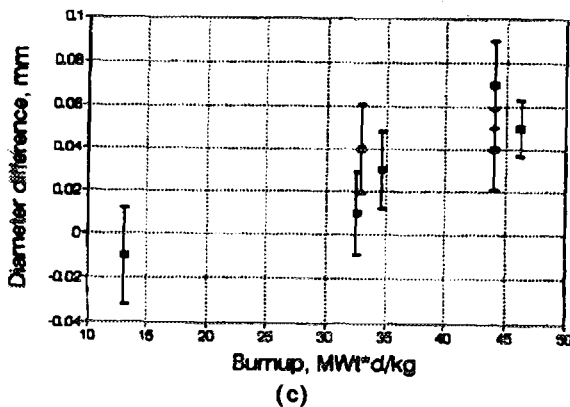
Figure 4 Dependence of fuel pin diameter change (a), spacers hole diameter (b) and diameter difference of spacer hole and fuel pin (c) on fuel burnup

In the process of operation the channel guides of the safety and control rods take the shape of the fuel assembly. The change of length, outer or inner diameter was not detected. The measurement of spacer grid cells diameter revealed the increase of distinction between fuel rod diameter and that of grid cell being freed from the fuel rods (Fig. 4).

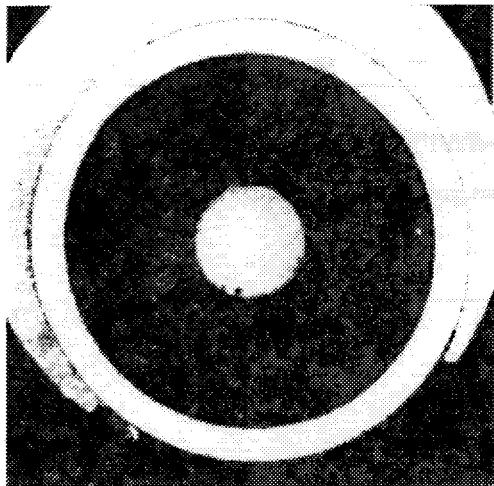
**Figure 8 Fuel element macrostructure**

The dimensions of fuel pellet central hole do not change in the burnup range covered (Fig. 8). The change of the grain size goes slowly (Fig. 9) and that points to the low (lower than  $1500^\circ\text{C}$ ) fuel temperature. The maximum dioxide uranium swelling does not exceed 4%. Fuel pellets are mainly fragmented by 3 to 5 parts preserving therewith its cylindrical shape. The fuel column length in some cases increases up to  $58 \text{ mm}$ .

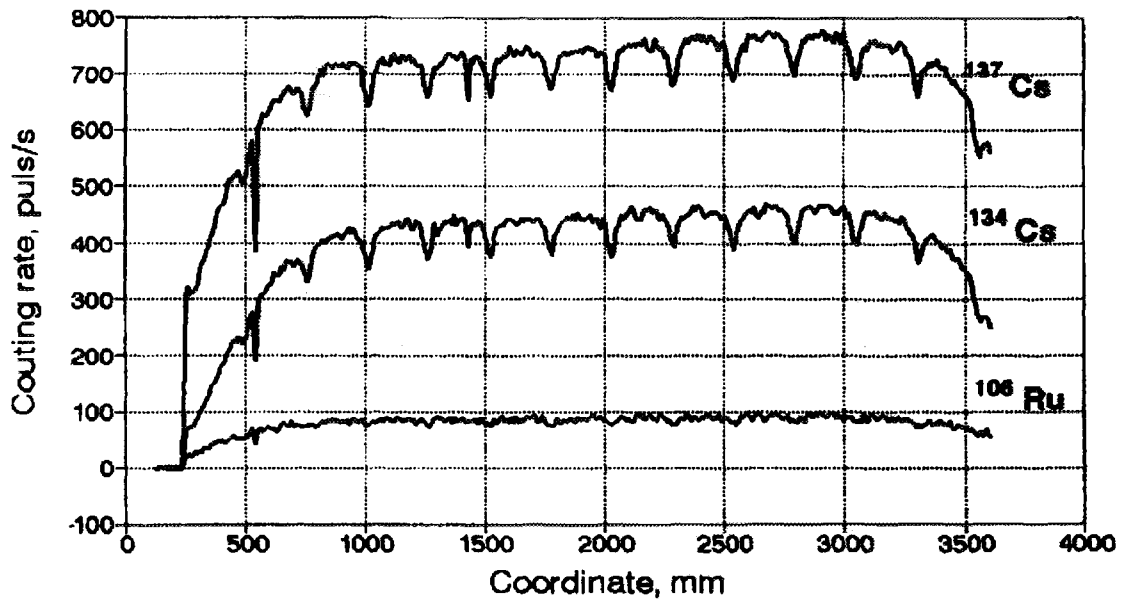
Figure 10 Distribution of fission products gamma activity along the fuel rod length

The distribution of all radionuclide fission products (Fig. 10) points to the absence of the axial migration among them and confirms the low fuel temperature in the operation process. In the areas of spacer grids the decrease of radionuclide concentration is observed.

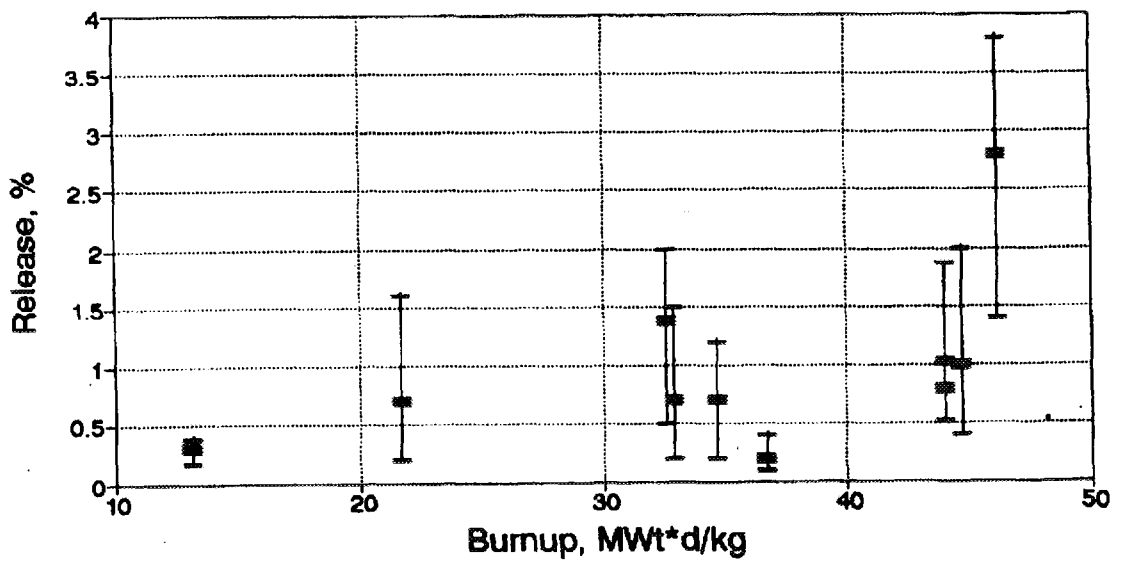
Figure 11 Dependence of fission gas release on burnup

In the process of fuel burnup the fuel gas pressure slowly increases and for those fuel assemblies which have been tested did not exceed  $30 \text{ atm}$  (Fig. 11). The pressure increase was conditioned by the noble gas fission products release from fuel. The dependence of gas fission products release from the size of fuel grains has been found.
