EXPERIENCE ON RELIABILITY OF INSERTION OF CONTROL ROD WITH PWRs IN JAPAN

H. Nakata

Nuclear Power Engineering Corporation, Tokyo, Japan

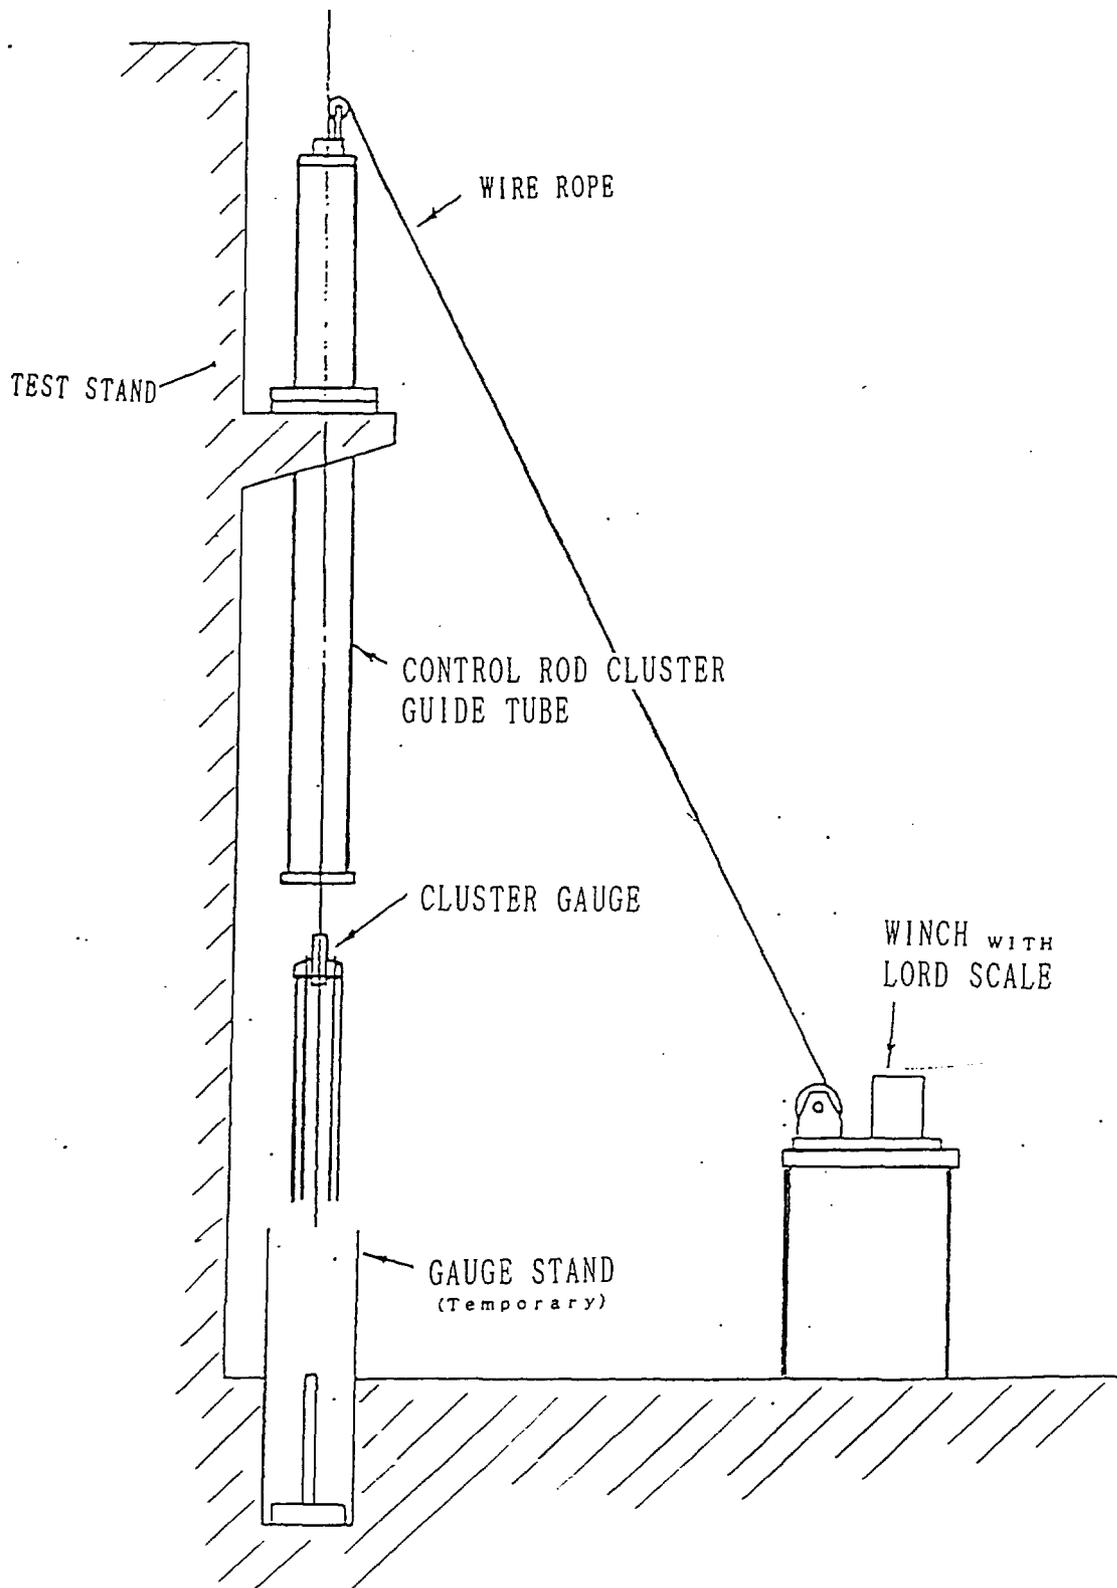
Fig-2 FRICTION TEST FOR
ROD CLUSTER GUIDE TUBE

- 1) Each Control Rod Drive Mechanism is tested on the test loop for operating performance and the current shape of the actuating coil is recorded.
- 2) After manufacture of the Control Rod Cluster Guide Tube, the cluster gauge is passed through it one by one, and the friction force is measured to confirm that it is within the specified limit.(Fig-2)

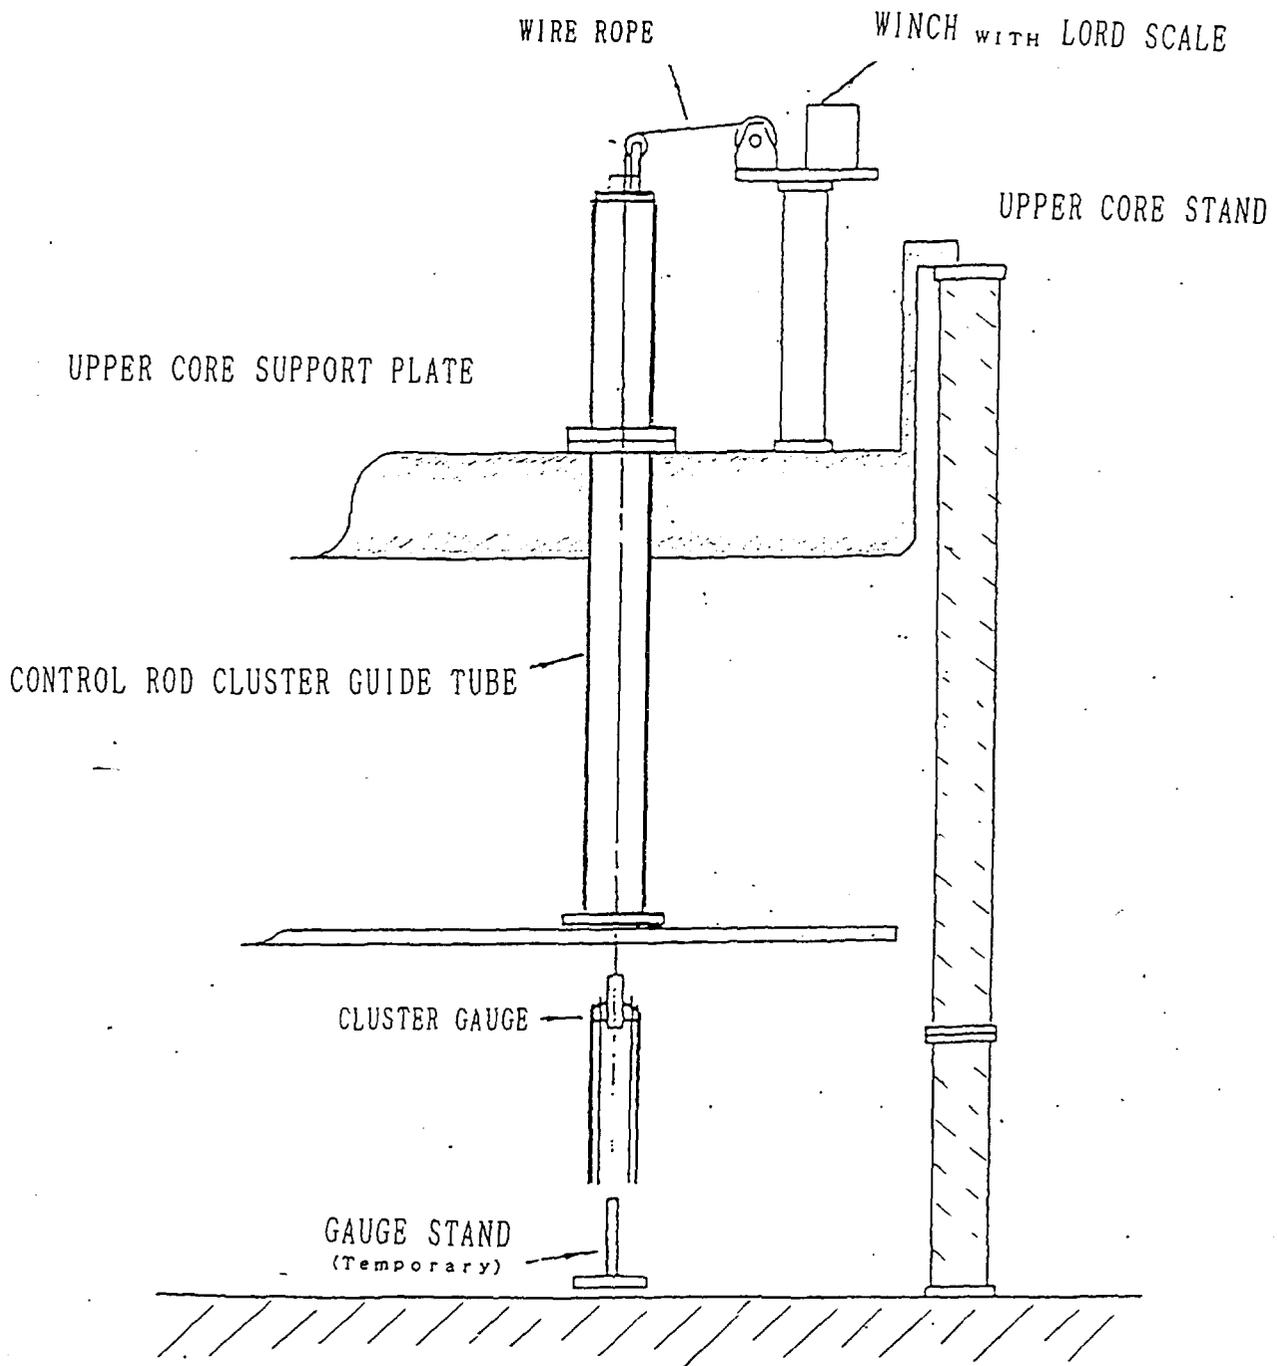
Fig-3 FRICTION TEST ON UPPER CORE SUPORT STRUCTURE

- 5) After assembling of the Upper Core Internal Structure, the Control Rod Cluster Gauge is inserted to each Guide Tube, and the friction force is measured to confirm that it is within the specified limit.(Fig-3)
