APPLICATION OF NON-DESTRUCTIVE TESTING AND
IN-SERVICE INSPECTIONS TO RESEARCH REACTORS AND
PREPARATION OF ISI PROGRAMME AND MANUAL FOR
WWR-C RESEARCH REACTORS

BY
MOHAMED KHATTAB

1996
INFORMATION CENTER
ATOMIC ENERGY POST OFFICE
CAIRO, A.R.E.

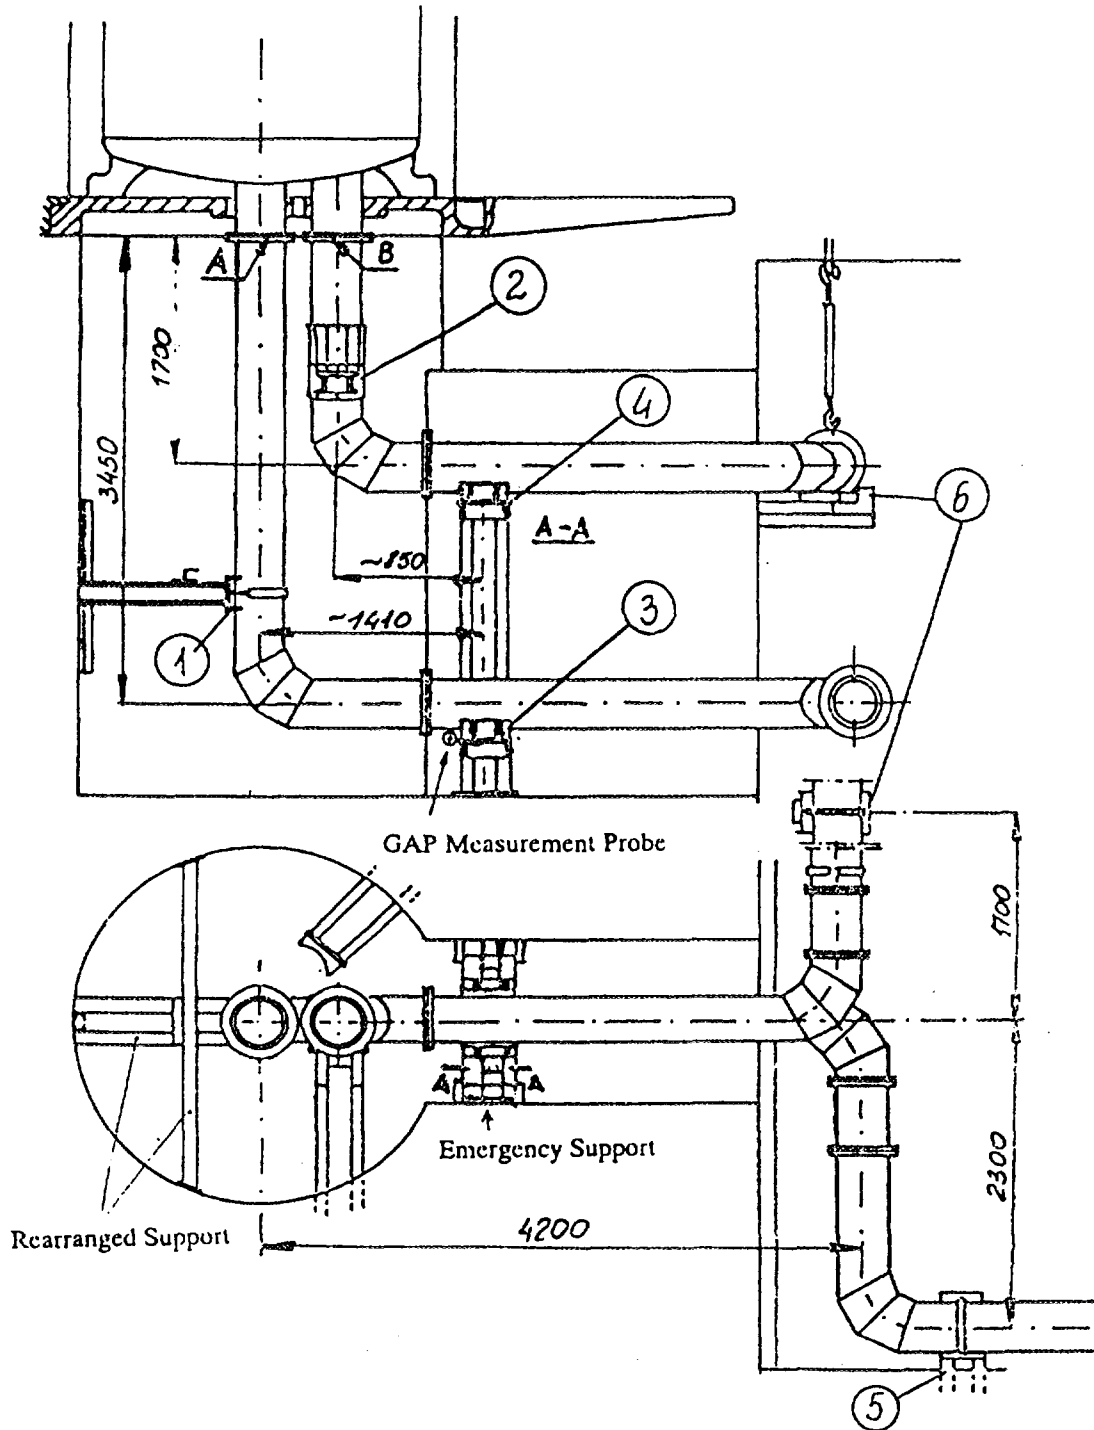
Fig.2. Primary Circuit Supports

the core. These joints are situated under the reactor, in an area which is accessible only for short periods of time due to high intensity of gamma radiation. In EWA reactor, emergency support of PCS was installed under the most critical joints to minimize the gap estrangement in case of sudden drop of the pipes connection under reactor vessel. The studies showed that beginning of fuel exposing takes about 8 seconds in the case of LOCA without the emergency support, and 400 seconds after installing it. Gap measurement probe was introduced to presage with the emergency state, Figs.(2-7). Thermal hydraulic studies were undertaken to determine the possible course of a reactor accident after break of these joints. The studies comprised analyses of heat removal from a fuel element. The upgraded reactors have provided with emergency core cooling system (ECCS). This system is controlled by electromagnetic valves supplied from emergency electric power sources. The valves would open due to spring and gravity forces whenever the electric power is lost. Two out of three monitoring system for water level and pressure measurements were installed, providing an activation signal for valves opening in case of a LOCA.[4].
