PICKERING UNIT 1 CHEMICAL CLEANING

ABSTRACT

CANDU MAINTENANCE CONFERENCE 1995

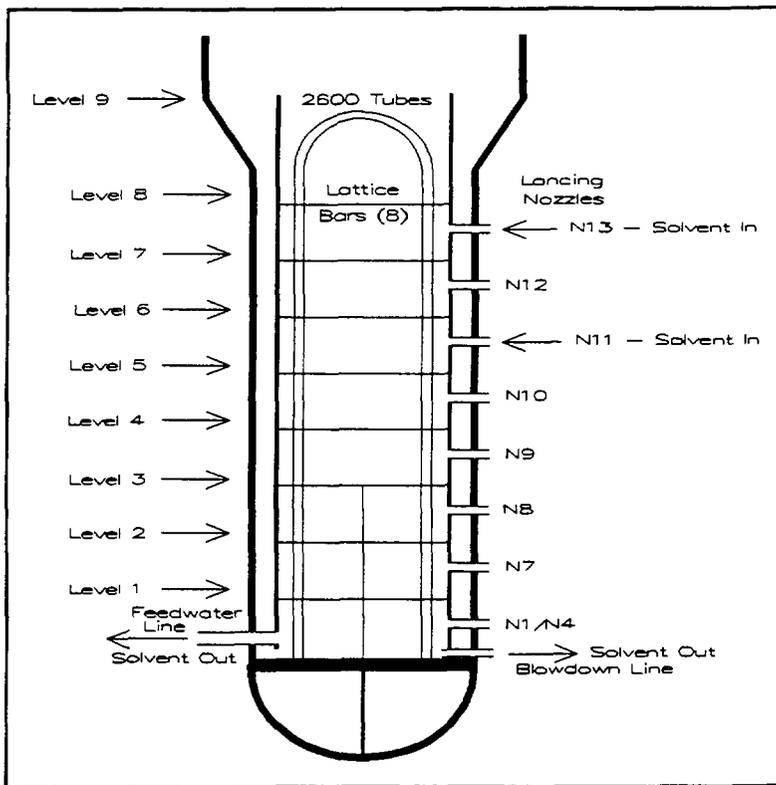
Figure 1
Solvent Connections and Solvent Levels - Pickering 1 Boilers

A hybrid probe was installed in each boiler just above the tubesheet in existing sludge lancing nozzles N1 or N4 (see Figure 1). Experience indicated that this was likely to be the region of highest corrosion.

ZRA probes were installed in one boiler in each bank (boiler 10 in the west bank and boiler 7 in the east bank) at various elevations. Again, existing sludge lancing nozzles were employed to gain access to the boiler (see Figure 1). These probes were designed to provide an indication of corrosion as a function of elevation.

Two venting operations were performed at level 8 (see Figure 1) over a three hour period. The level was sequentially lowered to levels 7, 6, 5, 4, 3, 2 and 1. It was held at levels 7 and 6 for 2 hours each. Two vent operations were performed at each level. It was held at levels 5 and 4 for 12 hours each with venting being performed every 2 hours.
