UPGRADING PRIMARY HEAT TRANSPORT PUMP SEALS

CANDU MAINTENANCE CONFERENCE 1995

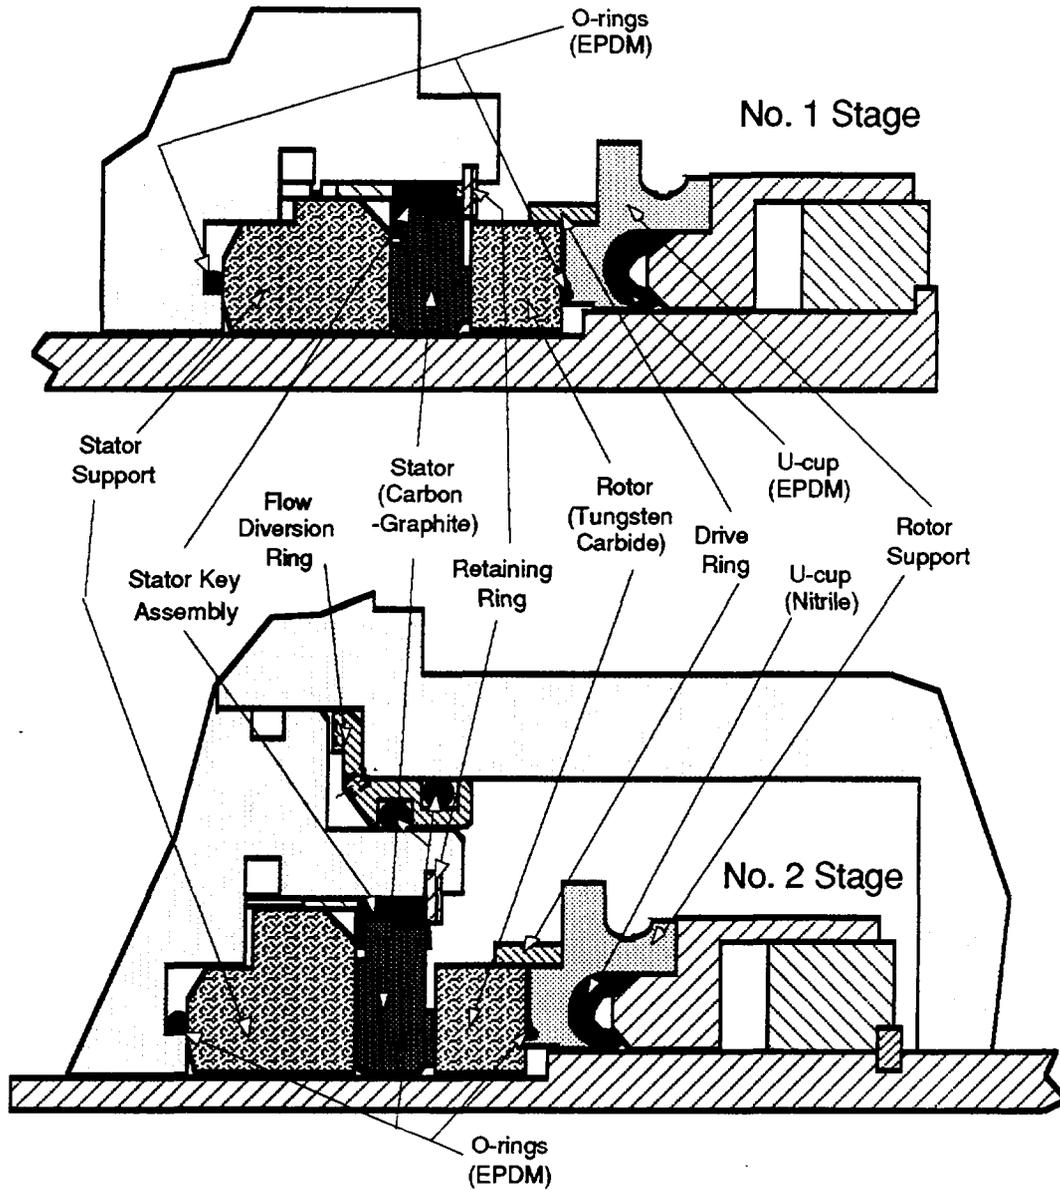
Fig. 1: Two Stage CAN8 Seal for CAN2 Replacement.

The CAN8 design, shown in Fig. 1, was chosen as the replacement for the CAN2 PHTP seals at Bruce-A. Designed in 1991 for both Boiling Water Reactor (BWR) and CANDU® service, the CAN8 design is capable of operating at high or low pressure with no loss in performance. This capability is achieved through improved control over seal face deflections derived from low hysteresis between the seal rings and their supporting surfaces.

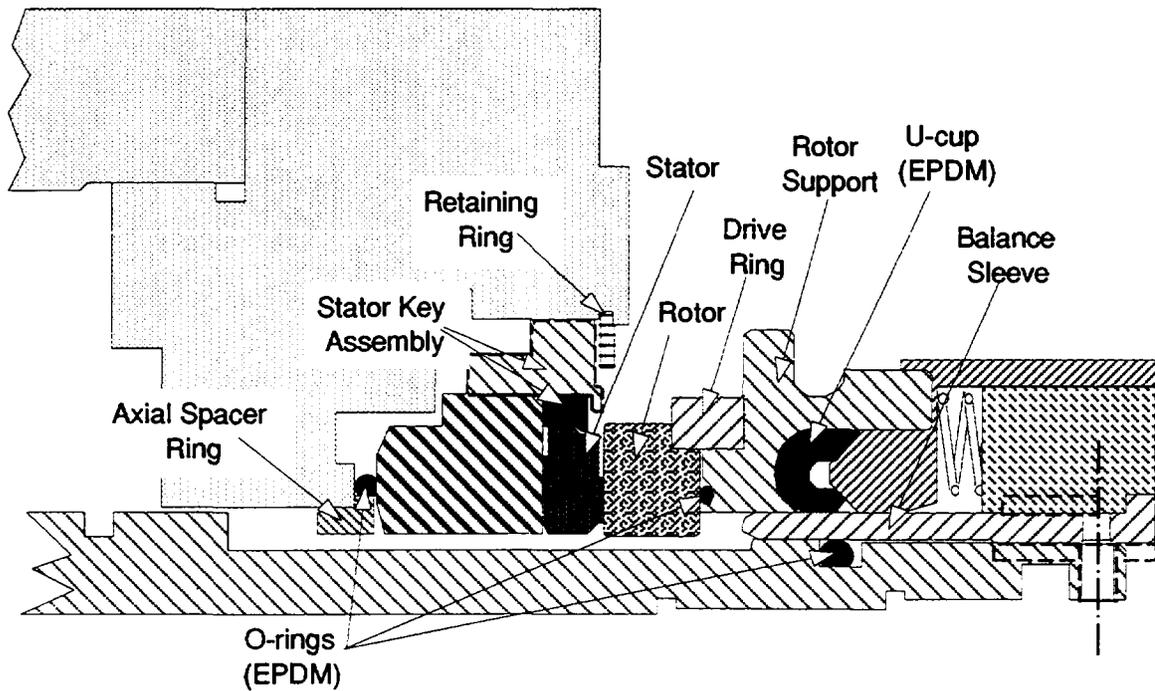
Fig. 4: CAN8 Primary Stage Replacement for Three Stage CAN2 Seals.

The CAN8 seal design has now been extended to include a third stage, the same as the No. 1 stage used in Bruce-A. This is shown in Fig. 4. It allows upgrade of the CAN2 seals in use at Darlington, Point LePreau, and Wolsong-1. This is accomplished by machining the shaft sleeve to accept a new balance sleeve and adding an axial spacer to the stationary assembly. By avoiding the use of new larger-size seal rings, support rings, and elastomers, any uncertainty in performance of a "new" seal design has been minimized.
