VITRIFICATION PILOT PLANT EXPERIENCES AT FERNALD, OHIO

July 18, 1997

For presentation at Science and Technology for Disposal of
Radioactive Tank Wastes Symposium, September 1997

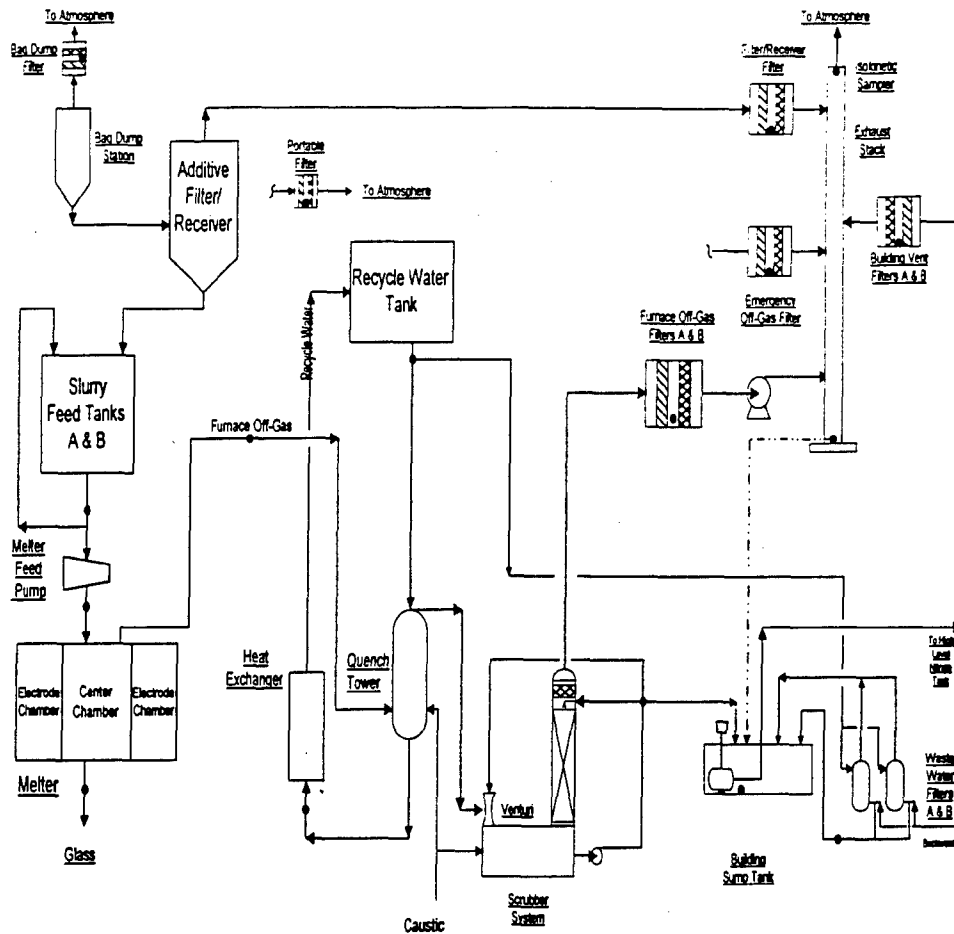
Figure 2
Schematic Process Flow Diagram of the Pilot Plant

The VITPP contains the vitrification melter (furnace) and systems for feed preparation, off-gas treatment, wastewater treatment, a control room, and product-forming and handling which includes a gem-making system. The gem making system cuts the continuous stream of molten glass from the melter into discrete "gobs," which then cool into their final vitrified waste form (called "gems" because of their squashed marble size and shape). A schematic process flow diagram of the VITPP is shown in **Figure 2**.
