Feedback from Practical Experience with Large sodium Fire Accidents

V.P. Luster, K.F. Freudenstein (Siemens AG KWU)

1 SODIUM FIRE ACCIDENT IN THE ALMERIA SOLAR PLANT

2 SODIUM FIRE ACCIDENT IN THE ILONA TEST FACILITY AT BENSBERG

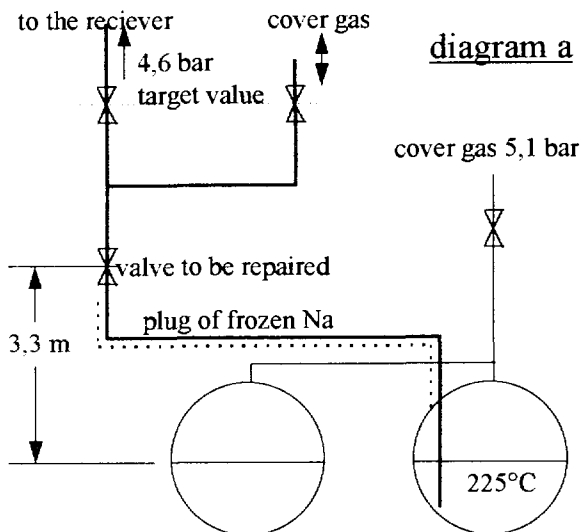
The valve to be repaired was the first one in the suction line of the "cold" circulation line. The normal cover gas pressure of about 5 bars was to be maintained.

In order to isolate the repair area the following conditions have been created in the system (see diagram a)

- several valves were closed in the upper part of the sodium plant
- sodium was frozen over a length of several meters in the suction line.
- the necessary height of the sodium column was adjusted by creating a pressure difference of 0,6 bar between the upper and the lower part of the system.
- The lantern of the valve should be removed in order to get access to the sealing bellow. After preparing the access and removing the flange bolts operators start hand grinding of the seal weld of the flange (believing that the repair area is depressurized and well isolated from the cover gas pressure and from the cold sodium storage vessel).

- During the first period of grinding the seal weld the leak tightness was maintained by an auxiliary helicoflex seal. When about 2/3 of the seal weld perimeter were cut the helicoflex seal gave way. By this the flange was suddenly lifted up. Several gulps of gas with sodium aerosols were expelled, followed after a few seconds by a strong sodium jet. This was the begin of a violent sodium spray fire.

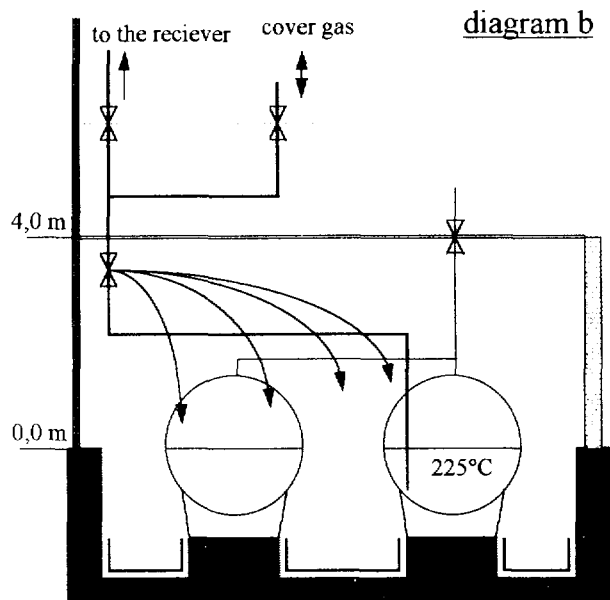
The valve was located in a horizontal section of the line which was in parallel to the a wall of the building at one meter below the + 4 m level floor. The opening of the flange was limited by the spindle to an angle of 40° and oriented to the middle to the room. Figure 3.

As a consequence the sodium jet was projected horizontally to the middle of the room spraying through the installation zone across the cold storage as shown by diagram b.

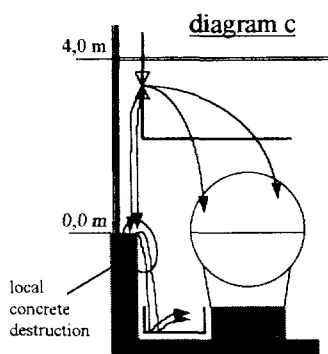
Even within this zone no heavy structures like the storage vessels or sodium pumps were significantly attacked by the fire. Steel profiles of the gratings were locally deformed but not destroyed. Only within the inner fire zone smaller supporting profiles suffered ruptures.

The large vessel supports were locally deformed at the edges, but did not fail although the vessels held the normal contents. Sodium catch pans built of flat ferritic steel plates collected the unburnt sodium, debris and hot reaction products. Although these catch pans were significantly deformed by thermal loads (hot spots) they were able to fulfil their task satisfactorily.

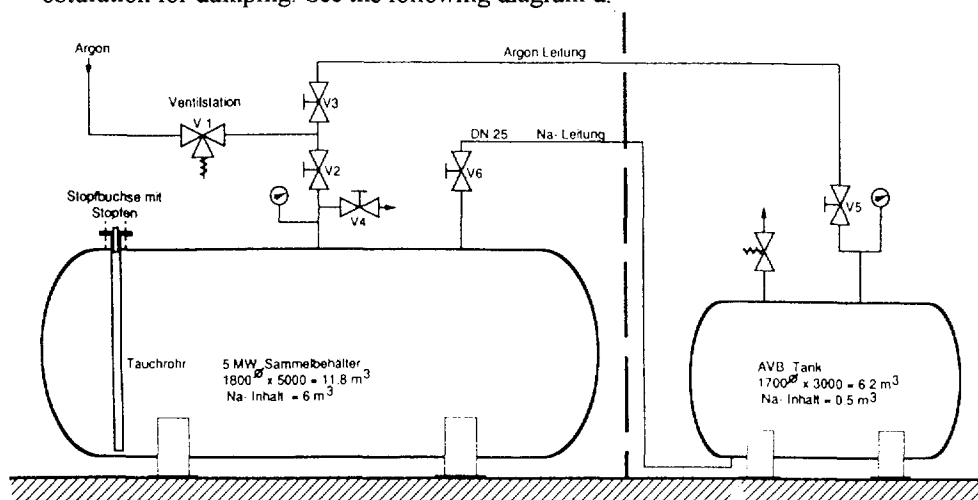
The task at the time of the accident was to store provisionally and to accept sodium from another plant on the site. The plant consisted mainly of the two sodium storage vessels. They were connected with an argon supply system and provided with pressure regulation and monitoring system but had no process connection to the ILONA facility. The vessels remained from two older test loops which were formerly dismantled : the 5 MW-Test loop and the AVB (plant operation test loop). Corresponding to its function the installation was simple. The only sodium line DN 25 connected the two vessels. The 5 MW vessel had a dip pipe with gland plug obturation for dumping. See the following diagram d.

Due to a failure of the pressure regulation valves the cover gas control became unavailable during the heating procedure. The increasing gas pressure lifted the gland in the dip pipe and released sodium. About 6 hours after start of heating procedure the fire alarm from the ILONA basement was given by the central fire alarm system.

Probably the gland plug did not open completely the cross section of the dip pipe. A flow resistance remained. Therefore the leakage flow was small (the time which is necessary to melt the sodium may also play a role). Sodium and reaction products were flowing over the tank outside and came easily in contact with the tank surface because there was no cladding. Additional reaction with insulation material and electrical equipment might have enhanced the energy release.
