| K.2. Leakage Experiences with 1 MW Steam Generator | A. Kanamori M. Kawara A. Sano | Japan |

K.3. KNK-Steam Generator Leak- K. Dumm Fed.Rep.Germany
age, Evaluations and W. Ratzel
Improvements

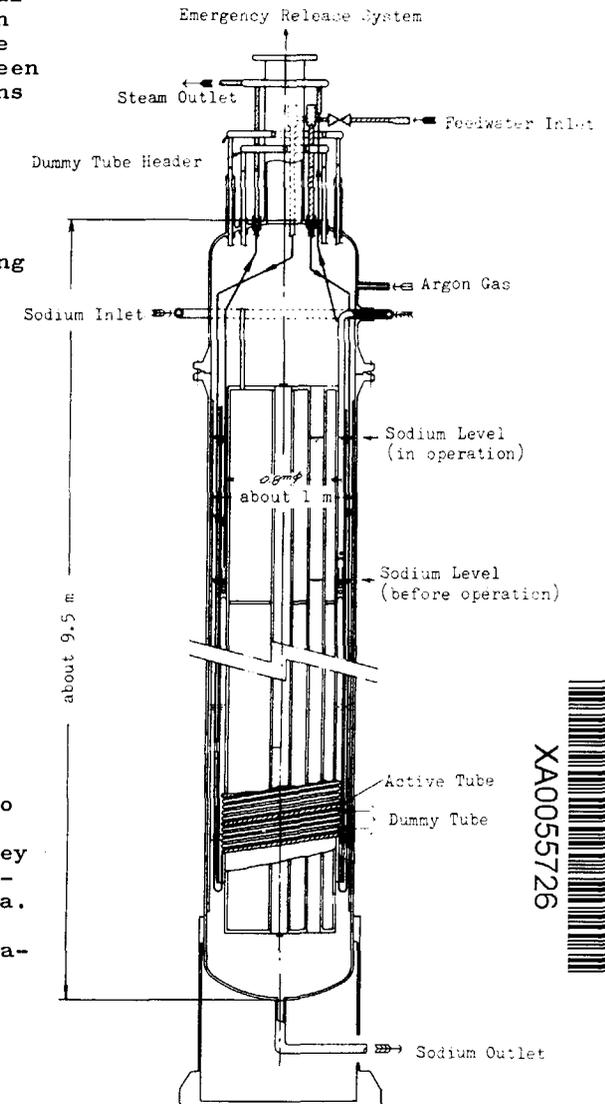
FIG. 1. 1 MWt Steam Generator-Schematic

The modified steam generator is shown in Fig. 1. Two feedwater tubes penetrate the shell by each at the top and go down to the bottom forming straight downcomers. Then, they are turned upward forming herically coiled heat transfer area. The downcomer tube is covered with another tube of bigger diameter so that an argon gas may be filled with the gap to restrict the excessive heat absorption in the region.

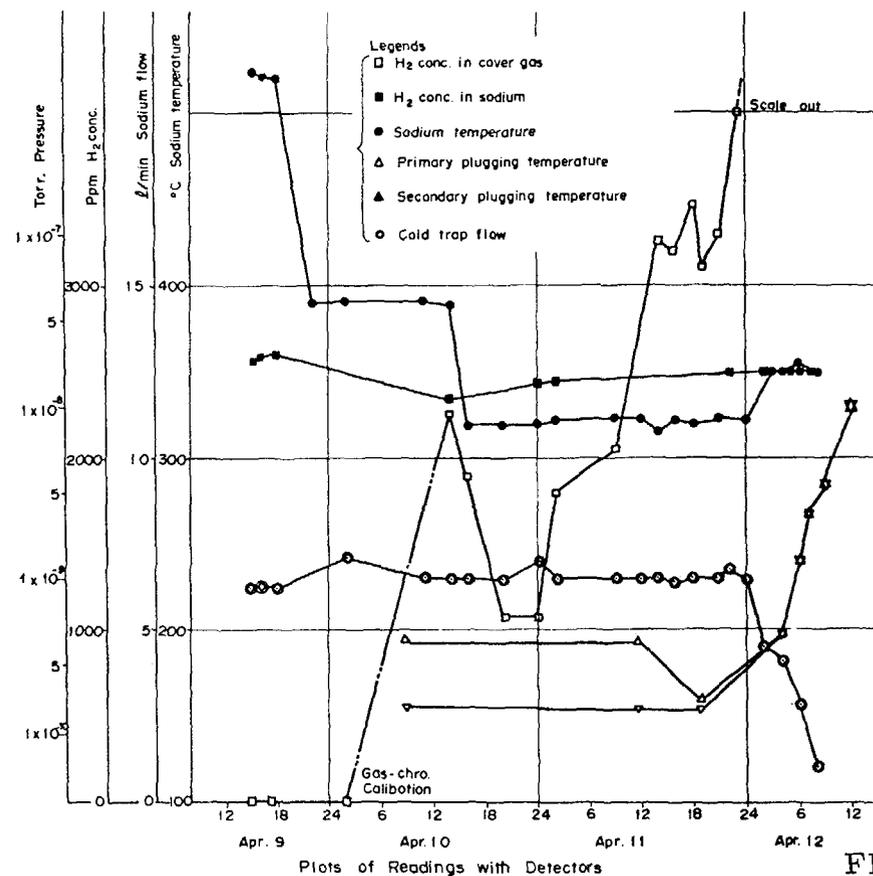
FIG. 2.

Hydrogen concentration continued on such a high level of 3200 ppm around for about 6 hours and went off scale of 4000ppm. The operators, who had previous difficulties in calibrating the instrument, wondered that the calibration was defective because no change in the membrane detector which was used to monitor hydrogen in sodium had been noted. Three or four hours later of the off-scale, an increase of hydrogen with the membrane detector, a going up of plugging temperature and a decrease of sodium flow through cold trap were noticed at almost the same time. Judging with these readings, water leakage was likely definite and it was decided to shut down the operation for inspection. Plots of the above readings under the situation are shown in Fig. 2.

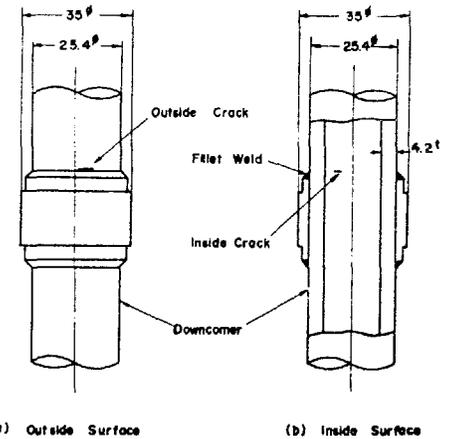
FIG. 8.

Location of the Tube Crack

When it was lifted up again for the inspection, some reaction products were found arround the open end of downcomer and then the outer tube was cut away to inspect the downcomer, which showed the expectation was right. The damaged part is shown in Fig. 8. It was a similar cracking along the heat affected zone and the causes was considered to be the same as the previous one. The downcomer tube was replaced to new one and spacers were changed to be fixed with inside of the outer tube with screws.
