SECOND LEAKAGE EXPERIENCE

K.3. KNK-Steam Generator Leak- K. Dumm Fed.Rep.Germany
age, Evaluations and W. Ratzel
Improvements

K.4. Post-failure Metallurgical Investigation of KNK Steam Generator Tube Damage	H. Lorenz G. Herberg (presented by E.D.Grosser)	Fed. Rep. Germany
--	--	-------------------

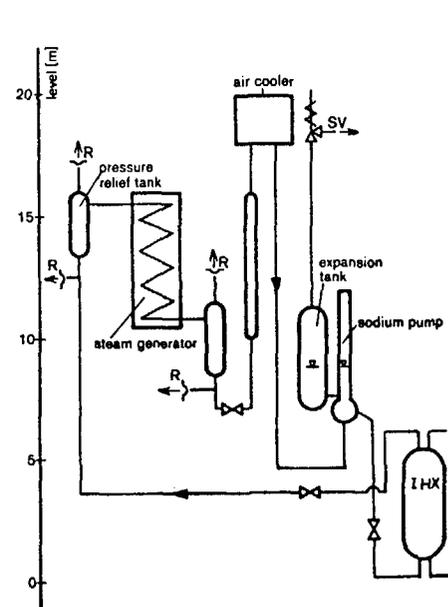
KNK SECONDARY HEAT TRANSFER SYSTEM Figure 1

Fig. 1 shows the geometrical arrangement of the secondary sodium loop with its main components. As explained later the event was partly influenced by this geometrical arrangement. The steam generator with the connected pressure relief system is illustrated in Fig. 2. Steam is produced in 28 parallel tube-in-tube units which are connected to headers. Three additional units are available as spare parts; they are not connected to the headers. Each sodium outlet is equipped with an inductive bubble indicator by which hydrogen bubbles originating from a sodium-water reaction can be detected. At the time when the leak occurred each sodium outlet was additionally equipped with a thermocouple for low load stability measurements. In the case of large sodium-water reaction fast pressure relief is achieved by 4 rupture discs. Previously to the steam generator failure described here all rupture discs were designed having an actuating pressure of 20 bar.
