## DESIGN, CONSTRUCTION AND OPERATING EXPERIENCE OF BOILERS AT WYLFA POWER STATION

R.N. RAZZELL

Wylfa Power Station,  
Central Electricity Generating Board,  
Gwynedd, United Kingdom

### Abstract

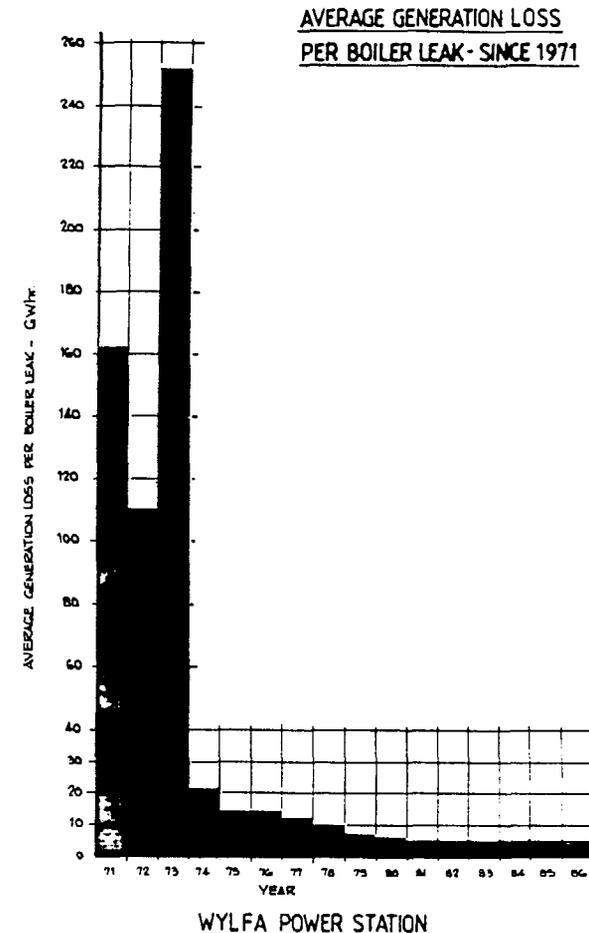
Although some difficulties were experienced with the early design the method proved a great success. Through operating experience, the jack and tool have been developed until it is now a relatively straight/forward operation to fit one. The main improvements have been a redesigned plug giving a better lead into the tube to be sealed and synchronising gears to prevent the plug being diverted by escaping gas during fitting. (See Fig. 14).

The main advantage of using the jack system is that the reactor can remain on load during fitting. Only the offending boiler and its associate need be taken out of service and by increasing load on the remaining boiler pair 80% full load can be maintained. From identifying a leaking boiler to return to full power can now take as little as 24 hours.
