SODIUM LEAKAGE EXPERIENCE AT THE PROTOTYPE FBR MONJU

A. MIYAKAWA, H. MAEDA, Y. KANI, K. ITO
Monju Construction Office,
Japan Nuclear Cycle Development Institute,
Fukui-ken, Japan

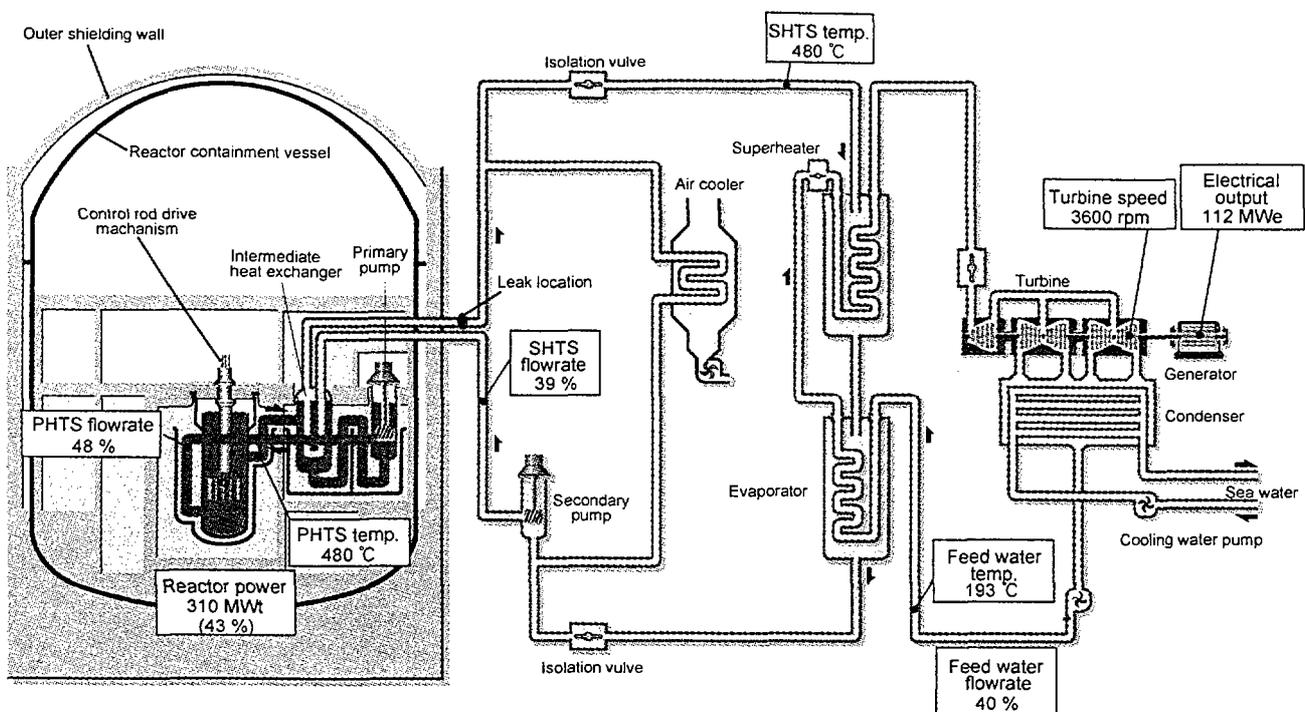
Fig. 1. MONJU plant condition (just before the sodium leak).

After a plant trip test, Monju restarted operation on 6th December 1995. On 8th December, power was being raised for the next plant trip tests, part of 40% electric power tests. The thermal power had reached 43% when an alarm sounded at 19:47 due to an off-scale sodium temperature at the outlet of IHX in the secondary circuit loop C. A fire alarm (smoke detector) sounded at the same time. A sodium leak alarm in the secondary circuit followed. The plant conditions of Monju at that time are shown in Fig.1. The presence of smoke was confirmed when the door of the piping room was opened. The plant operators decided to begin normal shutdown operations because they judged it was a small sodium leak had occurred. Reactor power-down operations began at 20:00.

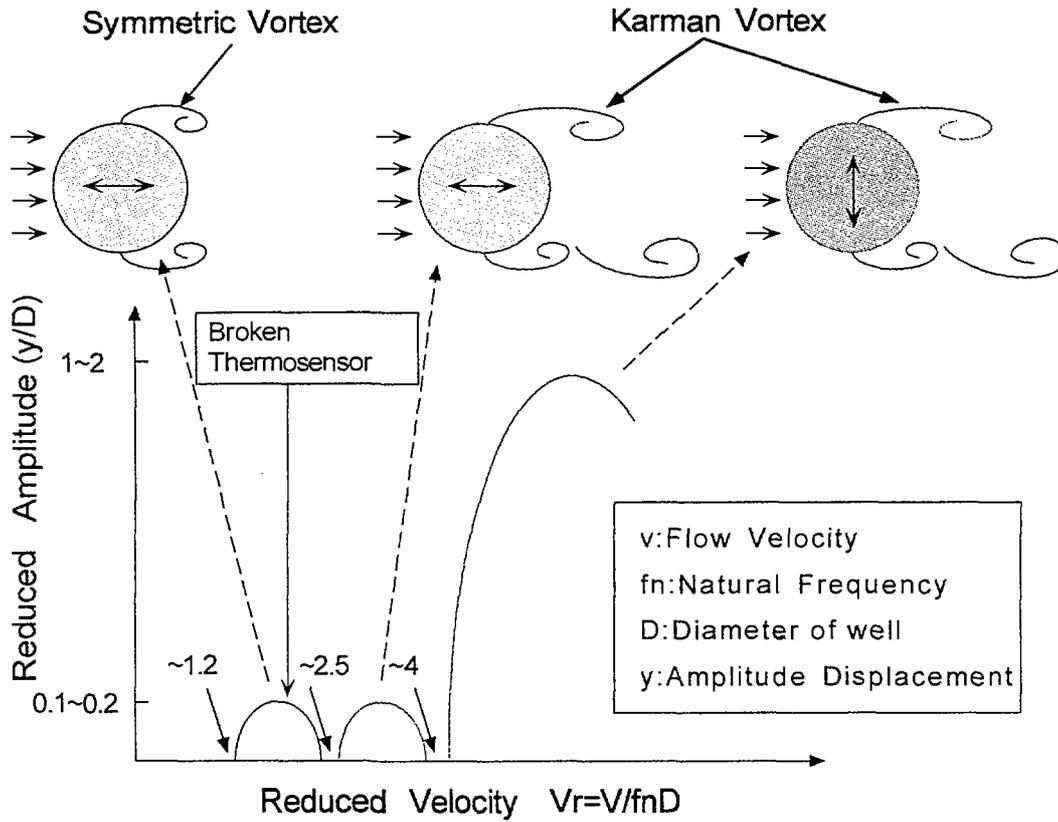
Fig. 6. Explanation of vortex shedding.

Detailed microscopic and metallographical examinations of the well tube and the fracture surface, examination of welded parts of the well, detailed examination of the sheathed thermocouple were carried out at JAERI and the National Research Institute of Metals (NRIM). The detailed measurement of the damaged part (fracture surface) was undertaken with microscopes and laser microscopes. As a result of these inspections, it was found that the fracture surface showed the typical features of high cycle fatigue with crack initiation, very slow propagation, and final ductile rupture, as shown in Fig.5. In parallel, flow-induced vibration analysis and mockup tests were conducted to identify the direct cause of the failure. These investigations confirmed that the breakage of the thermocouple well was caused by high cycle fatigue of the well tube tip due to flow-induced vibration. This vibration was not caused by well-known Von Karman vortex shedding, but a symmetric vortex shedding (Fig.6). According to fatigue crack analysis on the basis of the flow rate history, it was estimated that the cracks initiated at the early stage of the 100% flow operation, propagated in the subsequent operation, finally leading to the well tube failure in the last 40% flow operation. It was confirmed that the estimated breakage process agreed with the investigation results of the fractured surface and the full scale in-water experiment .

It was decided to replace all the thermocouple wells susceptible to vibration in the secondary circuit with modified designs. A new design guide against the flow-induced vibration was prepared by JNC. It is more comprehensive and definitive than the existing design guide "ASME N-1300".

Using this design guide, three new thermocouple well designs were developed, according to their functional requirements and locations. All the designs use a tapered well, instead of steep diameter change. A leak suppression mechanism is also incorporated into the new design. The three thermocouple designs, Type A, B, and C are shown in Fig. 7, along with the existing design. The "Type A" thermocouple well is directly welded to the pipe wall, while the "Type B" and "Type C" thermocouple wells are mounted on the existing nozzles. The three design types have different penetration designs and different insertion length into the flowing stream.
