EVALUATION OF ALUMINIUM-CLAD SPENT FUEL CORROSION IN ARGENTINE BASINS.

Div. Corrosión, Unidad de Actividad Materiales

Comisión Nacional de Energía Atómica, Av. Gral Paz 1499, (1650) San Martín (Buenos Aires) - Argentina

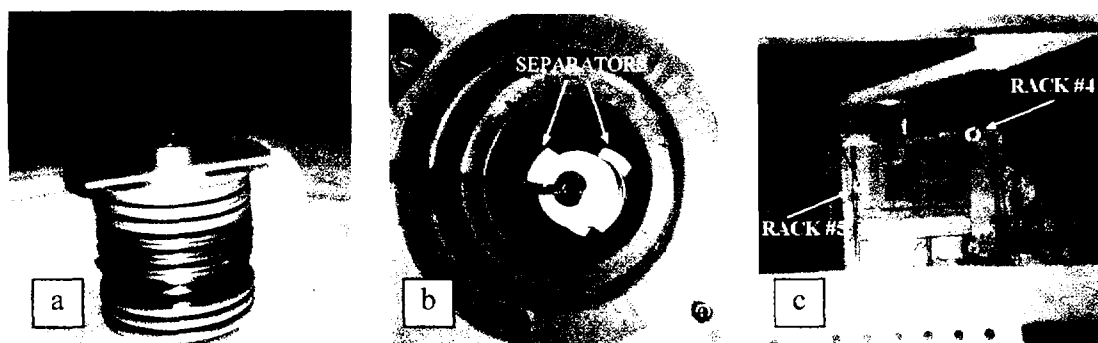
Fig. 1: (a) Racks #2 and #3 before immersion; (b) Rack #3 entering a channel at CSF; (c) Racks in position in RA3 DP.

In figure 1(c), racks #4 and #5 can be seen in place into the RA3 DP, nearby a spent fuel canister. For the location of samples in RA6 DP similar criteria was applied. In the case of the RA6 RP, the racks was hanged at core's height but close to the pool wall.
