NEA/CSNI/R(2002)22

**NUCLEAR ENERGY AGENCY
COMMITTEE ON THE SAFETY OF NUCLEAR INSTALLATIONS**

**LESSONS LEARNED FROM HIGH MAGNITUDE EARTHQUAKE
WITH RESPECT TO NUCLEAR CODES AND STANDARDS**

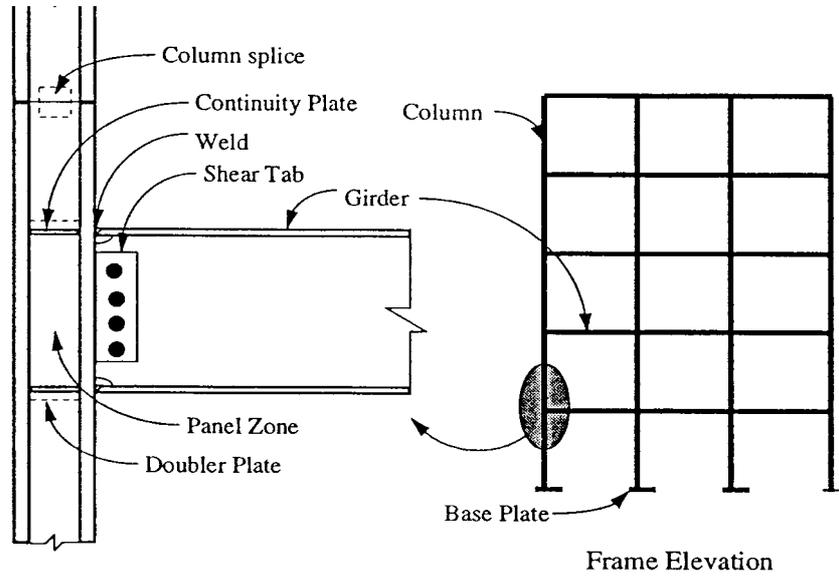
Figure 2-1 - Elements of Welded Steel Moment Frame

flange-web connections of steel moment-frame buildings were, in some cases, due to poor weld quality contributing to a lack of fusion between the girder flange and the column. In addition, back-up and dam bars served as crack initiation sites (see Appendix the Figures 2-1 to 2-6 from /SAC 95/).
