International Conference
Nuclear Energy for New Europe 2007
Portorož /Slovenia /September 10-13

**CODEX-CT-1 AND CT-2 INTEGRAL TESTS:
TWO POSSIBLE SCENARIOS OF THE PAKS-2 INCIDENT**

Péter Windberg, Zoltán Hózer

Hungarian Academy of Sciences KFKI Atomic Energy Research Institute
Fuel and Reactor Materials Department

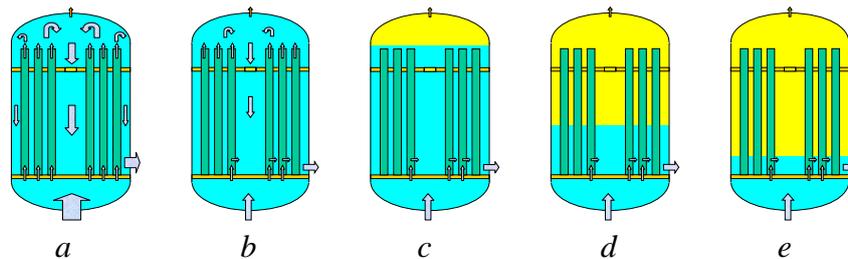
Fig.4. [1] Flow path of coolant in the cleaning tank during normal cleaning operation (a), at the beginning of intermediate cooling mode (b) and the steps of steam volume formation (c,d,e)

After the initiation of intermediate cooling mode part of the coolant could bypass the fuel assemblies and did not take part in the removal of decay heat. Two paths were identified for the bypass flow:

- The working type VVER-440 fuel assemblies have perforation holes in the shroud.
- The perfect seating of the assemblies was not controlled and some gap could exist.

The flow through the assemblies was not enough to remove the decay heat and the temperature in the upper part started to increase. When the saturation temperature was reached the formation of a steam volume took place in short time. This period lasted about 2,5 hours

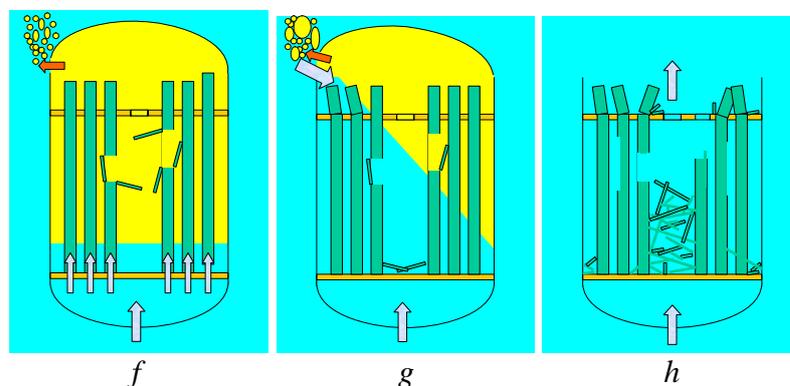
Fig. 5 [2] The main phases of reflood

1. The opening of the hydraulic locks created a small gap between the cover and the vessel.
2. Some gas was released through the gap from tank into the spent fuel storage pool and the pressure in the tank decreased (Fig.5.f).

3. Water injection through the inlet line could reach higher elevations than before the opening of the cover due to low pressure.
4. Intense steam production took place when the cold water evaporated on the hot surface of the fuel. Probably this process resulted in vertical upward movements of the assemblies, that were recognised by the signs of interactions between the inner surface of the cover and the assembly headers. These signs were found after the removal of the cover.

5. The pressure increase in the tank lead to the rising of the cover and increase of the gap between cover and vessel.
6. The large gap size facilitated water penetration from the surrounding pool and so large amount of water flooded the fuel assemblies from the pit (Fig. 5.g).

7. Finally the tank was filled up by water and stable circulation of coolant was established with the pump (Fig. 5.h).

The thermal and mechanical loads resulted in the fragmentation of many fuel rods. This final event of Paks-2 cleaning tank incident was modelled in all three CODEX CT experiments with a short time water inject from above and reflood from the bottom.

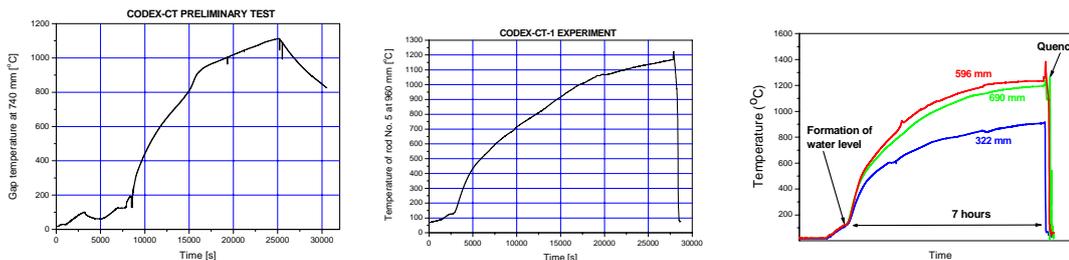
Fig.6. Temperature histories in the preliminary, CODEX-CT-1 and CT-2 tests

Fig.6 shows the temperature histories. In the CODEX-CT integral tests the maximum temperatures were nearly 1200-1250 °C. The final reflood of the bundle led to significant temperature increase in some positions. In test CT-2 the maximum temperature reached during the oxidation phase was 1250 °C, but during quench the peak value was 1380 °C.

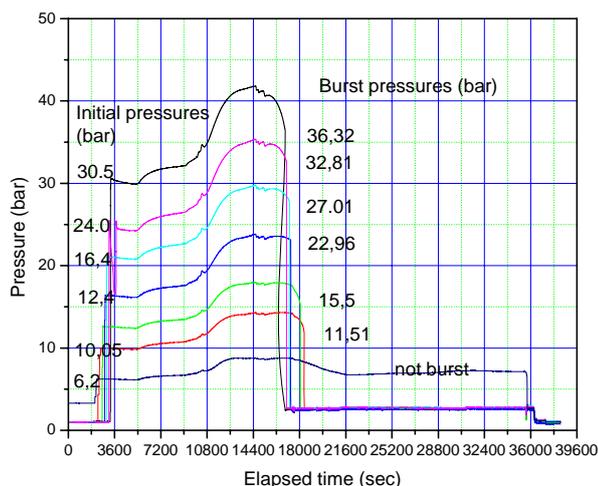
Fig.7. Fuel rod pressures in CODEX-CT-1 test

The Fig.7 shows the pressure histories in rods. In both CODEX CT-1 and CT-2 tests the story happened similarly. The rods with high pressure lost their integrity due to burst at 800-900 °C. The pressure increase reached a maximum during the tests and before burst their value slightly decreased (Fig. 7). It was a result of plastic deformation that increased the internal gas volume and had larger effect on the pressure change, than the temperature increase. Long ballooned sections were observed in the post-test examinations.
