# BWR Fuel Performance under Advanced Water Chemistry Conditions – a Delicate Journey Towards Zero Fuel Failures – a Review

**S. Hettiarachchi**

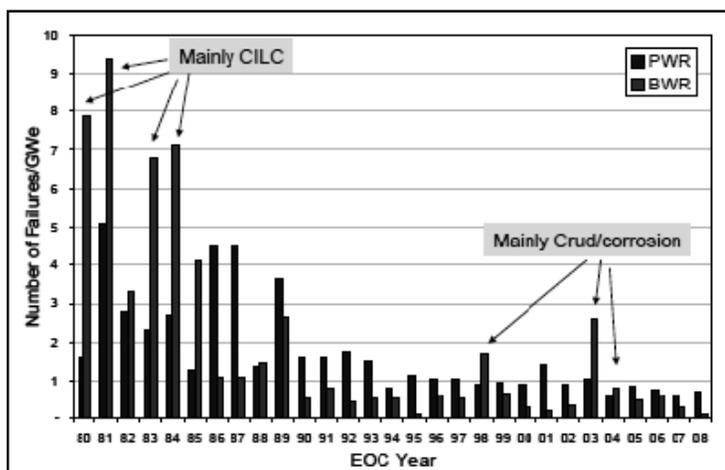
Figure 1. Number of Failed Fuel Assemblies in US Light Water Reactors [2].

It was shown earlier in Figure 1 that the US industry annual average fuel failure rates in number of failed fuel assemblies per gigawatt electricity produced for both BWRs and PWRs. About eight BWR4 and BWR 5 units in the US

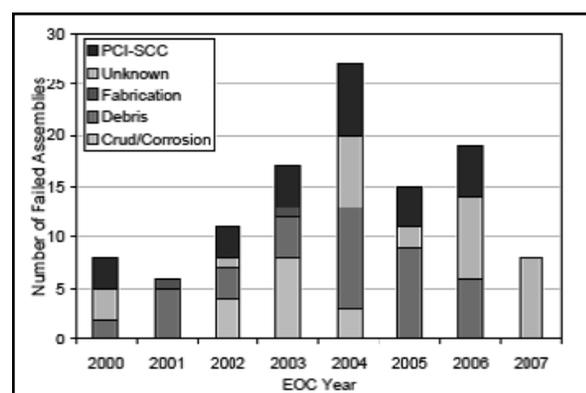
Figure 2. US BWR Fuel Failure History from 2000 to 2007 [1].

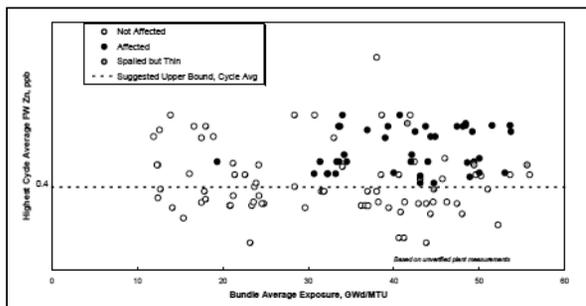
even though noble metal was not implicated in any of the corrosion related fuel failures that occurred during 2002 to 2004. It was later determined that the crud spallation is potentially more related to the higher levels of zinc usage than to the noble metal input, Figure 4 [2]. However, the allowable noble metal input over the life time of a fuel bundle still remains restricted to a level accepted by the industry despite the fact that noble metal has not been implicated in any of the fuel failures. Thus, guideline limits on both noble metal input and zinc input into BWRs have been established and there have been no fuel crud/cladding related fuel failures in US BWRs since 2004 [2].

Figure 4. Feedwater Zinc vs. Bundle Exposure and Spalling Experience [1].

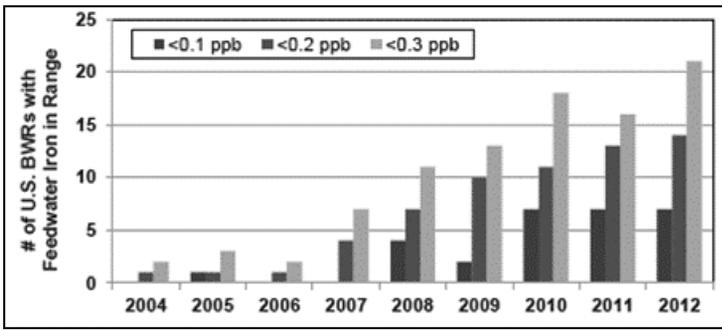
Figure 12. Evolution of Low Feedwater Iron Operation at US BWRs since 2004 [11].

rates [4]. In order to further control fuel crud, US plants also adopted the use of low feedwater iron inputs in the range  $< 0.1$  to  $< 0.3$  ppb using better filtration technologies. The reduction of feedwater iron also has the added benefit of increasing the performance of zinc in reducing radiation fields. Figure 12 provides a representation of employing better filtration technologies that resulted in lower feedwater iron levels year after year [11]. BWR operators are also using  $< 0.4$  ppb zinc in the feedwater, per EPRI Water Chemistry Guidelines [12], under NMCA conditions in order to minimize the tenacious ferro-magnetic crud formation on fuel cladding material. However, there are a few NMCA plants that still use  $> 0.4$  ppb feedwater zinc because of the overwhelming benefits of zinc addition on radiation field reduction without any impact on long-term fuel performance.

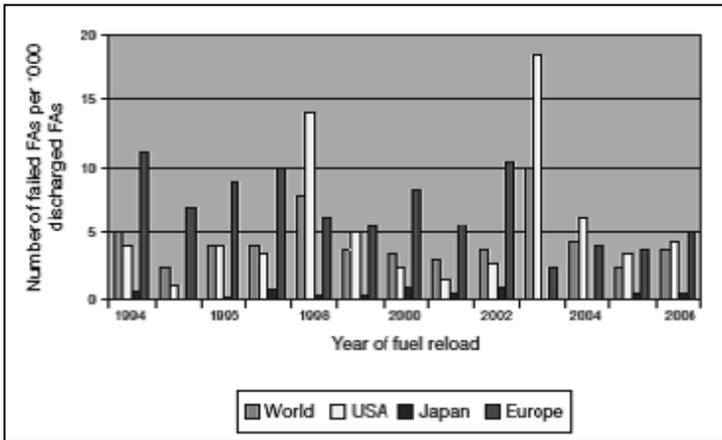
Figure 13. BWR Fuel Assembly Failure Rates Presented as Leaking Assemblies per 1000 Discharged Assemblies [14].

In the last decade, BWR fuel failure rates have been decreasing systematically, and Figure 13 shows the BWR fuel assembly leak rates from 1994 to 2006 for US, Japan and European region [14]. The Figure shows leaker rate maximums in 1998 and 2003 for US while the leaker rate in Japan was close to zero. The average fuel assembly (FA) failure rates per 1000 discharge FAs for the entire period 1994 to 2006 are : World average – 4.4, US – 5.4 (4.3 if massive BF2 failures were eliminated), Japan – 0.4 and Europe (Finland, Germany, Spain, Sweden, Switzerland) – 6.8.

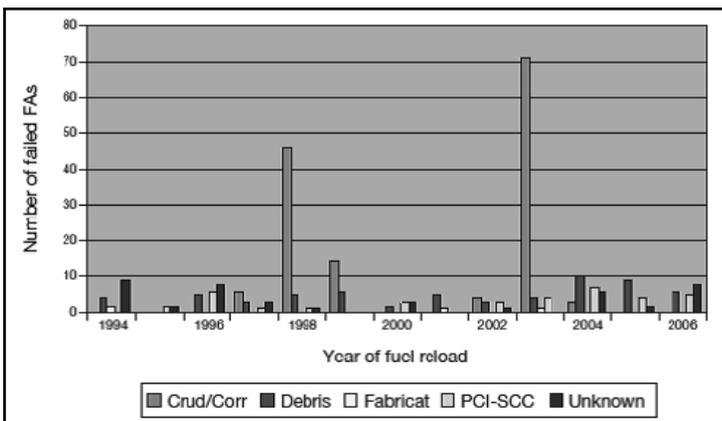
Figure 14. BWR Fuel Failure Causes in the United States [14].

The distribution of failure causes in the US BWRs is shown in Figure 14. Accelerated cladding corrosion and tenacious crud deposition were identified as being behind massive failures in 1998 (46 failures were due to crud induced localized corrosion-CILC [15] and in 2003 (63 crud/corrosion induced failures in the Browns Ferry Unit 2 during cycle 12 [8]. If BF-2 failures are excluded from the statistics, corrosion/crud and debris related fuel failures in US BWRs are at the same level.

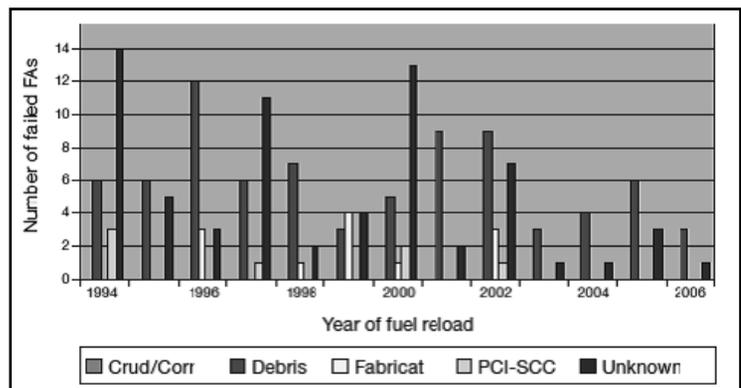
Debris related failures dominate in European BWRs with a significant amount of PCI-SCC failure types before 2002 as shown in Figure 15, with a decreasing trend of debris failures after 2002 [14].

Figure 15. BWR Fuel Failure Causes in Europe [14].

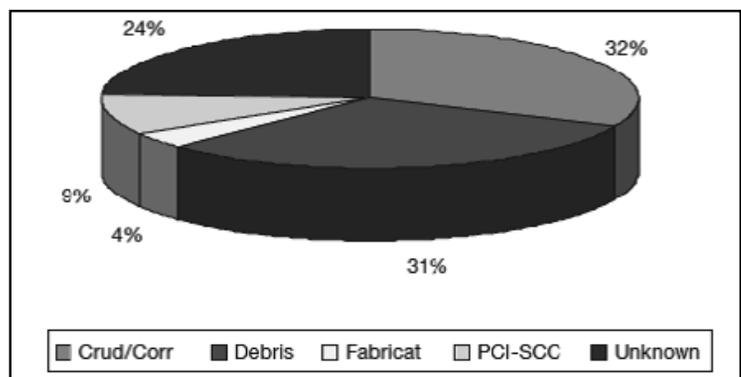
Figure 16 illustrates an estimate of BWR fuel failure causes worldwide. It is seen that crud/corrosion and debris related failures occur at the same frequency. PCI-SCC related failures are more or less uniformly distributed throughout the period 1994–2006, practically independent of the implementation of barrier cladding. Fabrication related failures were not observed during the last three years (2004–2006). However, the significant fraction of unknown failures is still a concern.

Figure 16. Estimated World Distribution of BWR Fuel Failure Causes [14].

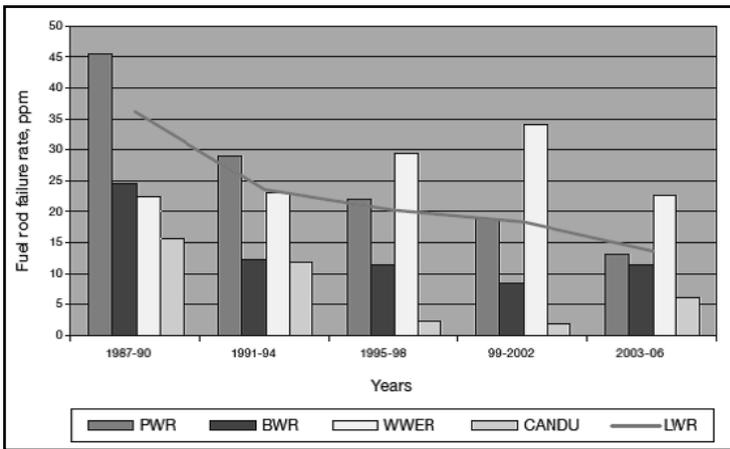
The fuel rod leaker rate comparison of all light water reactors over 4 year periods beginning from 1987 is presented in Figure 17. Overall, there is a decreasing trend of fuel rod leaker rates of LWRs since 1987.

Figure 17. Fuel rod leakage rate calculated for the period 1987–2006 [14].

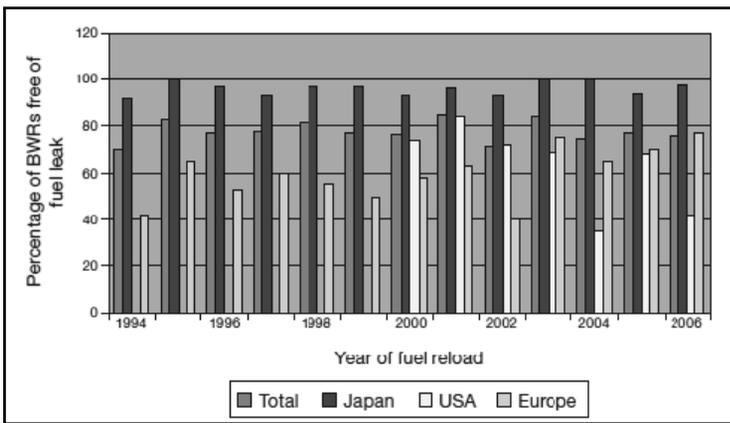
Figure 18 shows the percentage of leaker free BWR units

Figure 18. Percentage of BWRs with Zero Fuel Leakers up to 2006 [14].

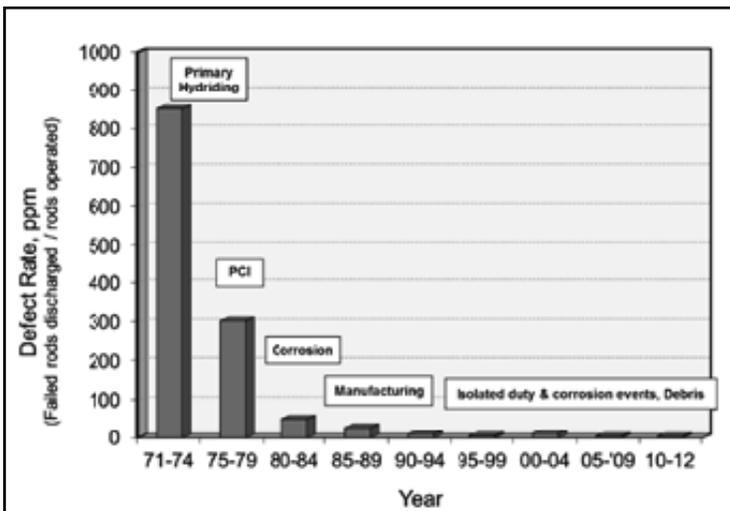
Figure 19. The Path to Zero Fuel Failures Over the 40 Plus Years [16].

The results of these efforts are reflected in the successful march towards zero leakers in the US as shown in Figure 19 [16]. However, sustaining this success is not an easy task since a single fuel failure event can affect the success achieved over many years concerted effort. Thus, it is critical to pay detailed attention to every activity that can potentially affect fuel failures in the BWR industry.
