105-DR LARGE SODIUM FIRE FACILITY CLOSURE ACTIVITIES EVALUATION REPORT

WHC-SD-EN-EV-034
Revision 1

105-DR Large Sodium Fire Facility Closure Activities Evaluation Report

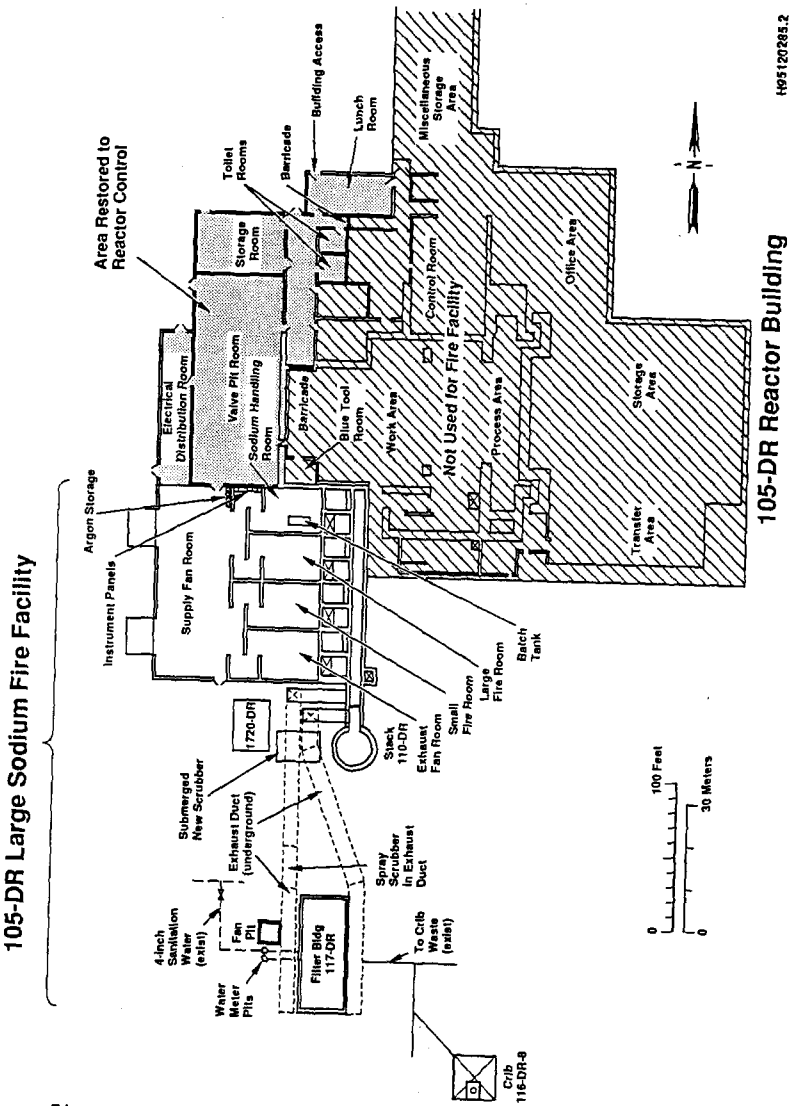
Figure 3. A Schematic of the 105-DR Reactor Building Including the Large Sodium Fire Facility Prior to the Start of Closure Activities.

Before the start of closure activities, Closure Area 1 of the 105-DR LSFF had been radiologically surveyed. Closure Area 1 was found to be uncontaminated. This survey allowed the radiological protection zone to be moved from the entry door on the south side of the building to the door into the 105-DR Reactor Valve Pit Room (Figure 3).

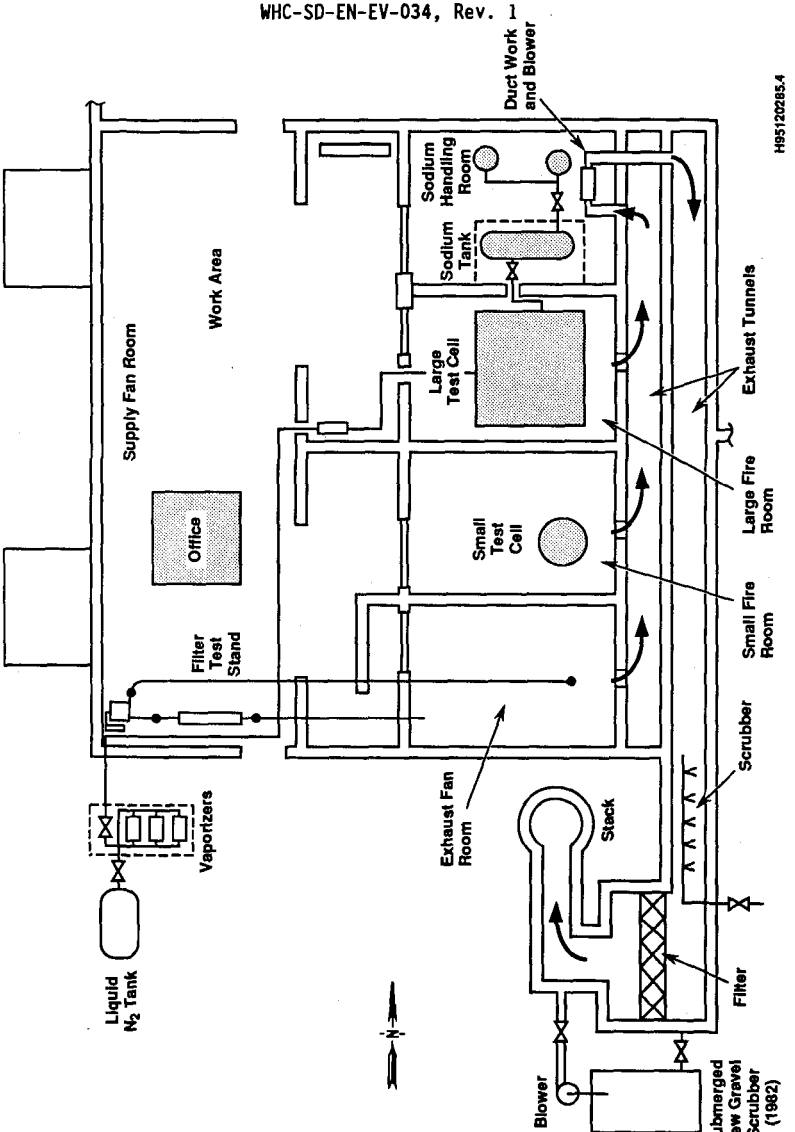
Figure 4. A Schematic of the Overall Large Sodium Fire Facility Exhaust System as Used During Operations.

As noted in the description of Area 2, there is duct work and a blower connecting the upper and lower parts of the reactor exhaust tunnels (Figure 4). This equipment is located physically within the Closure Area 1 Sodium Handling Room. The internal portions of the duct work and blower were heavily coated with carbonate.

The blower and associated duct work were included as part of the closure activities. They were located in the Sodium Handling Room (Figure 4) within the boundaries of Closure Area 1. Including the blower and associated duct work in the closure activities allowed the tunnel to be isolated and removed carbonate contaminated equipment from within the physical boundaries of Closure Area 1.

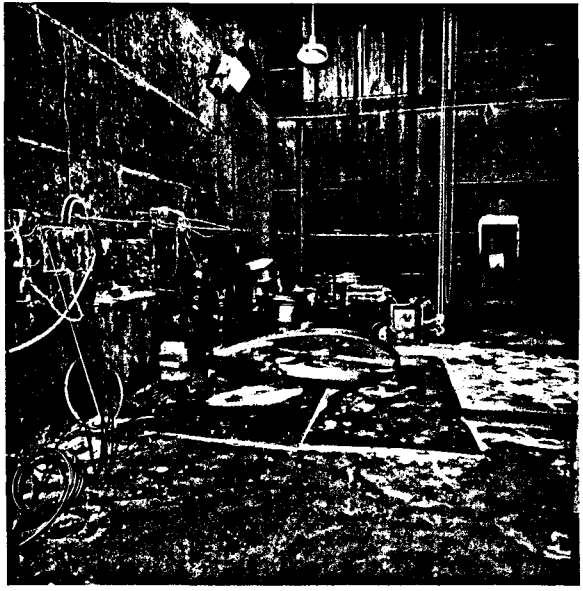
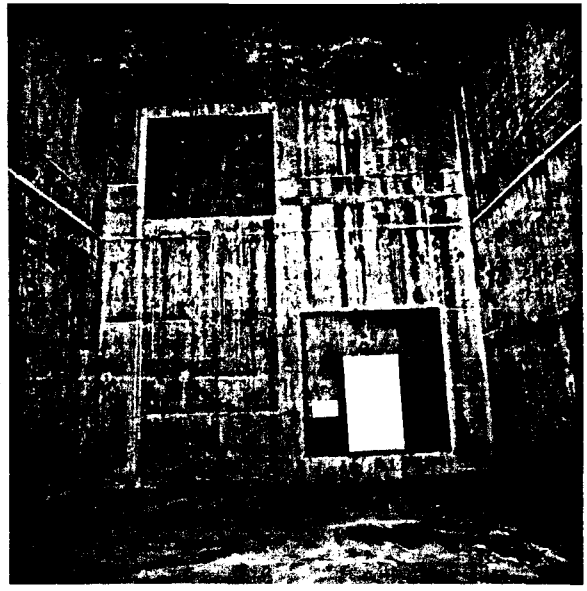
Figure D-1. 105-DR Large Sodium Fire Facility: Exhaust Fan Room During 1990 and After Completion of Closure Activities in March 1996.

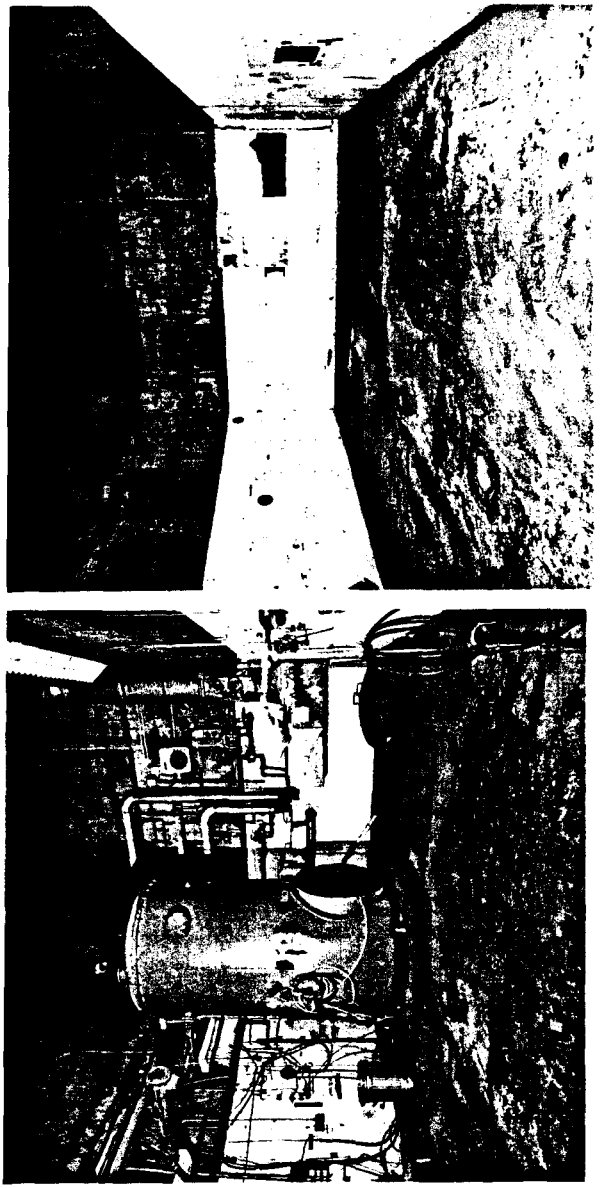
Figure D-2. 105-DR Large Sodium Fire Facility: Small Fire Room During 1990 and After Completion of Closure Activities in March 1996.

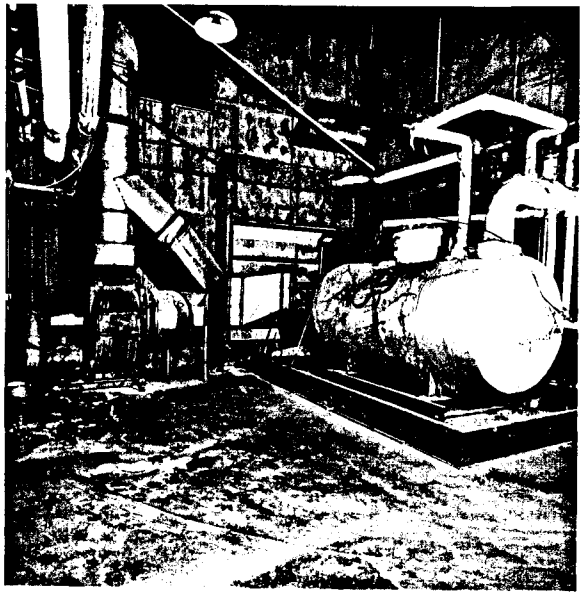
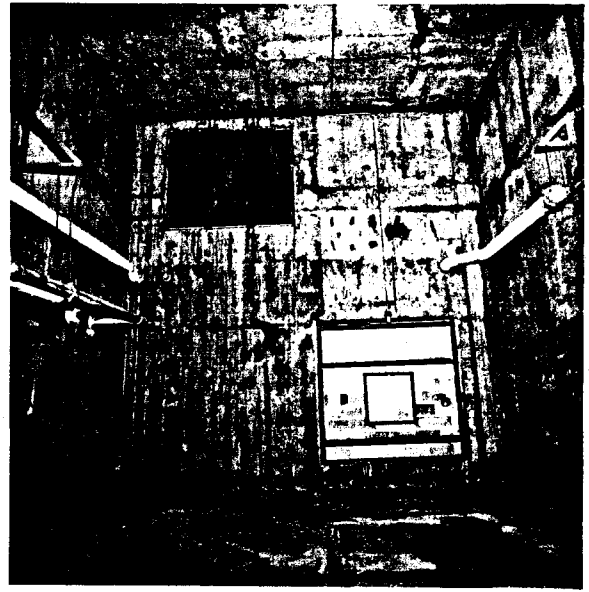
Figure D-4. 105-DR Large Sodium Fire Facility: Sodium Handling Room During 1990 and After Completion of Closure Activities in March 1996.
