AECB Staff Annual Assessment of the Bruce A Nuclear Generating Station for the Year 1994

Atomic Energy Control Board
Ottawa, Canada

June 1995

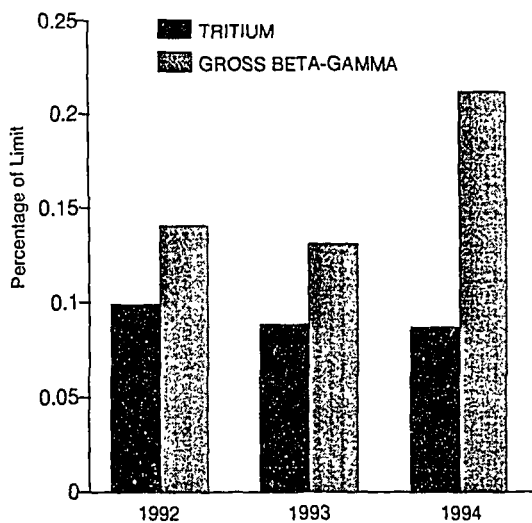
Figure 4: LIQUID RELEASES
Limit Varies with Radionuclide

The releases of radionuclides from Bruce A to the environment were below the operational annual target, which is 1% of the regulatory limit. Also, the weekly targets were not exceeded any time during the year. Figures 3 and 4 show the airborne and liquid releases from Bruce A during the last three years.
