IAEA Specialists' meeting on "Policies and Strategies for Nuclear Power Plant Life Management" in Vienna, Austria, from 28 to 30 September 1998

PLANT LIFE MANAGEMENT AT LOVIISA

Yrjö Hytönen, Alpo Savikoski***

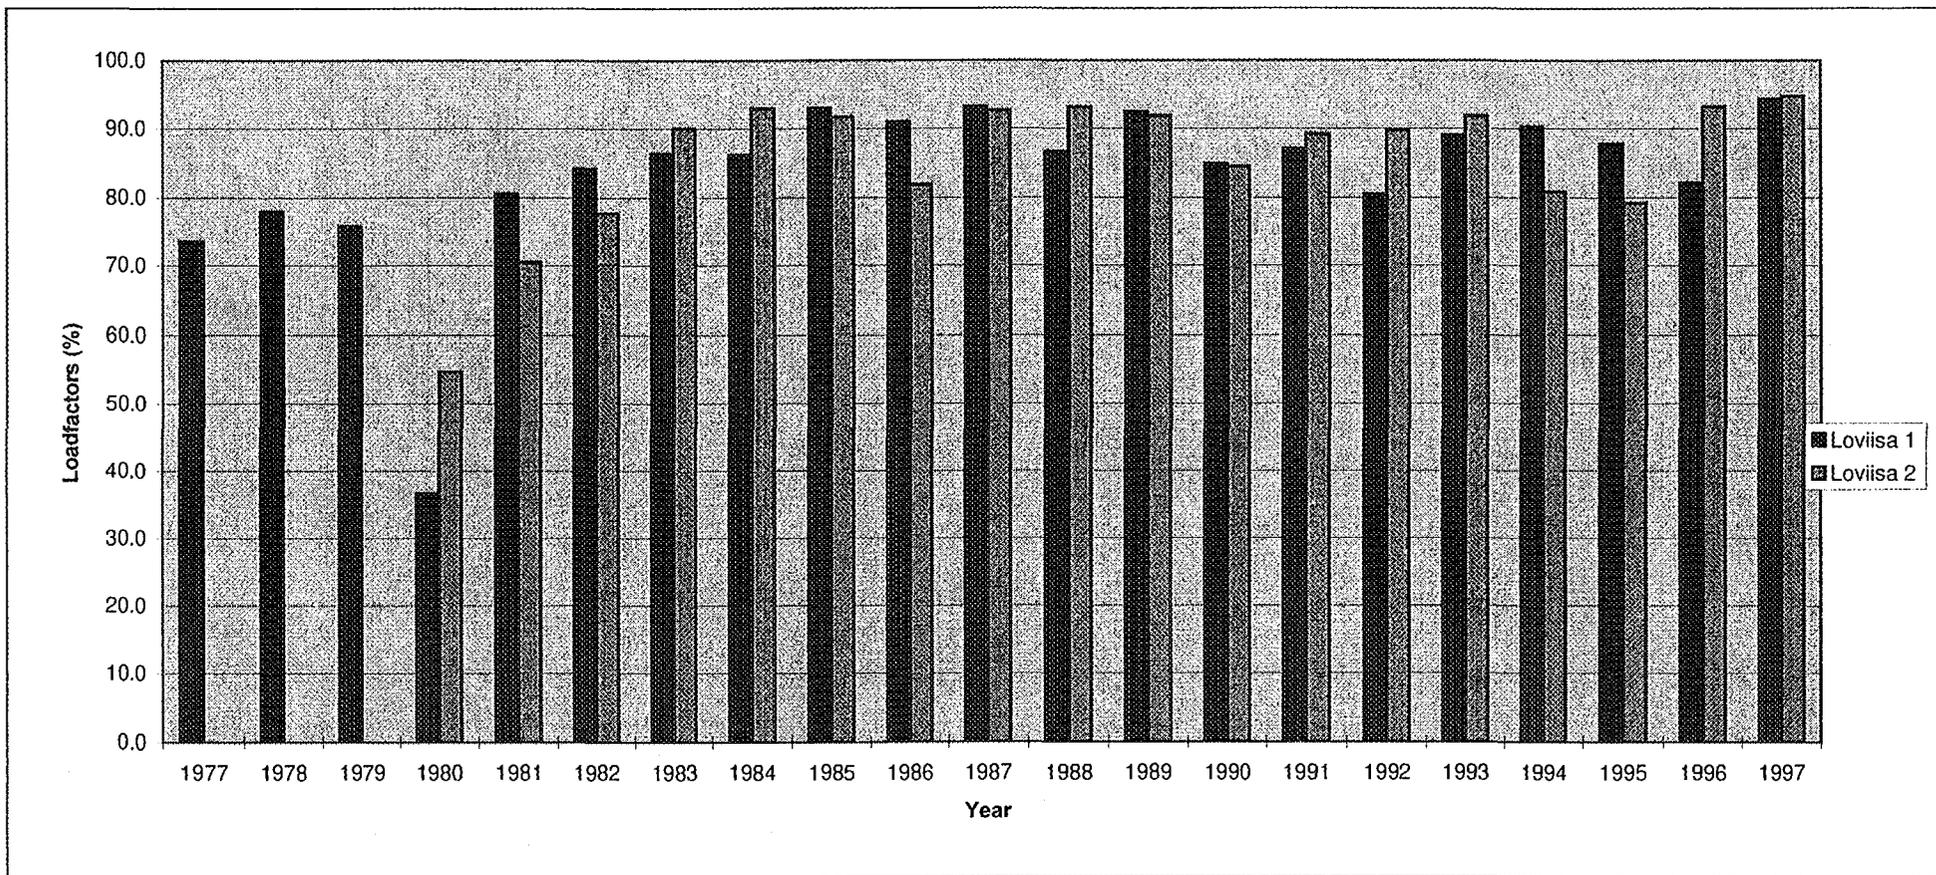
ATTACHMENT: LO1 & LO2 LOADFACTORS

1977	1978	1979	1980	1981	1982	1983	1984	1985	1986	1987	1988	1989	1990	1991	1992	1993	1994	1995	1996	1997
Loviisa 1	73.5	78.0	75.8	36.7	80.6	84.2	86.4	86.2	93.0	91.0	93.2	86.7	92.4	84.9	87.1	80.5	89.0	90.3	87.8	82.2	94.3
Loviisa 2				54.7	70.5	77.7	90.0	92.9	91.7	81.9	92.6	93.1	91.8	84.5	89.2	89.8	91.8	80.9	79.2	93.2	94.7
