International Conference
Nuclear Energy for New Europe 2004

An Overview of Non Destructive Inspection Services in Nuclear Power Plants

Simon Farley

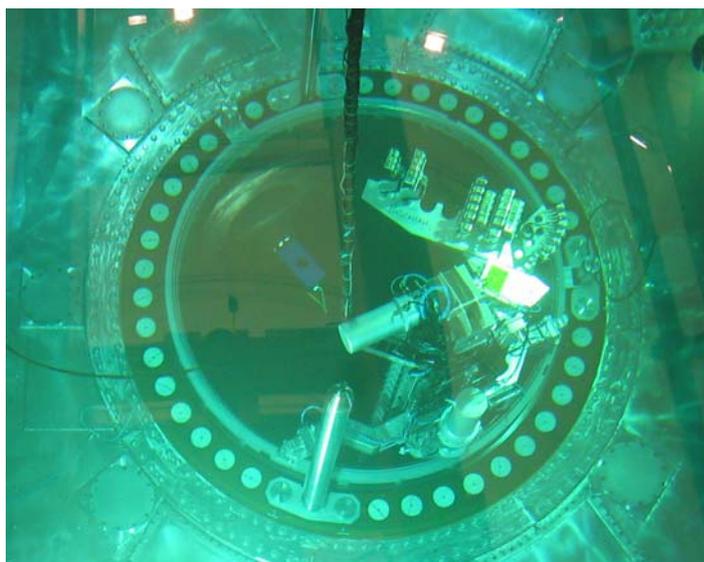
Figure 1: MIDAS IV Submarine and Inspection Manipulator in the Reactor Vessel

Companies like Westinghouse have long since taken on this challenge to continually find new methods of inspection and repair. Solutions are provided to offer maximum benefit to the customer. For example, through the development of stand alone submarine systems that are able to perform the visual inspection of core internals or the ultrasonic inspection of baffle to former and barrel to former bolts without necessitating the use of the fuel handling bridge or the polar crane. Liberating vital components such as the bridge and crane provide NPP with more flexibility during outage planning, thus saving time and cost. Figure 1 shows the MIDAS IV Submersible Remotely Operated Vehicle (SROV) and a reactor vessel inspection manipulator, both designed to save critical outage time.

The Westinghouse fleet of SROVs has been developed to remotely visually inspect a great range of components such as the core internals, primary coolant loops and pumps, steam generator bowls and many more.

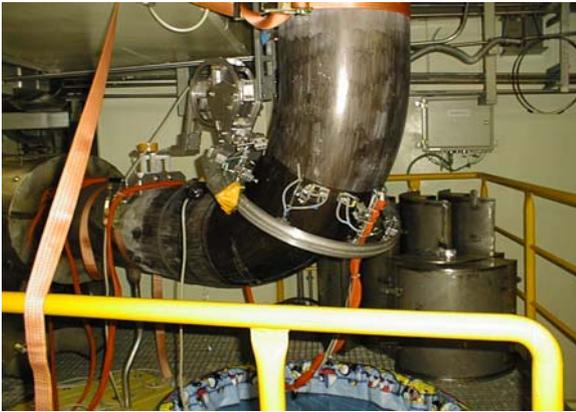
Figure 2: Ultrasonic inspection of surge line elbow

sonic testing) of piping systems, pressure vessels and other safety related components. Using a wide range of specialized manipulators Westinghouse regularly performs the mechanised ultrasonic inspection of the outer welds of steam generators, pressurizers, coolant pumps and piping systems. The manipulators are of versatile, modular form, enabling them to adapt to the geometry of the component being inspected and to remotely trace the area of inspection with specifically designed UT-probes. Figure 2 shows a manipulator remotely tracing the contour of a bend in the surge line. The latest development in reactor vessel inspection, the SUPREEM manipulator, is depicted in Figure 3.

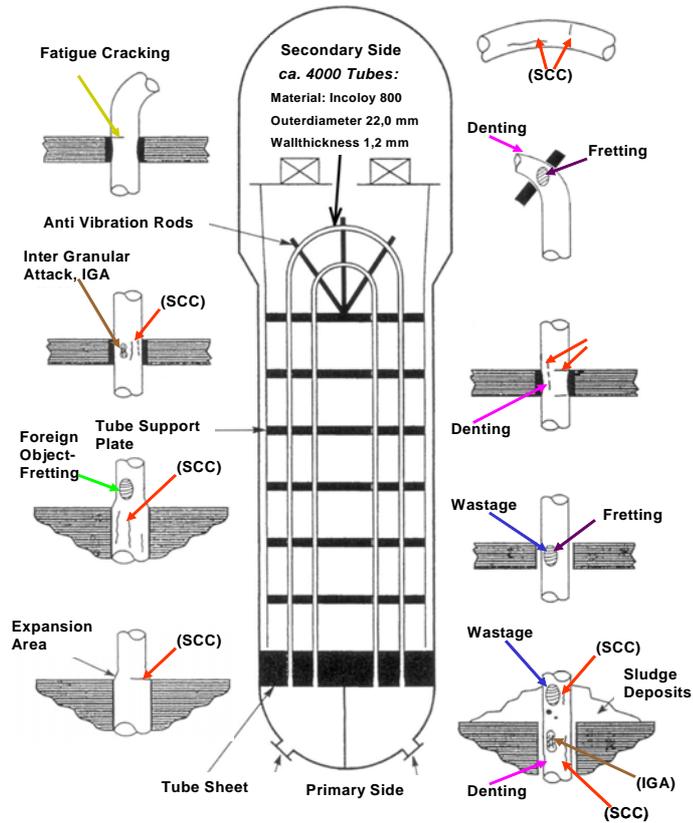
Overview of Typical Steam Generator Tube Damage

Figure 4: Typical damage to steam generator tubes

Tube integrity is integral to the safe operation of steam generators. Because of past problems with steam generator tubes affecting the operation of steam generators, the nuclear industry continues activities related to improving tube integrity [3]. The primary side of the tubes (from the inner surface) are periodically inspected using a range of ET probes and less frequently UT probes to detect cracks, loss of material (wastage & fretting) and changes in cross section (denting). Less frequently, a visual inspection of the inter tube area on the secondary side of the steam generator is performed, requiring miniature camera systems and endoscopes down to a size of 3 mm. Figure 4 shows some of the typical problems with steam generator tubes.

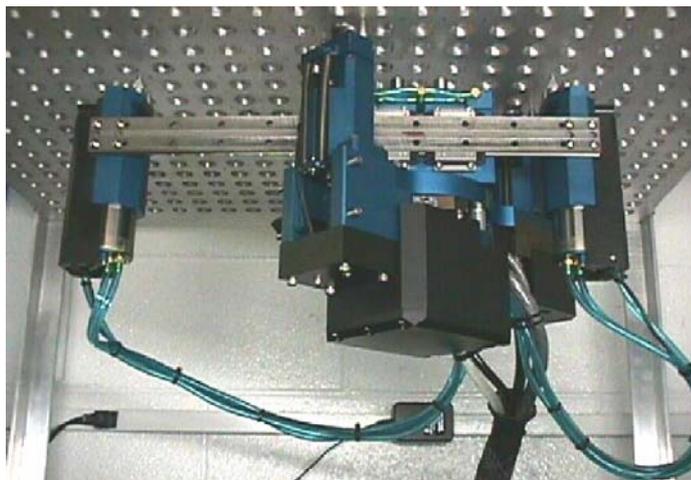
Figure 5.: PEGASYS Steam generator inspection manipulator

Several generations of remotely operated manipulators have been developed culminating in the ROSA inspection and repair arm and the recent light weight and quick to install PEGASYS manipulator, shown in Figure 5.

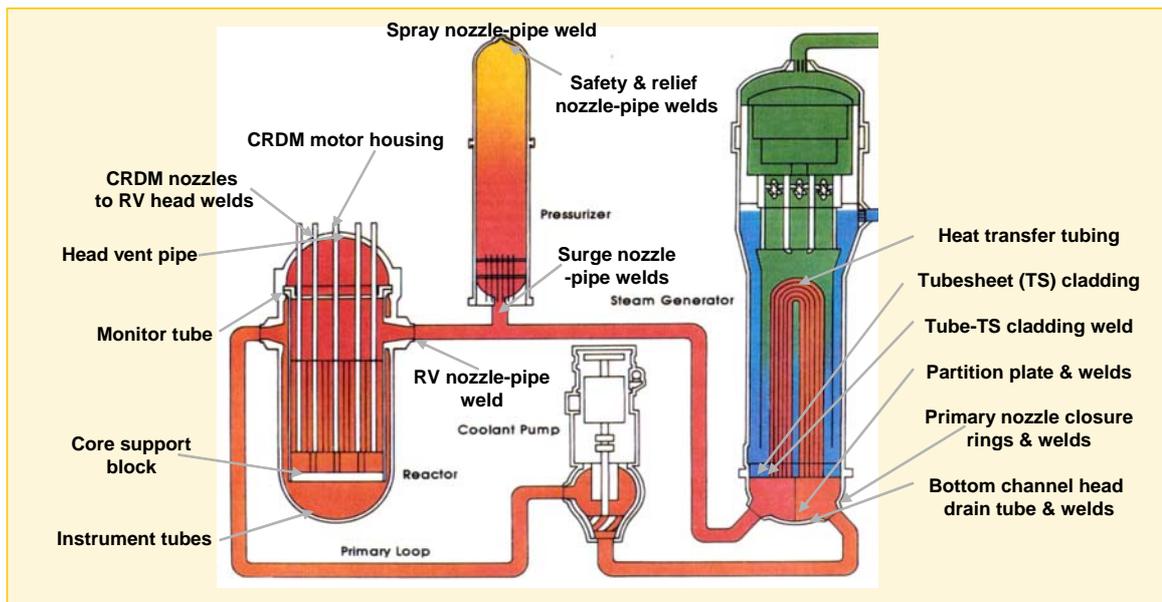
Figure 6: Alloy 600 Locations in Westinghouse Plants

Alloy 600 is used to fabricate various parts in nuclear power plants, including reactor vessel head penetrations for control rod drive mechanism (CRDMs), in-core instruments (ICIs) and thermocouples, reactor vessel bottom mounted instrument (BMI) penetrations, pressurizer heater sleeves, and various other instrumentation ports. An overview is given in Figure 6. Related weld materials Alloy 82 and Alloy 182 are used to join these Alloy 600 parts to the ferritic steel components and also as a bi-metallic weld joining ferritic base materials to austenitic stainless steel base materials. Alloy 600 and its associated weld filler metals were originally used because of expectations of resistance to service-induced cracking. However, parts fabricated from these materials have demonstrated a susceptibility to primary water stress corrosion cracking (PWSCC) [5].

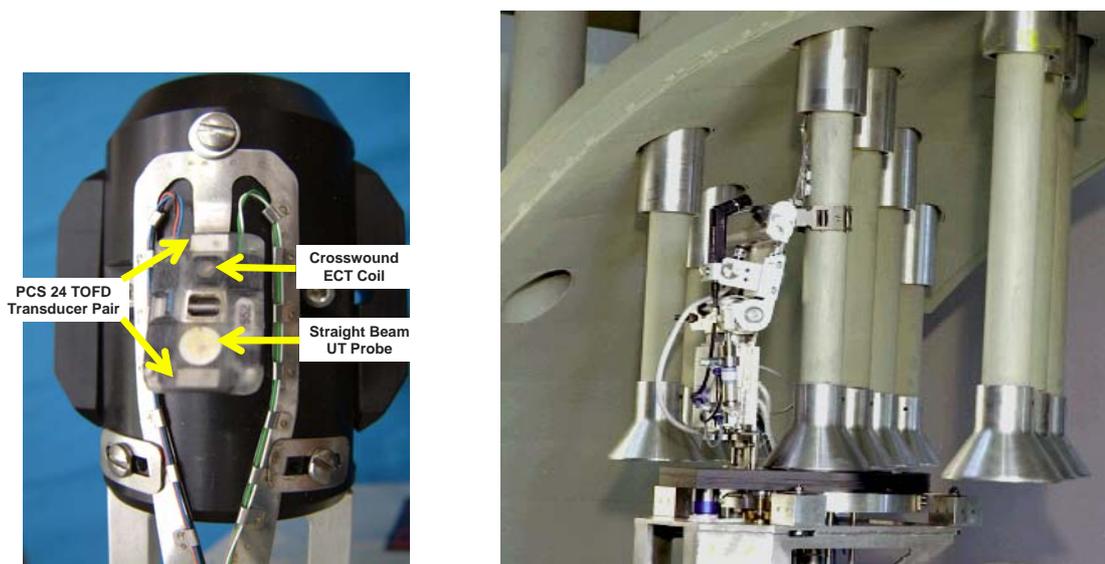
Figure 7 & 8: Combo probe & Gap scanner for Inspections of Penetrations with Thermal Sleeves

The radial gap between the VHP nozzle and the thermal sleeve is usually only about 3 mm. To avoid having to remove the thermal sleeves to access the potentially cracked area, Westinghouse developed a range of slim sword like probes (gap probes) to inspect from the inner surface of VHP nozzles. These include a differential ET probe with two pancake coils used for crack detection and a TOFD (Time of Flight Diffraction) UT probe for subsequent crack depth sizing. The recently developed Combo probe includes ET surface examination, TOFD UT volumetric examination and straight beam UT for leak path detection all in one probe (Figure 7). If deposits cover the surface, the surface can be cleaned before starting the inspection using specially developed sword type cleaning probes. In case the roughness or geometry of the surface (for example, if the penetration has been repaired) does not allow an ET inspection, Westinghouse has developed and qualified a gap probe to visually inspect the inner surface of penetrations equipped with thermal sleeve.

The Gap Scanner inspection tool, shown in Figure 8, is specifically designed to guide the range of gap probes into the annulus between the inner surface of the VHP nozzle and the thermal sleeve and to manipulate the probes so as to scan the surface area to be inspected.

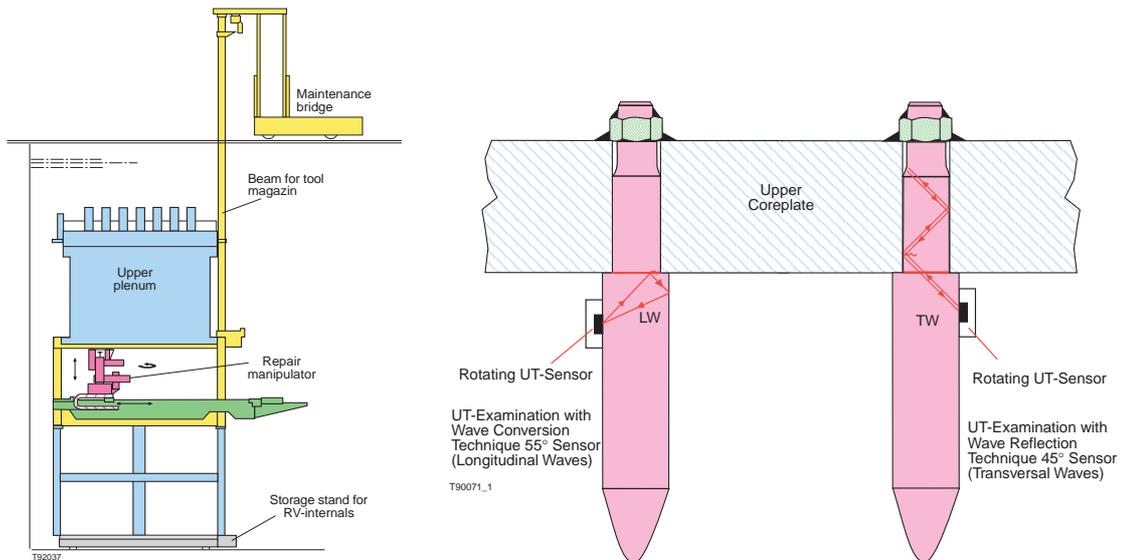
Figure 10: Schematic view of FAP inspection

An ultrasonic inspection method using an angle beam technique was developed. Probes with a detection sensitivity of less than 1 mm in depth were rotated 360° around the surface of the pin providing a complete volumetric examination from the collar to the threaded area of the pin. Figure 10 shows a schematic view of a FAP inspection.

Many FAP's of this type were subsequently replaced with a new improved Westinghouse design, which includes a central bore hole for improved ventilation. Although no further failures have been encountered the FAPs of some plants are still regularly inspected by passing a new UT probe variant through the centre of the FAP via the bore hole.

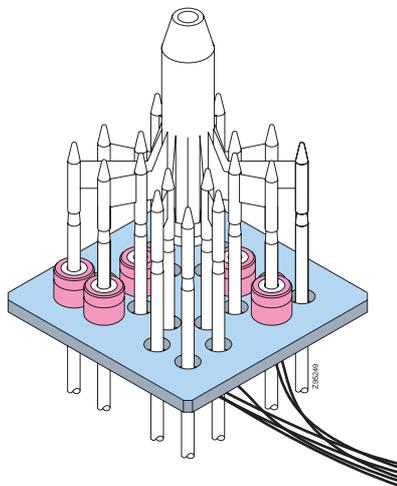
Figure: 11: RCCA passing through ET probes

The facility used to inspect the control rods basically consists of a support plate carrying up to 6 eddy current inspection probes, through which the RCCA is passed (Fig. 11). The inspection plate is installed in the fuel elevator or on top of a free location in the fuel storage rack. Each probe is equipped with two encircling coils, which are operated in both absolute and differential mode: Absolute mode (together with an external reference probe) to determine loss of cross section due to wear marks and their axial extension; differential mode to detect defects such as cracking due to absorber swelling. In addition to the encircling coils, each probe carries up to 16 pancake coils, radially arranged to determine the circumferential profile of the control rod.
