PERFORMANCE OF CANDU-6 FUEL BUNDLES MANUFACTURED IN ROMANIA NUCLEAR FUEL PLANT

A. BĂILESCU, A. BARBU, F. DIN, GH. DINUȚĂ, I. DUMITRU, A. MUSETOIU, G. SERBAN, A. TOMESCU

Nuclear Fuel Plant Pitesti, Romania, abailescu@fcn.ro

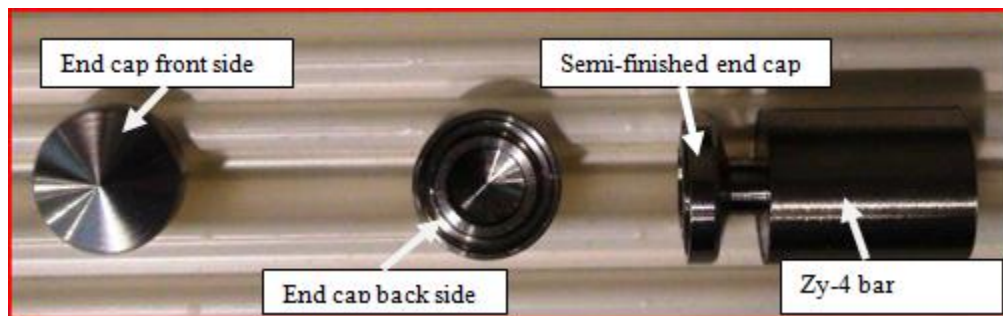
The end caps are then machined on a C.N.C. turning lathe. A visual and dimensional inspection is then carried out after which the end caps are ultrasonic degreased, rinsed and dried. The end caps are now ready for use at the closure welding (**Figure 2**).

Figure 2 End cap manufacturing

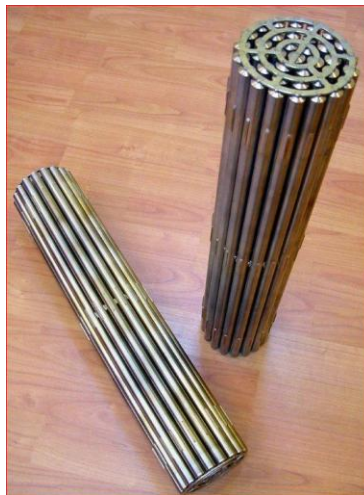
Each fuel bundle must be assembled so it meets the specification with respect to squareness of the end supports, diameter, minimum spacing of elements, radial distance from the outer surface of the outer element to the end support, location of spacers and overall size (**Figure 7**). This last check is performed on a "GO-NO-GO" gauge which represents the smallest opening that a bundle has to pass through in entering and leaving a fuel channel in the reactor.

Figure 7 Fuel bundle general view

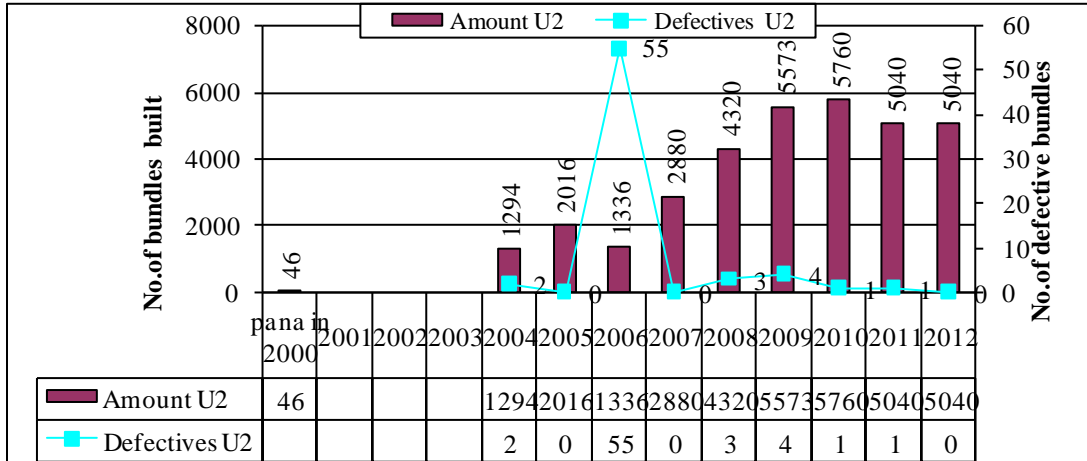
In accordance with agreed procedures and practices, during January to December 2012, were sent notifications to Cernavoda "identifying suspect bundles U2 Cernavoda NPP Unit". Last fuel bundles defect in Unit 2 was download in on the 14.08 .2012 (**Figure 9**). The 66 fuel bundles downloaded from U2 are manufactured by FCN Pitesti delivered from 2004-2011 and from 2006-2011

Figure 9 CANDU-6 Performance for Cernavoda U2
