## FATIGUE CRACK INITIATION AT COMPLEX FLAWS IN HYDRIDED Zr-2.5%Nb SAMPLES FROM CANDU PRESSURE TUBES

LIVIA-NICOLETA STOICA, VASILE RADU

RATEN ICN, Pitesti, Romania  
nicoleta.safta@nuclear.ro

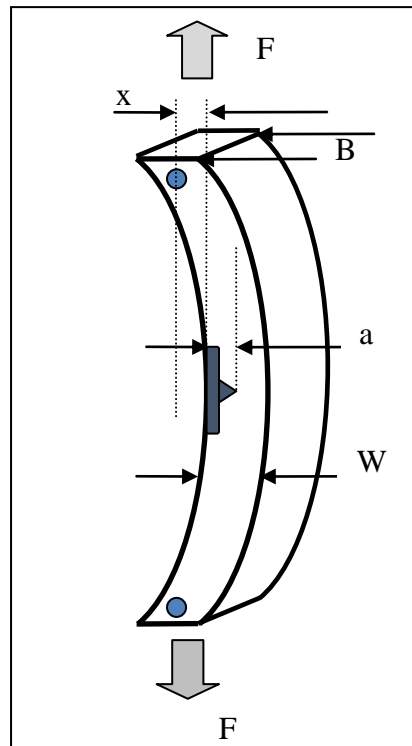
**Fig.1.** The C-type specimen having complex-type defects (BPFF combined with DFF)

In the experimental program of fatigue testing the samples cut from Zr-2.5%Nb rings were used at different hydrogen concentrations. Each sample has been prepared as “C shape” type specimen with complex defects (BPFF combined with DFF) (Figure 1). The following steps were applied:

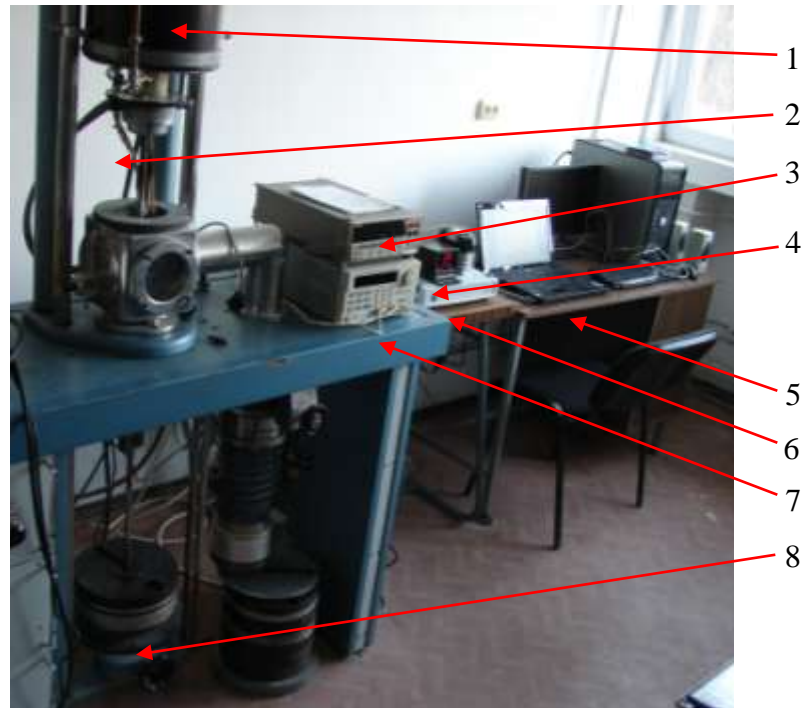
**Fig. 2.** Experimental for achievement the re-orientation of the hydrides at complex flaw tip (BPFF combined with DFF)

The experimental setup described in previous papers [2,3] is shown in Figure 2 and contains the following components of the experimental chain:

1. the oven;
2. sample clamping device;
3. digital multimeter;
4. temperature regulator;
5. PC data acquisition;
6. signal amplifier (Spider);
7. AC power;
8. Load sample platters.

segment, Zr-2.5% Nb alloy. To obtain the reorientation phenomenon hydrides the specific tests have been carried out by thermal cycling [2,3]. Thus, the creep ADAMEL machine was used with an experimental setup to allow thermal cycling treatment of the samples under controlled load type defects hydride complex, which is shown in Figure 2.

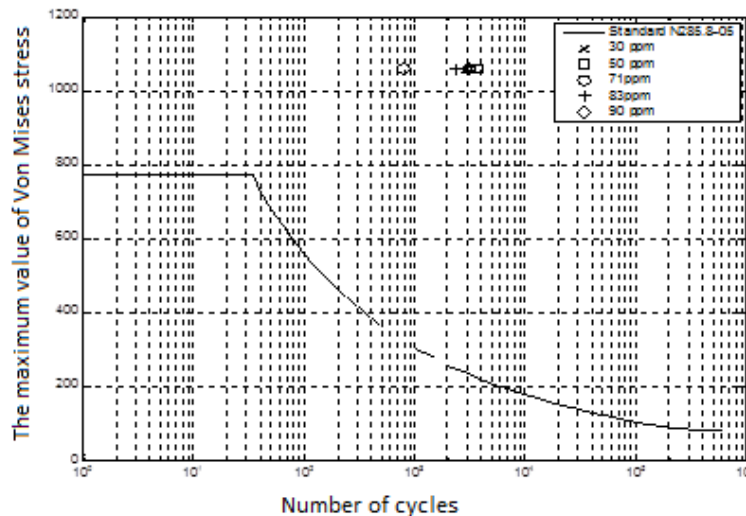
**Fig.8.** The experimental results of the fatigue on Zr-2.5%Nb specimens with complex flaws and fatigue curve from N285.8

The experimental results concerning of the life time are shown by the number of N cycles up to crack initiation versus the Von Mises amplitude stress. Moreover, it appears that the lifetime points displayed in the Figure 8 are in the safe region relatively away from the curve that separates the safe from

The results of the fatigue tests (complex flaws) from present work are processed and are shown in Figure 8. There are symbolized distinct hydrogen concentrations of specimens. Important to note that the results obtained in this paper are reported to the fatigue curve as they are described by the Canadian standard CSA N285.8-05.

4. The experimental results concerning of the life time are shown by the number of N cycles up to crack initiation versus the Von Mises amplitude stress (Basquin curve). It appears that the lifetime points for complex flaws (BPFF with DFF) are in the safe region relatively away from the curve, which separates the safe from un-safe region.
