AUSTRALIAN ATOMIC ENERGY COMMISSION  
RESEARCH ESTABLISHMENT  
LUCAS HEIGHTS

THE OPTICAL METALLOGRAPHY OF SOME MARAGING STEELS

E. MELLER  
J.T.A. POLLOCK

May 1981

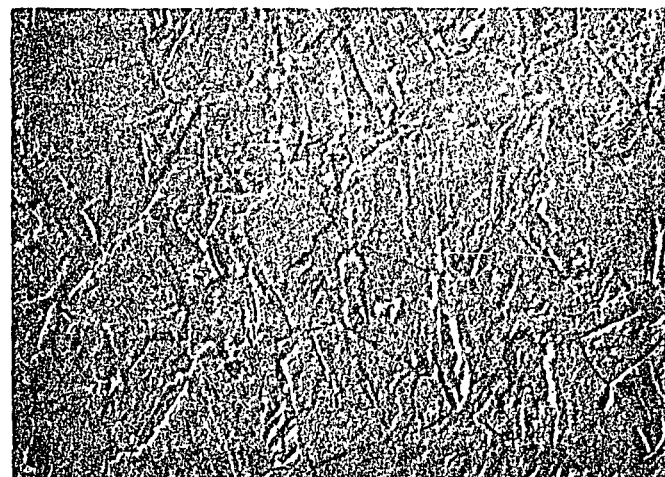
×500

FIGURE 3c. SANDVIK MAR 350 COLD-ROLLED MATERIAL FOLLOWED  
BY SOLUTION TREATMENT AT 900°C FOR 60 MINUTES

Hot-rolled, cold-rolled and solution-treated examples of MAR 350 are shown in Figures 3a, b and c. These microstructures were prepared with the Visapol unit by electropolishing using five per cent perchloric acid in glacial acetic acid, followed by electro-etching in one per cent hydrochloric acid in methylated spirits. The prior austenite grain size is revealed in all samples including the as-received bar; in the latter case, the very large austenite grain size suggests that it was hot worked above 900°C.
