REPORT ON THE ENGINEERING TEST
OF THE LBL 30 SECOND NEUTRAL BEAM SOURCE
FOR THE MFTF-B PROJECT

M.C. Vella, P.A. Pincosy, C.A. Hauck,
and R.V. Pyle

August 1984

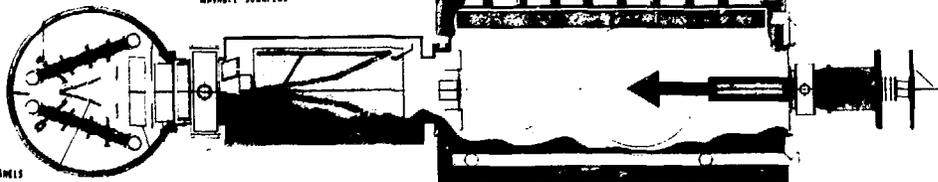
Figure 1. A sketch of the Neutral Beam Engineering Test Facility (NBETF) is shown, with the major beamline sections identified.

A schematic of the NBETF beamline is shown in Figure 1. NBETF was chosen as a test site because of its extensive beam diagnostics, optical and calorimetric, and because it is the only test site with the radiation shielding required for long pulse deuterium operation. As tested, the LBL APIS consisted of a magnetic bucket plasma source, called the Long Pulse Source (LPS), mated to a water cooled, 10 x 39 cm accelerator, called the Long Pulse Accelerator (LPA). A picture of the source as mounted on NBETF is shown in Figure 2. In comparison with other long pulse sources, the most outstanding feature of the LBL accelerator is its perveance per unit area of extractor. With 60% grid transparency, it gives 50% to 90% more current per unit area than other designs, with excellent beam optics.

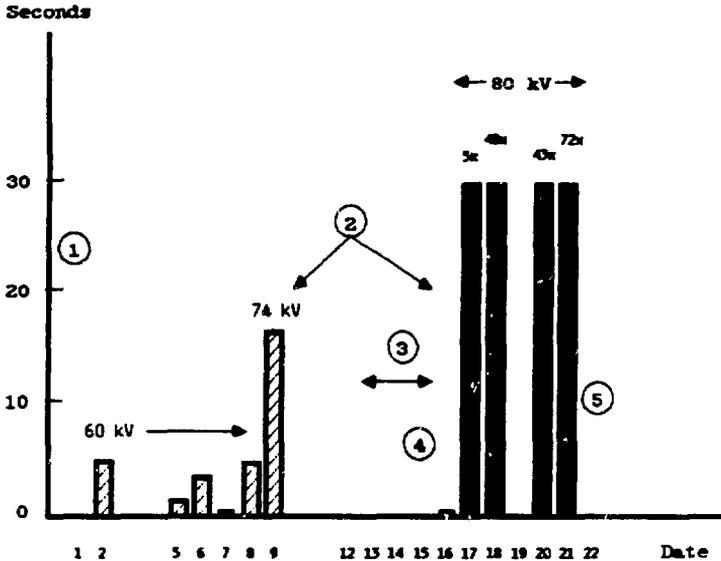
December Summary

| 1. Scraper bellows water leak. | 4. Short pulse hydrogen. |
| 2. Target bellows water leak. | 5. Christmas shutdown; up to air. |
| 3. High capacity pump repair. | |

Figure 4. December beam operation is illustrated. Days with 30 second operation are shown as dark columns; the number of shots counted for the Test is shown above.

A calendar overview of the Engineering Test is shown in Figures 4 and 5, which illustrate 30 second beam operations in December and January. A complete accelerator conditioning history is ruled out, since the LPA had been previously operated at 80 kV, in 1982 short pulse testing,⁴ and in the summer of 1983 during 30 second testing for MFTF-B.

In Figures 4 and 5, water leaks are indicated only for occasions which required significant time to repair. An underlying problem for evaluating source reliability is that nearly all 30 second shots were conducted with observable (on a gas analyzer) water leaks in the target tank. Target leaks had two effects: (i) source reliability deteriorated; and (ii) target calorimetry data were limited by noise on the thermocouple signals. For this reason, the source reliability demonstrated here probably represents a lower bound on source availability. Analysis of target calorimetry data is restricted to shots with clean data.

On December 20, an uncooled copper exit scraper and electrical switch were vaporized by the beam. This event is not noted on Figure 4, because

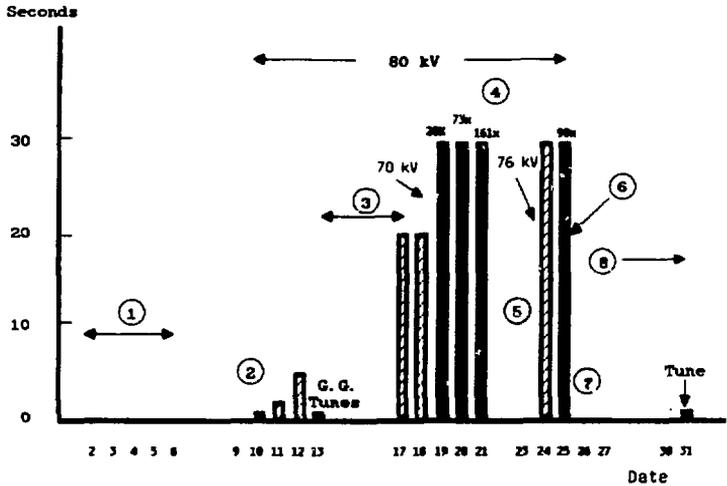
January Summary

| <ol style="list-style-type: none"> 1. Repair cryo system. Replace one molybdenum shield in plasma source. 2. Arc conditioning after Christmas shutdown. 3. Target bellows water leak. 4. Target accident. | <ol style="list-style-type: none"> 5. Recondition plasma generator and accelerator. 6. Engineering test completion. 7. Contaminated deuterium test. 8. Hydrogen test. |

Figure 5. January beam operation is illustrated.

The target accident indicated in Figure 5 on January 21 was relatively serious for the source. Near the end of a 30 second shot, the high capacity water pump for the target dropped out, but a fault in the control system allowed beam to continue. After 5 seconds with no water flow, two of the target panels ruptured at braze joints. The beamline vacuum system valves closed, but both the arc and accelerator had to be reconditioned from low power. Arc reconditioning was accompanied by serious filament spotting, which will be discussed in Section 3.

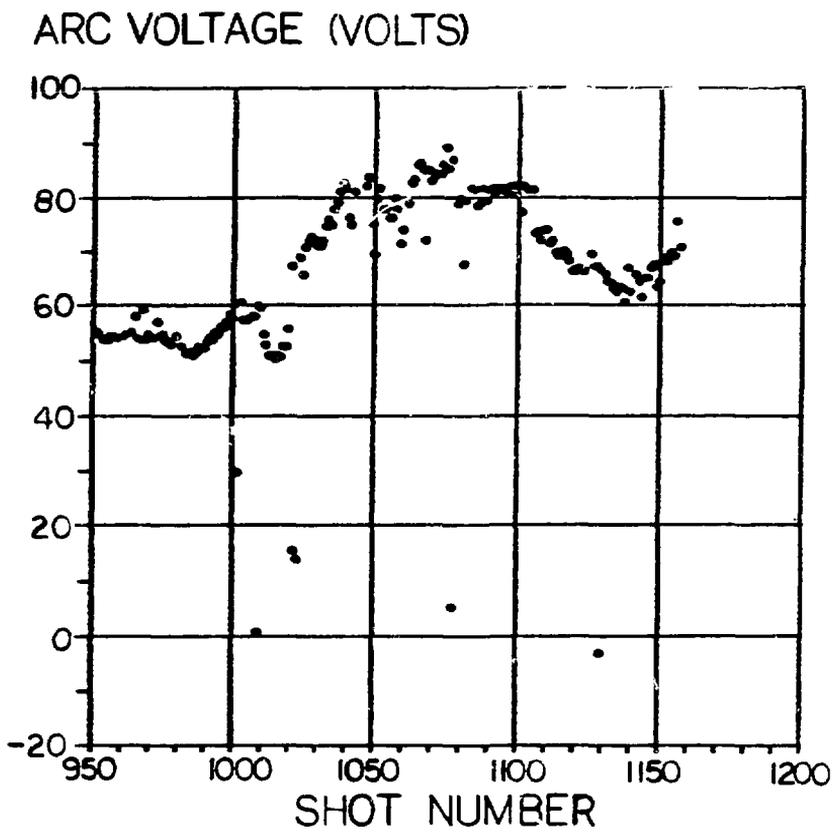
Figure 6. The conditioning history of the Long Pulse Source (LPS) is illustrated. Arc voltage is plotted vs shot number.

Initial arc conditioning was carried out in one shift on November 14. Arc voltage and arc power for each shot of the day are shown in Figures 6 and 7. To avoid source damage, conditioning is done with the arc spot detector set to just allow operation. The basic strategy is to run at the lowest possible voltage, in order to avoid spotting. Arc voltage and power are raised as arc spot detector faults decrease. In this case, initial operation was with the back plate magnets removed, which gives field-free anode area and allows operation as low as 40 - 50V. The first shots were also restricted to 10 msec pulses and 15 kW, while the arc spot detector was setup.¹ The pulse length was later stretched to 0.5 sec. When arc power reached 80 kW at 80 V, the pulse was stretched to 4 seconds. The backplate magnets were then installed, and the source conditioned from 15 kW, 60 V to 70 kW, 70 V with 0.5 sec shots. Finally, the pulse was stretched to 2 seconds.

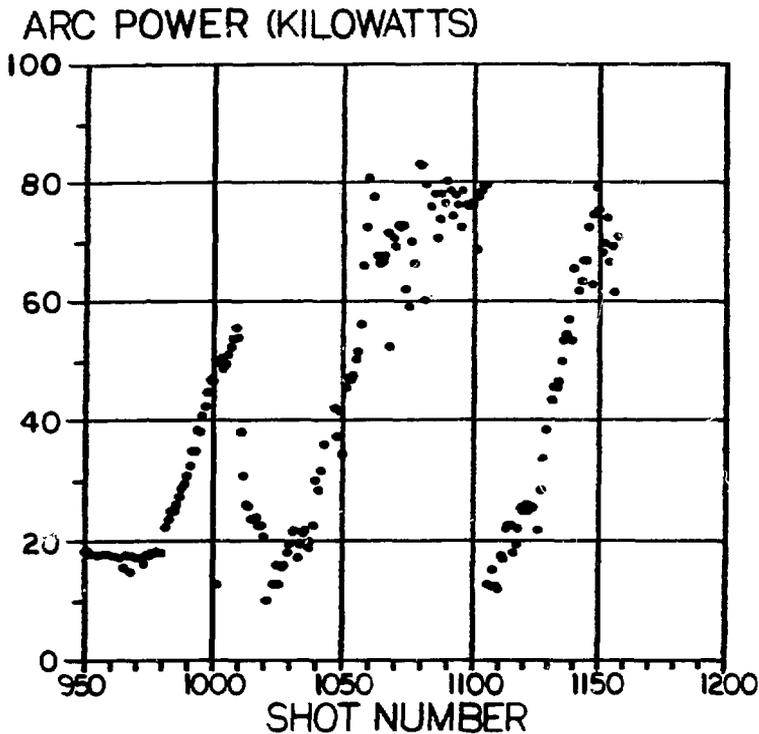
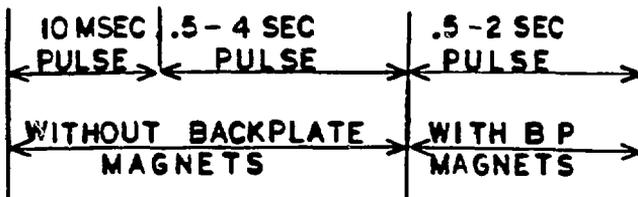
Figure 7. The conditioning history of the Long Pulse Source (LPS) is illustrated. Arc power is plotted vs shot number.

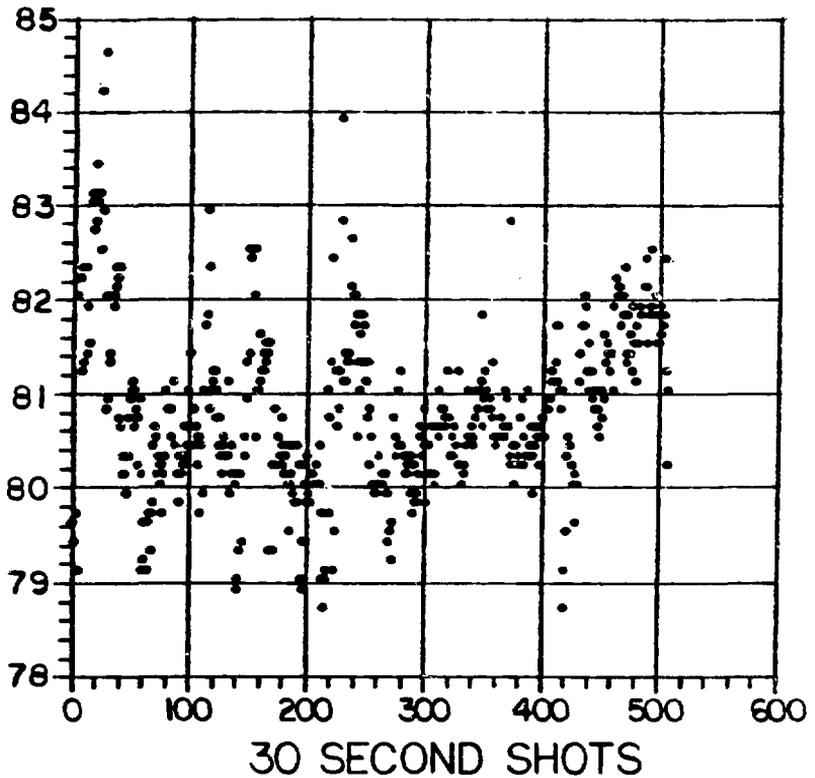
Figure 8. The 30 second shot history of the Long Pulse Accelerator (LPA) is illustrated. Accel voltage is sequentially plotted for each shot counted in the Test.

Prior operation of the LPA rules out a complete accelerator conditioning history, but the Test shot history shows evidence of conditioning, and reconditioning. Computer averaged voltage, current and perveance for each of the 508 shots counted in this Test are shown in Figures 8, 9 and 10. In Figure 8, accel voltage is plotted vs shot number. The NBETF power supply is

unregulated, and the shot average range is seen to be 78.8 - 84.6 kV. The variation of accel voltage over each shot was approximately $\pm 2\%$.

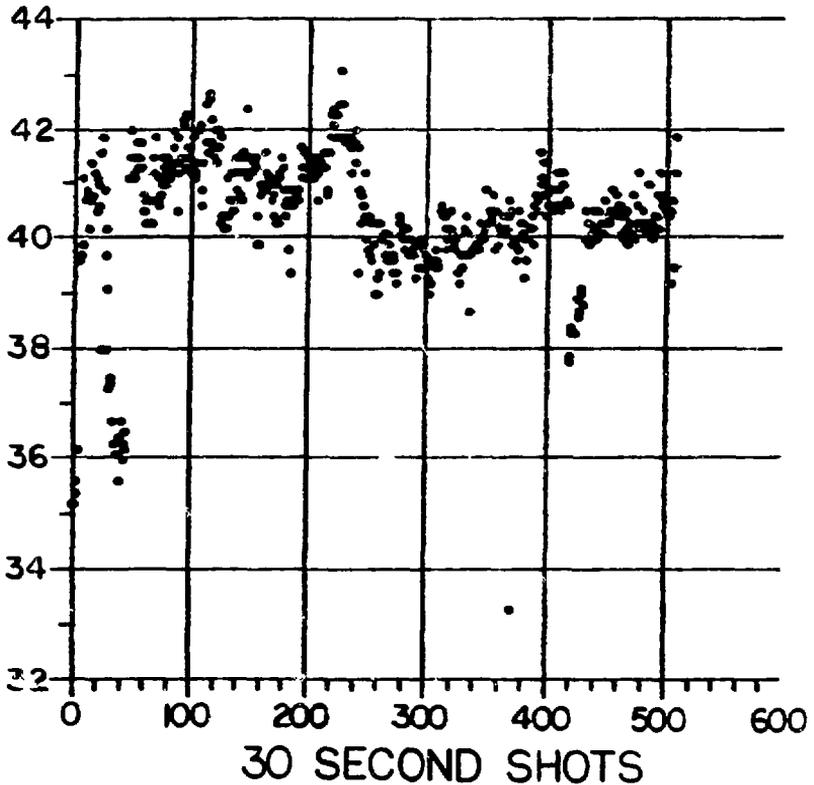
Figure 9. The 30 second shot history of the Long Pulse Accelerator (LPA) is illustrated. Accel current is sequentially plotted for each shot counted in the Test.

In Figure 9, accel current is shown for the same shot sequence; the range is approximately 35 - 43 A. Perveance is shown in Figure 10; the Test range was 1.4 - 1.9 μ pervs. On all 30 second shots, arc feedback regulation^{6,7} was used to maintain a constant accel current. The feedback system compared an input signal with a precision reference voltage, and phase controlled the arc power supply to maintain a constant input. During the Test, the input used was the saturated ion current read by a newly developed, 1/4" O.D. water cooled plasma probe, biased -22 V with respect to cathode. With arc regulation, the variation in accel current over a 30 second shot was determined by arc and filament power supply ripple, approximately $\pm 2\%$. Without regulation, beam operation up to 10 seconds required careful adjustment of the filament current; the stepper was used for filament adjustment. Due to changing arc efficiency, variation in the unregulated arc level gave a gave an accel current which had a maximum/minimum difference of 10%.

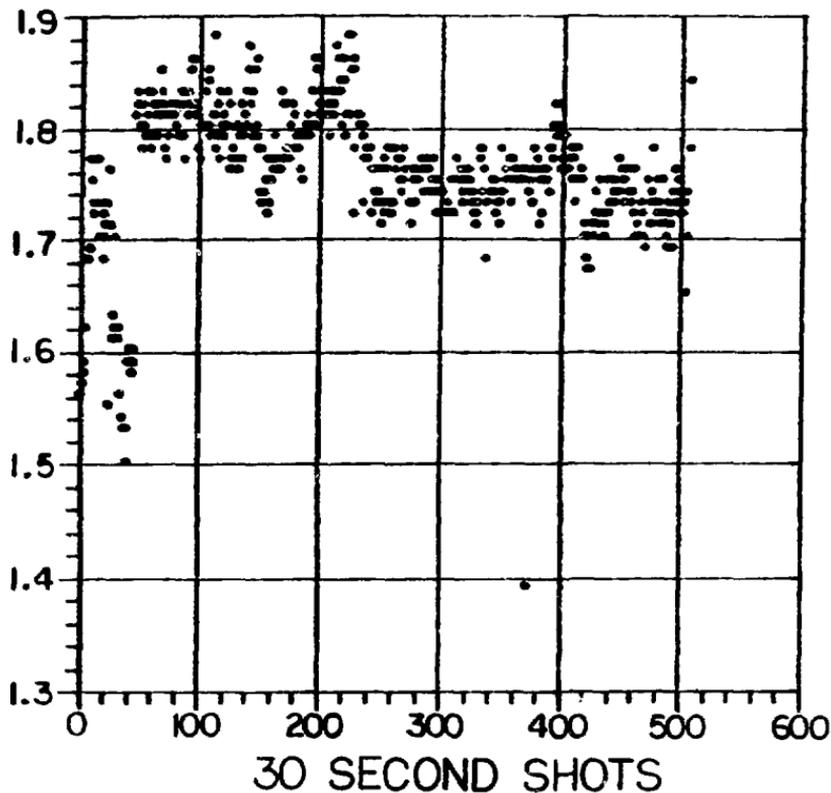
Figure 10. The 30 second shot history of the Long Pulse Accelerator (LPA) is illustrated. Accelerator perveance (upervs) is sequentially plotted for each shot counted in the Test.

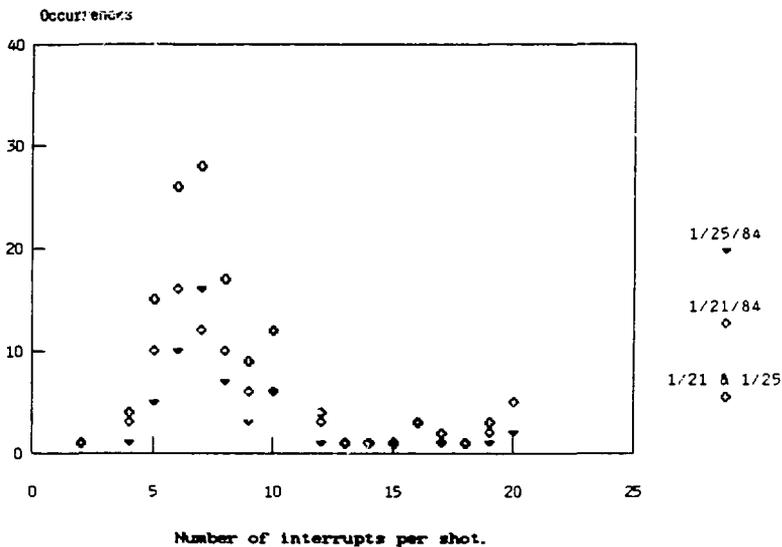
INTERRUPTS DURING 80 KV, 30 SECOND OPERATION

Figure 12. The number of times that a particular number of faults occurred on a 30 second shot is plotted for the best days of operation, January 21 and 25.

The average number of interrupts per shot for January 21 and 25 is plotted in Figure 12. During the Test, interrupts decreased with conditioning from 40 to 5 per shot. Although the conditioning history is obscured by beamline downtime, the downward trend in interrupts on days of prolonged operation shows reconditioning, and suggests further improvement.

Accel reliability for January 21 and 25 is illustrated in Figure 12, where the occurrence of a given number of interrupts is plotted. The peak of the distribution is at 6 or 7 interrupts per shot. The nonstatistical features on the tail suggest another variable in addition to accelerator conditioning. During testing, a tendency for bursts of interrupts associated with target leaks was apparent, and would account for these features. At the end of the Test, the accelerator appeared to still be conditioning.

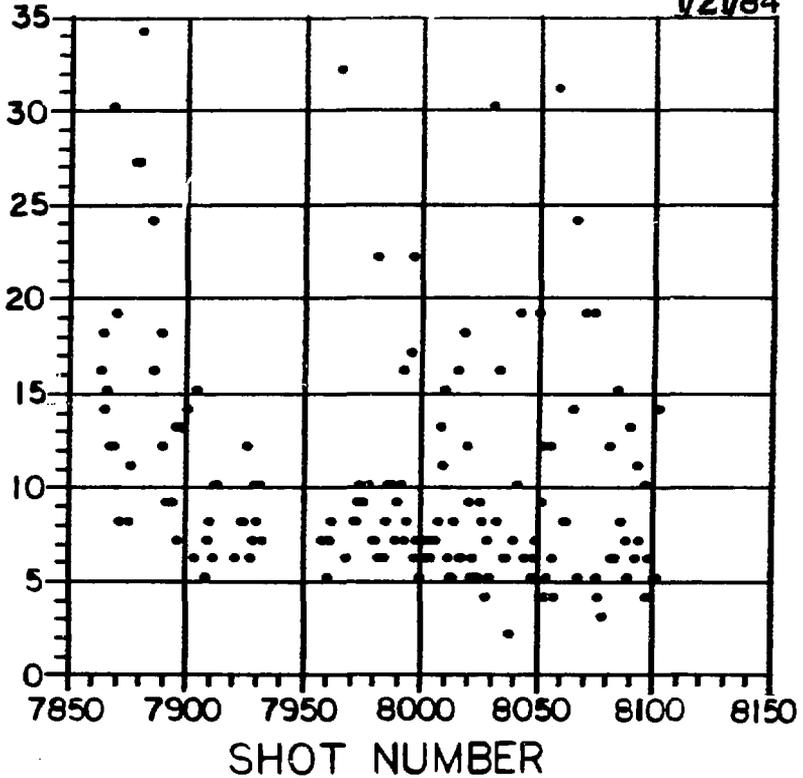
Figure 13. The interrupt history for January 21 is shown; the number of interrupts on each 30 second shot is plotted vs shot number.

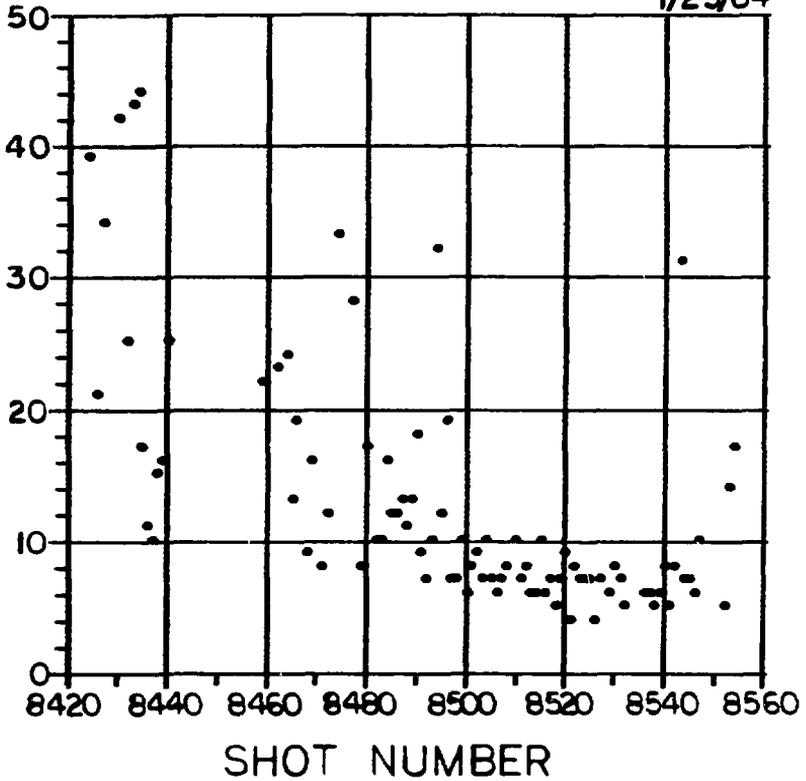
Figure 14. The interrupt history for January 25 is shown; the number of interrupts on each 30 second shot is plotted vs shot number.

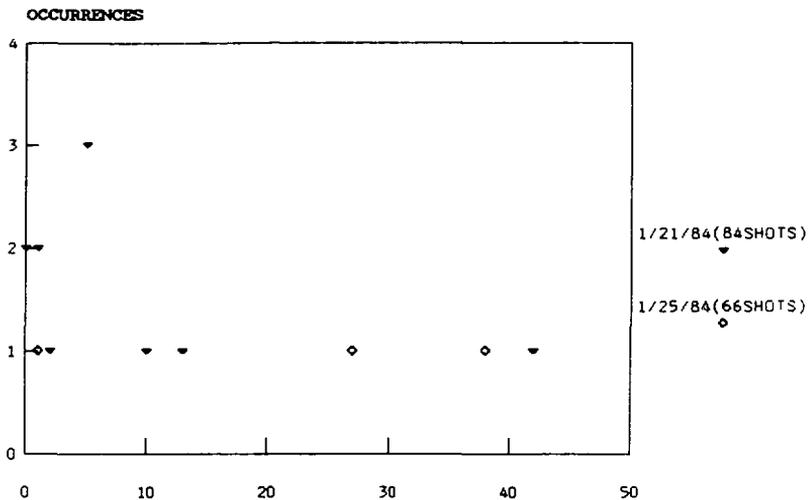
SOURCE RELIABILITY / ARC SPOTS / WITH WATER LEAK

Figure 15. The number of times that a particular number of arc spots occurred is shown for the two best days of operation, January 21 and 25.

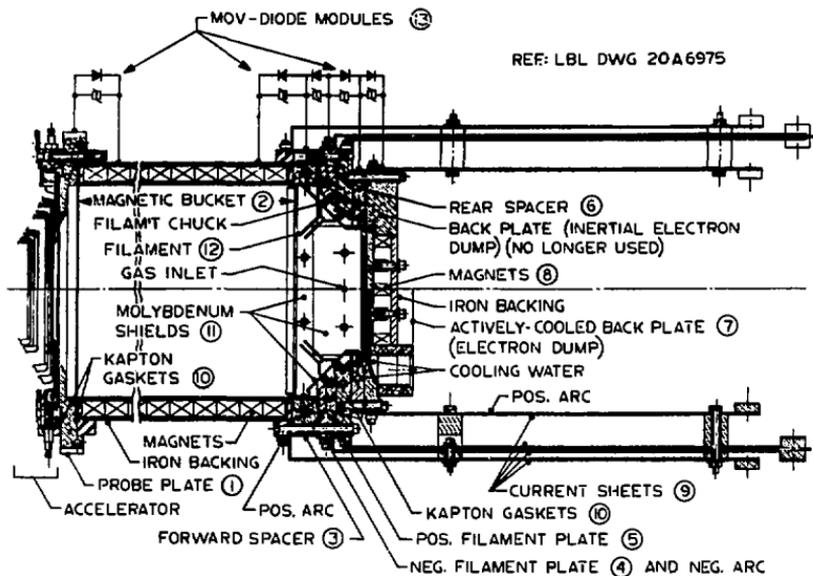
Figure 17. A schematic of the Long Pulse Plasma Source (LPS) is shown; the major components are identified.

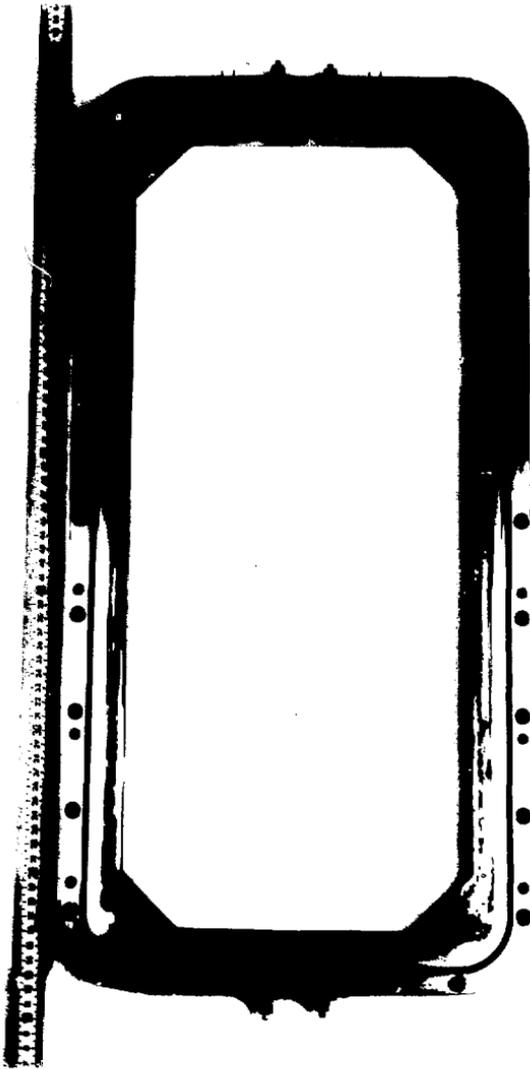
Figure 20. A picture of the forward spacer between the filament sandwich and the bucket is shown following the Test.

reduced arc efficiency, and caused spotting in the gap between the spacer plates and anode, which is shown in Figure 20 and 21. A design fix which functionally replaces the shields is suggested in Section 5.

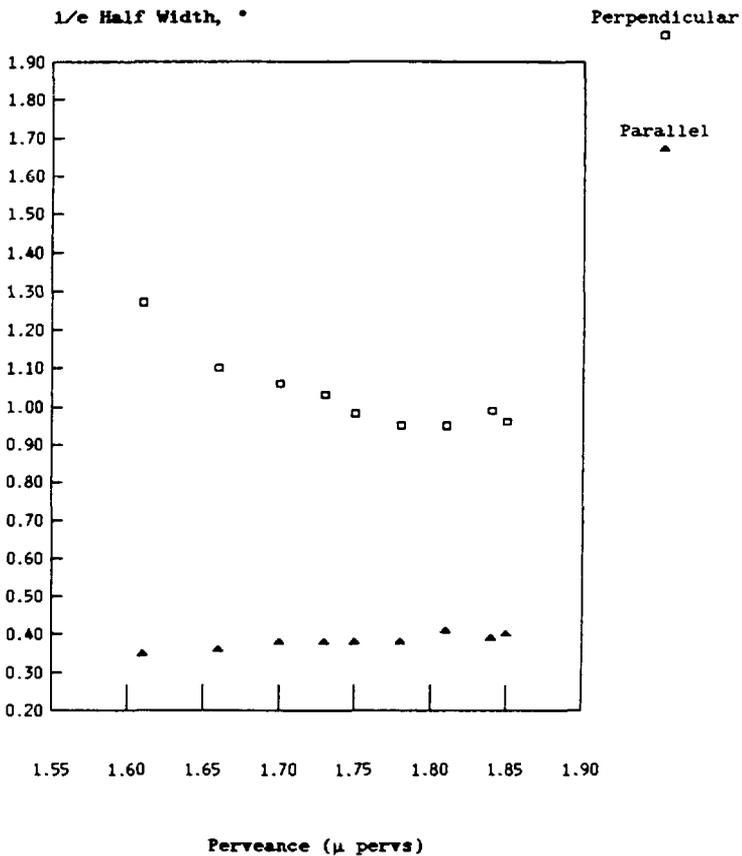
80 KV DEUTERIUM INERTIAL CALORIMETER TUNE

Figure 23. A tune on the inertial calorimeter is shown; divergence is plotted vs perveance for 75 msec shots with 83.5% gradient grid bias.

divergence. The lowest optimum divergence was found at 1.80 μ pervs with an 83.5% gradient grid, and had 1/e half angles of 0.38° (parallel to the slots) \times 0.95° (perpendicular). This measurement represents an upper bound on neutral beam divergence, since it includes both ions and neutrals. An 83.5% tune with the inertial calorimeter is shown in Figure 23; this gradient grid bias was used for most of the Test.

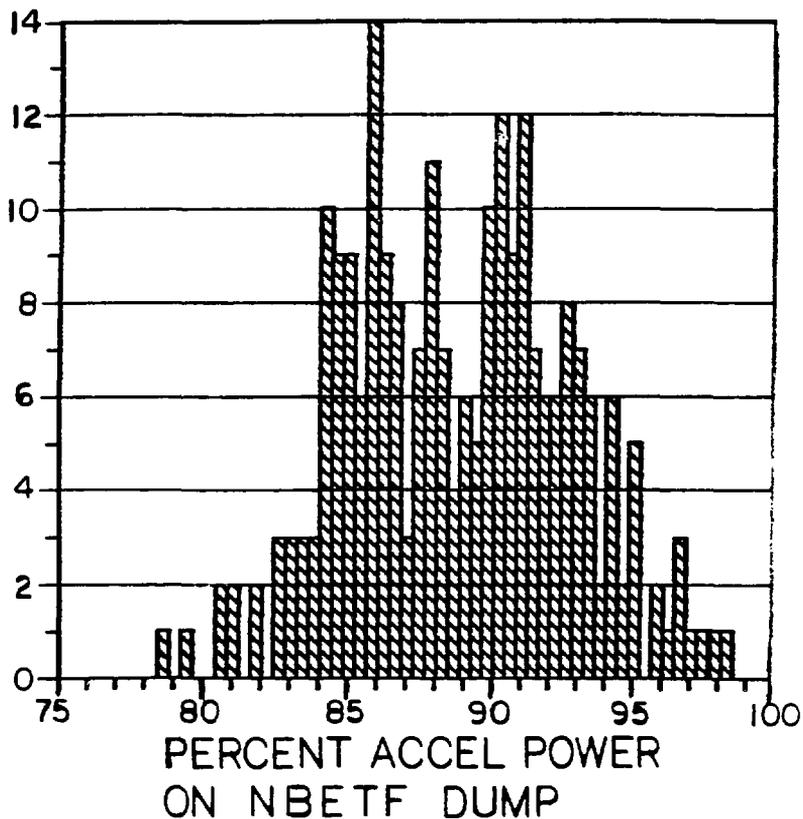
Figure 25. A histogram is shown of the power fraction measured on the active beam target. The number of 30 second shots is plotted vs the percentage of power on the target.

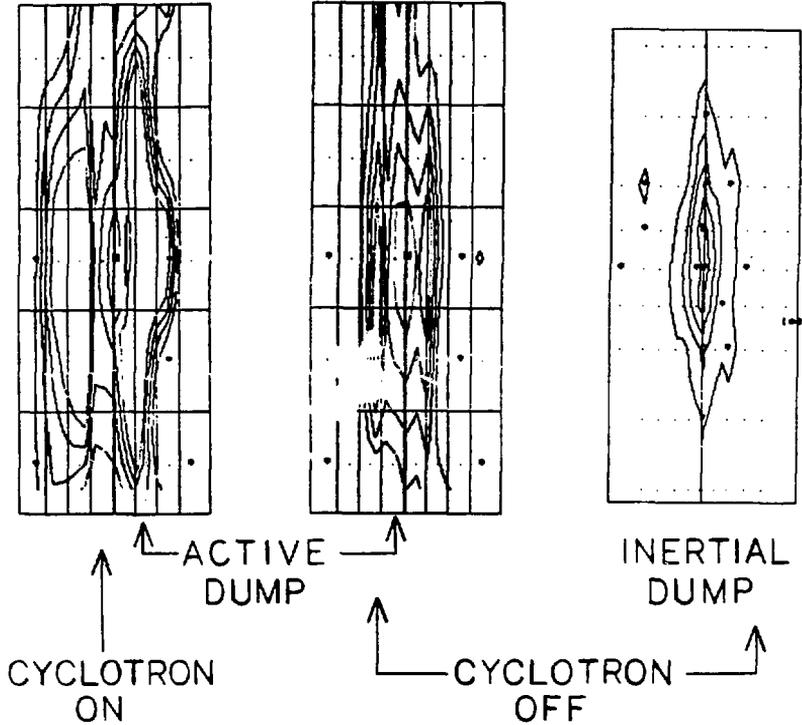
BEAMDUMP CALORIMETRY

Figure 26. Isotherms are shown from the inertial calorimeter and the active target. The active target is shown with the cyclotron ON and OFF.

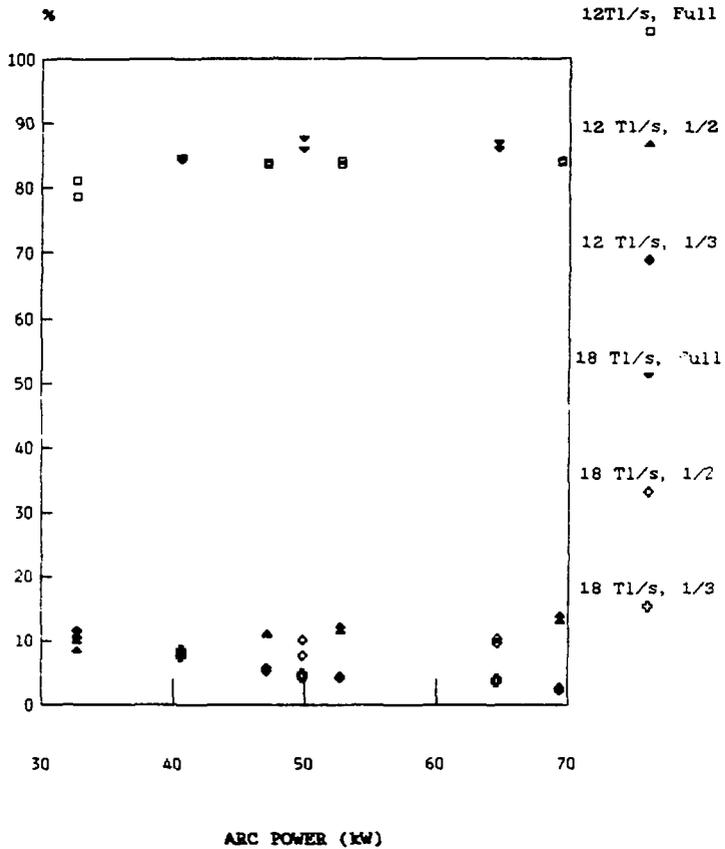
80 KV, 30 SECOND OMA SPECIES (DEUTERIUM)

Figure 27. OMA species is plotted vs arc power at 12 and 18 Tl/s gas flow.

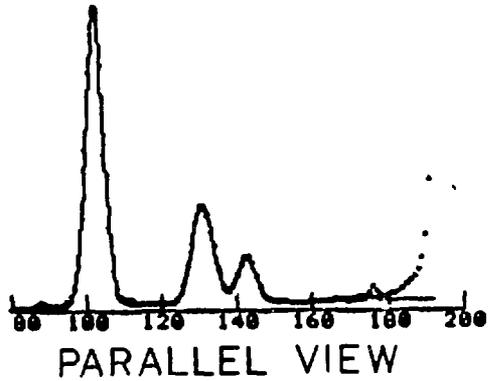
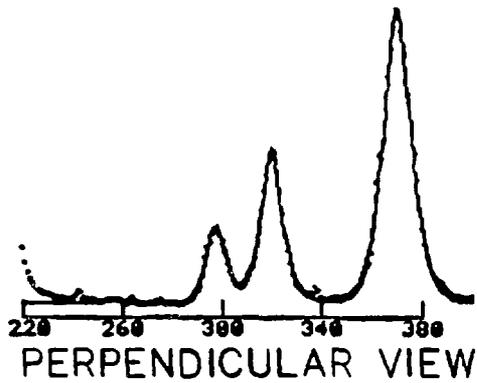
OMA DATA

Figure 28. Typical OMA data from a 30 second shot are shown.

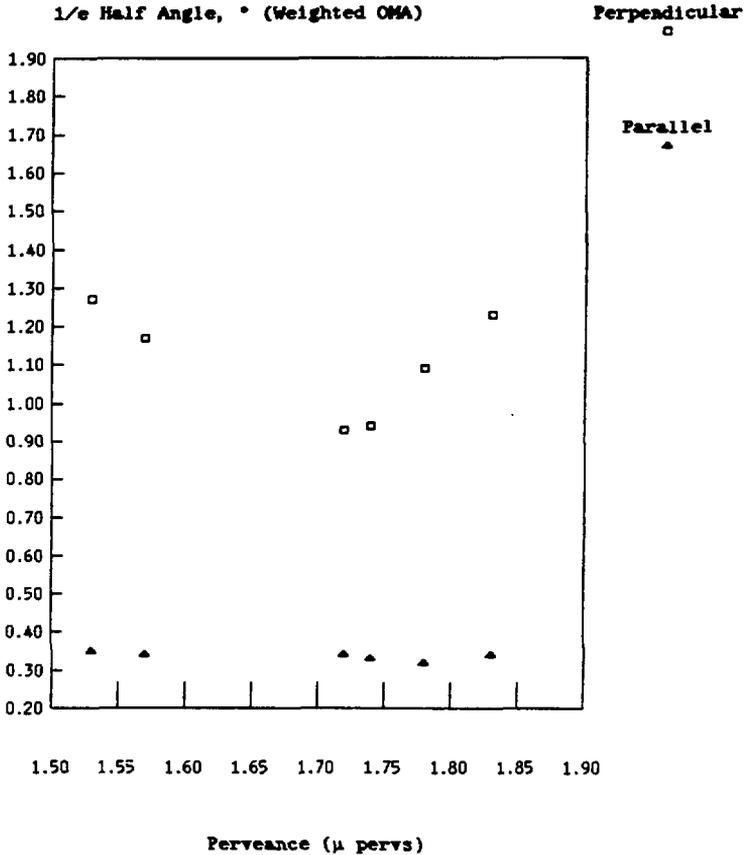
80 KV CONTAMINATED DEUTERIUM (2.4% OXYGEN), 12 TL/S

Figure A.1. OMA beam divergence (RMS) is plotted vs perveance during testing of the LLNL oxygen-contaminated (2.4%) deuterium bottle at 80 kv.

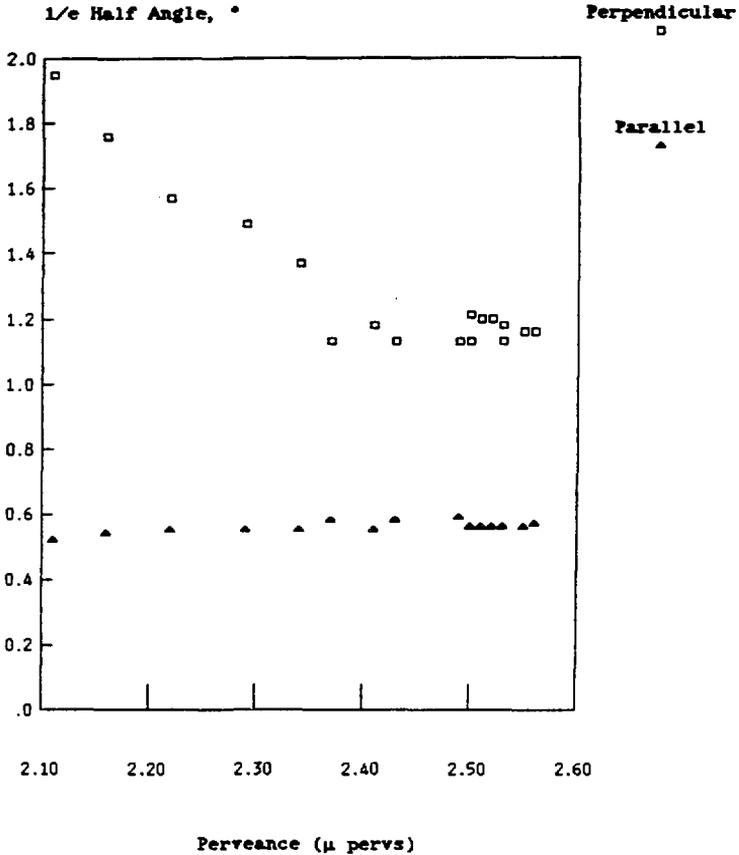
80 KV HYDROGEN (26 TL/S)

Figure B.1. Inertial calorimeter beam divergence is plotted vs perveance for hydrogen at 80 kV; the beam pulse was 75 msec.
