Waste Streams that Preferentially Corrode 55-gallon Steel Storage Drums

INEL-95/0291

Idaho National Engineering Laboratory
Lockheed Martin Idaho Technologies
Idaho Falls, Idaho 83415

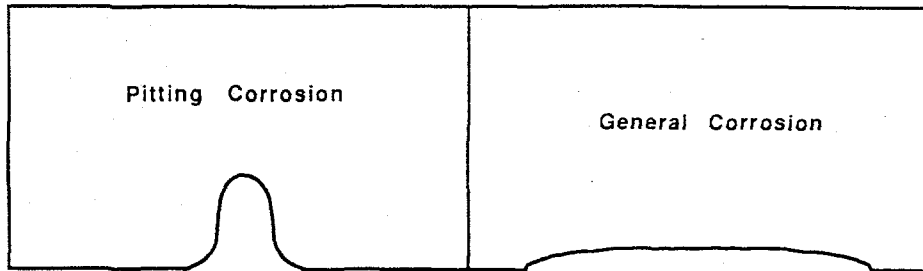
Figure 1-1. Drum Corrosion Types.

Pitting corrosion: Pitting corrosion is at distinct spots where deep pits are produced. The pit acts as a small corrosion cell. Pitting rate will be about ten times the general rate of corrosion.

General corrosion: Surface layers of metal are converted to corrosion products in such a way that the thickness of the section is uniformly decreased.

Figure 1-1 shows a schematic of the two principal modes of drum corrosion failure: a) pitting corrosion, and b) general corrosion. Figure 1-2 shows the hypothetical corrosion depth, $x(t)$, as a function of time. There is no scale on the time axis since neither the corrosion rate, dx/dt , nor the time to failure, t_f , is known. The survey set out to identify the waste streams (WS) that are especially corrosive to steel waste drums and the time to earliest failure for each waste stream for which drums have been observed to fail by corrosion.

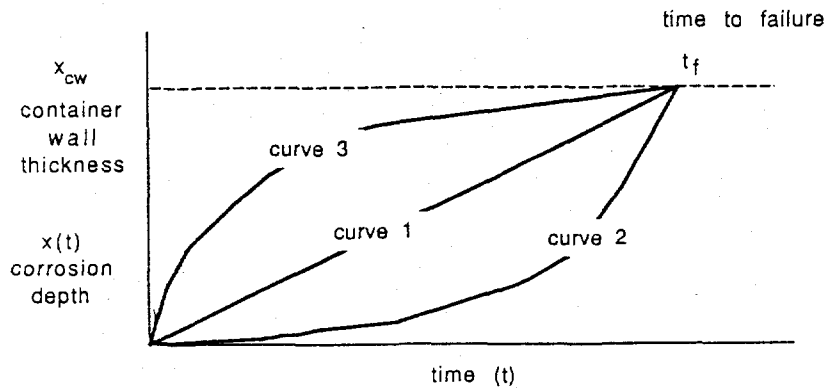
Figure 1-2. Corrosion Curves.

Curve 1: linear corrosion rate

Curve 2: Corrosion which is initially slow but increases with time

Curve 3: corrosion which is initially rapid and slows asymptotically decreasing with time

The three curves in Figure 1-2 depict linear corrosion (curve 1), corrosion which is initially slow but increases with time (curve 2), and corrosion which is initially rapid and slows asymptotically (curve 3). All physical corrosion curves must show corrosion depth as a monotonically increasing function (the corroding container wall can not heal itself), i.e., $dx/dt \geq 0$. Failure will occur when the corrosion depth is equal to the container wall thickness, x_{cw} , i.e., when $x(t) = x_{cw}$.

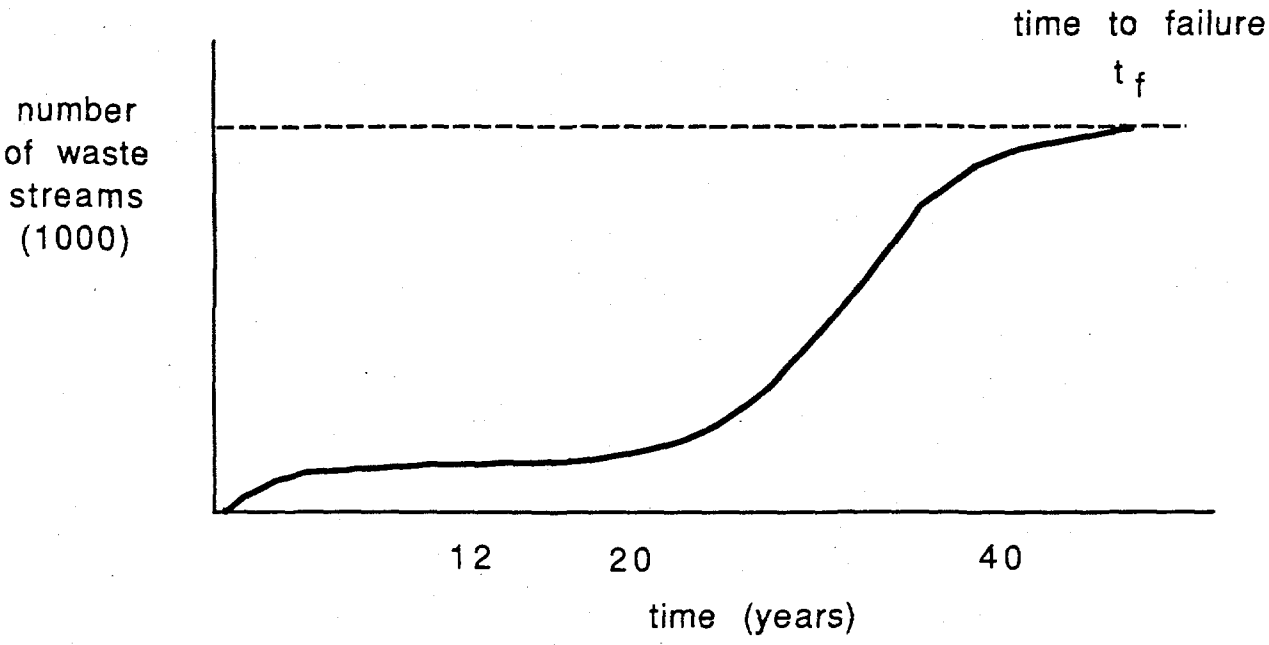
Figure 2. Expected Drum Failure Rates.

In Figure 3, a time scale has been placed on the curve, which is a composite of curves 1 and 3 from Figure 1-2. At the RWMC, drums have been in a weather protected but otherwise limited control environment for up to 12 years. None of these drums have experienced internal corrosion failure; approximately 1% either have been overpacked or will shortly be overpacked due to visibly severe external corrosion. This is inconsistent with the original design life of 20 years. Under good conditions, drums could be expected to last 20 to 40 years. Sometime beyond 40 years most will have failed or be near failure.

Based on a nominal corrosion rate of carbon steel of about 0.001 in./yr (25 micron/yr) and a drum wall thickness of 0.06 in., the 20 - 40 years expected life corresponds to a loss of 30% to 50% wall thickness. A general corrosion rate of 0.01 to 0.02 in./yr is generally listed as "moderate" corrosion. Pitting corrosion is generally ten times as rapid as general corrosion; internal corrosion is expected to be dominated by pitting corrosion. For a 55-gal drum, such a corrosion rate would coincide with an early time-to-failure of 2-5 years.

Based on the model shown in Figure 3 and the fact that highly corrosive wastes were rarely packed directly in carbon steel drums, we anticipate that there will be an early failure peak of 2-5 years attributable to internal corrosion. Very few, if any, drums have been stored in protected, inspectable storage for times required to experience significant failures by external corrosion.

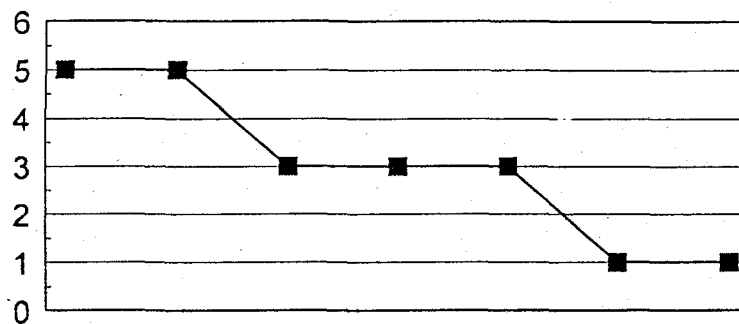
Figure 3. Drum Failures.

Years in Storage	1 year	2 years	3 years	4 years	5 years	6 years	7 years
Number of Failures ■	5	5	3	3	3	1	1

The survey reported that 21 waste streams from seven DOE facilities caused the 55-gal steel storage drums to be overpacked or repackaged because of preferential corrosion by the waste stream components on the drum.

The number of drums for each waste stream was not identified during this survey. Each waste stream could have from one to hundreds of drums. Figure 3 shows the time to failure for the first drum of a each specific waste stream to fail. Most of the waste streams experienced failures within three years; the longest time to first failure was seven years. This observation is in agreement with Figure 2 and supports our hypothesis that the failures are due to internal corrosion.
