## **Termination of Past Nuclear Activities at the Nuclear Research Institute**

**Helena Janžekovič, Milko Križman**  
Slovenian Nuclear Safety Administration  
Železna cesta 16, SI-1001 Ljubljana, Slovenia  
[helena.janzekovic@gov.si](mailto:helena.janzekovic@gov.si), [milko.krizman@gov.si](mailto:milko.krizman@gov.si)

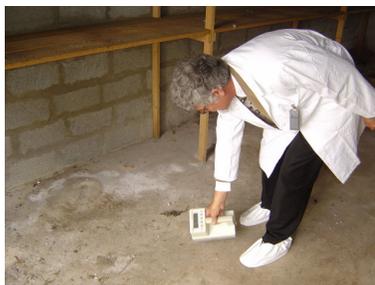
On the on – site inspection as a rule an inspector was accompanied by the expert of the SNSA. The essential part of the on – site inspections was a use of the measurement equipment in order to find the contaminated areas or sources of ionising radiation. The instrument *FieldSpec* [4] for measurement of gamma dose rate and identification of radionuclides emitting gamma with  $^3\text{He}$  counter for a detection of neutrons was used. In addition a contamination monitor was used when necessary. Also a personal electronic pager for a fast detection of the gamma radiation was used. The contamination areas were scanned by a Berthold *Contamination Monitor LB 122*. Figure 1 shows the expert from the SNSA on the on site – inspection at the IJS measuring the contamination of the floor of an abandoned storage.

Figure 1: Measurement of the floor contamination on the on site inspection of the SNSA at the IJS.

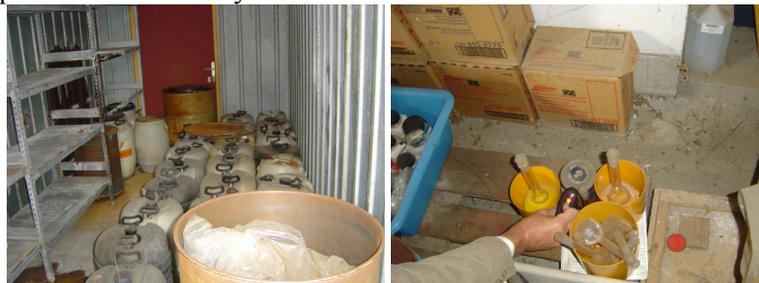
- In addition during the inspections of SNSA around 200 unregistered sources or out of a proper control were found at the IJS. During handling of some sources only part of protective measures was in place. Furthermore, some sources were not treated as radioactive material at all either during their storage or during their everyday use. Some sources were liquids which required pre-treatment before their storage in the Central Interim Storage for Radioactive Waste. Figure 2 shows abandoned storages of the liquid radioactive waste with uranium compound as well with yellow cake at the IJS.

Figure 2: Abandoned storages of the liquid radioactive waste with uranium compound as well with yellow cake at the IJS.

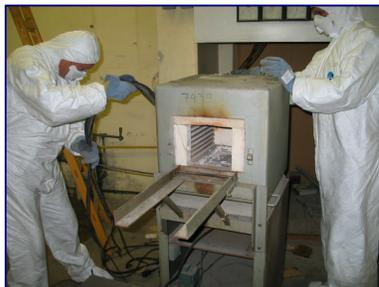
Figure 3: Decontamination of contaminated oven which was used in the past in the research of uranium compound at the IJS. The picture was provided by the IJS.

The IJS immediately started with the remediation activities including the decontamination of two nuclear laboratories and three different storages of radioactive waste at its sites. Meanwhile 60 above mentioned sources have been already stored in the Central Interim Storage for Radioactive Waste. The IJS staff started with decontamination procedures at some areas and the pre-treatment of radioactive liquids. The decontamination procedures are still in progress. Figure 3 shows the decontamination of contaminated oven which was used in the past in the research of uranium compound at the IJS.
